Profile/Photo Observation Report

Date:	04/08/2018	Weather:		Coding:	PACP 6.0
Pipe Length (ft):		Owner:	City of Hobart	Pre Clean:	No Pre-Cleaning
P.O.#:	19-1	Surveyor:	M. Pielacha	PSR:	M-404-025-M-404-014
Customer:	City of Hobart	Clean Date:		Shape:	C

Street:	Old Ridge Road	Flow Control:	Not Controlled
City:	Hobart, IN	Year Renewed:	
Location:	Light Highway	Tape/Media #:	DEP 19
Purpose:	Routine Assessment	Dia/Height:	18"
Use:	Sanitary	Material:	VCP
Drain Area:		Lining:

US MH: **M-404-025** DS MH: **M-404-014** Total Length Surveyed (ft): **339.7**

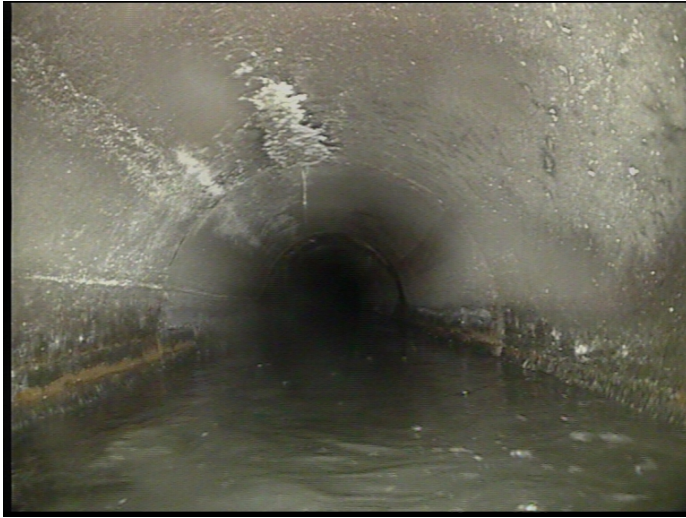
Code: **MWL**
Description: **Water Level**

Distance (ft): **.0**
Structural Grade: **0**
O&M Grade: **0**
Clock Start/From:
Clock To:
1st Value:
2nd Value:
Value Percent: **20.000**
Continuous Index:
Within 8" of Joint: **NO**
Remarks:

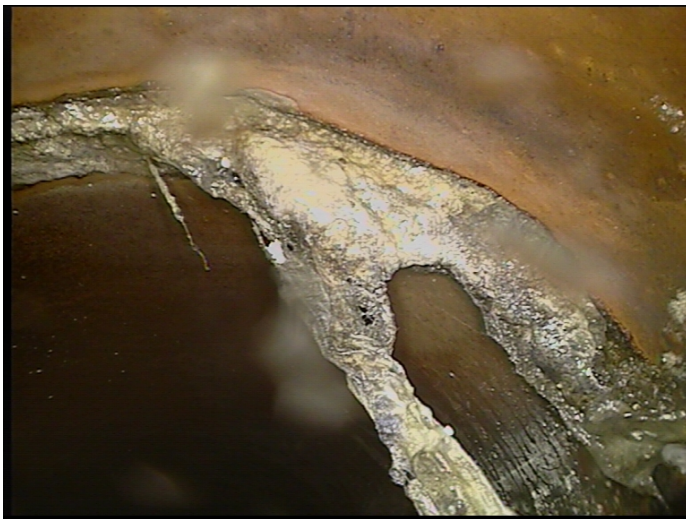
Code: **DAE**
Description: **Deposits Attached Encrustation**

Distance (ft): **65.8**
Structural Grade: **0**
O&M Grade: **2**
Clock Start/From: **12**
Clock To: **5**
1st Value:
2nd Value:
Value Percent: **5.000**
Continuous Index:
Within 8" of Joint: **YES**
Remarks:

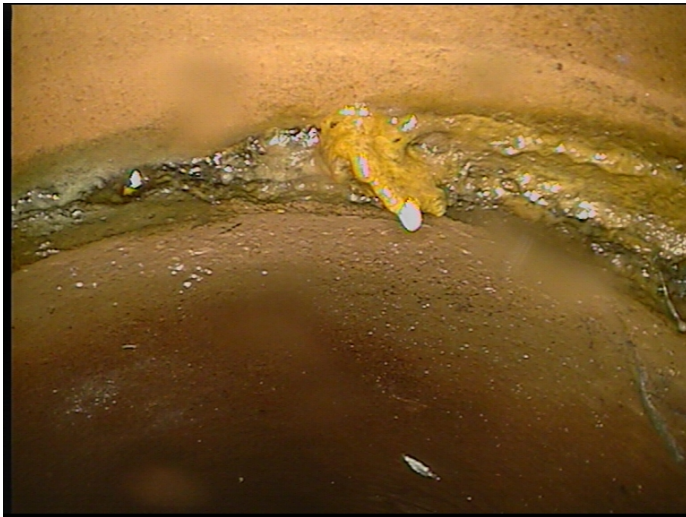
Code:	ID
Description:	Infil Dripper
Distance (ft):	91.6
Structural Grade:	0
O&M Grade:	3
Clock Start/From:	1
Clock To:	
1st Value:	
2nd Value:	
Value Percent:	
Continuous Index:	
Within 8" of Joint:	YES
Remarks:

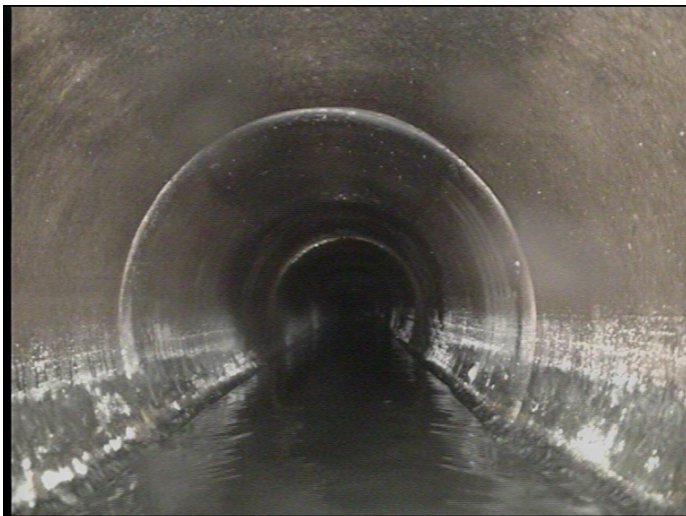
Code: **DAE**
Description: **Deposits Attached Encrustation**

Distance (ft): **130.2**
Structural Grade: **0**
O&M Grade: **2**
Clock Start/From: **7**
Clock To: **5**
1st Value:
2nd Value:
Value Percent: **5.000**
Continuous Index: **F01**
Within 8" of Joint: **NO**
Remarks:

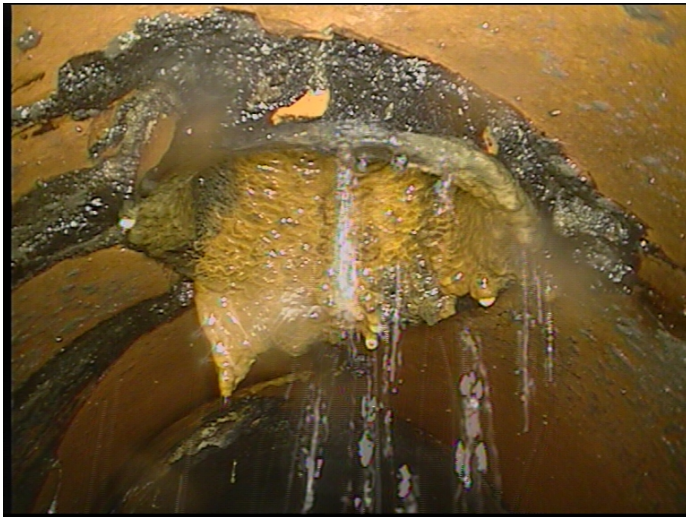
Code: **TBA**
Description: **Tap Break-in Active**

Distance (ft): **155.7**
Structural Grade: **0**
O&M Grade: **0**
Clock Start/From: **12**
Clock To:
1st Value: **4.000**
2nd Value:
Value Percent:
Continuous Index:
Within 8" of Joint: **NO**
Remarks:

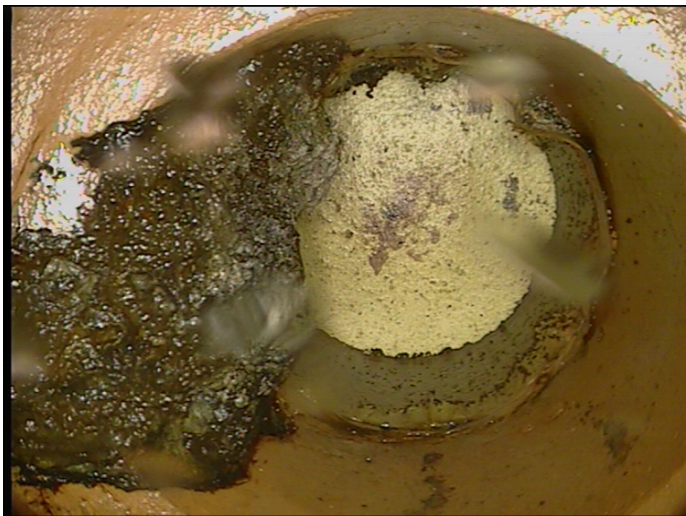
Code: **TFC**
Description: **Tap Factory Capped**

Distance (ft): **164.2**
Structural Grade: **0**
O&M Grade: **0**
Clock Start/From: **11**
Clock To:
1st Value: **4.000**
2nd Value:
Value Percent:
Continuous Index:
Within 8" of Joint: **NO**
Remarks:

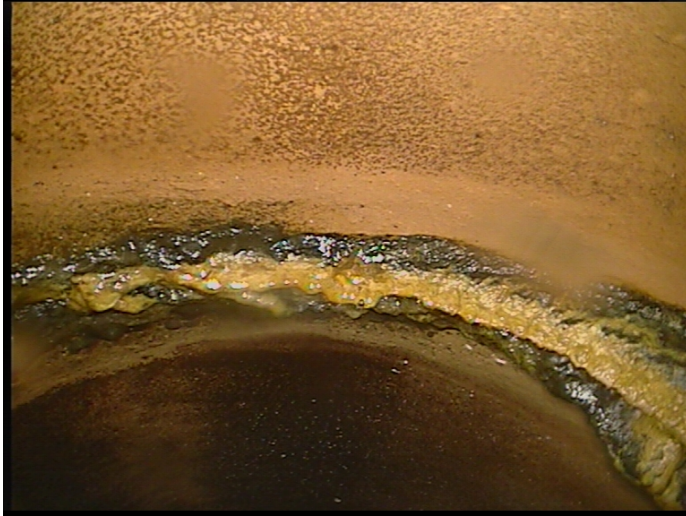
Code: ID
Description: Infil Dripper

Distance (ft): 216.5
Structural Grade: 0
O&M Grade: 3
Clock Start/From: 1
Clock To:
1st Value:
2nd Value:
Value Percent:
Continuous Index:
Within 8" of Joint: YES
Remarks:

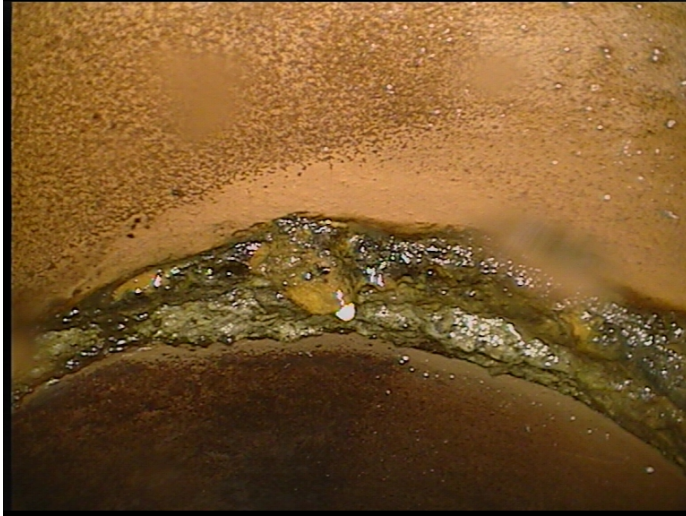
Code: **ID**
Description: **Infil Dripper**

Distance (ft): **275.6**
Structural Grade: **0**
O&M Grade: **3**
Clock Start/From: **1**
Clock To:
1st Value:
2nd Value:
Value Percent:
Continuous Index:
Within 8" of Joint: **YES**
Remarks:

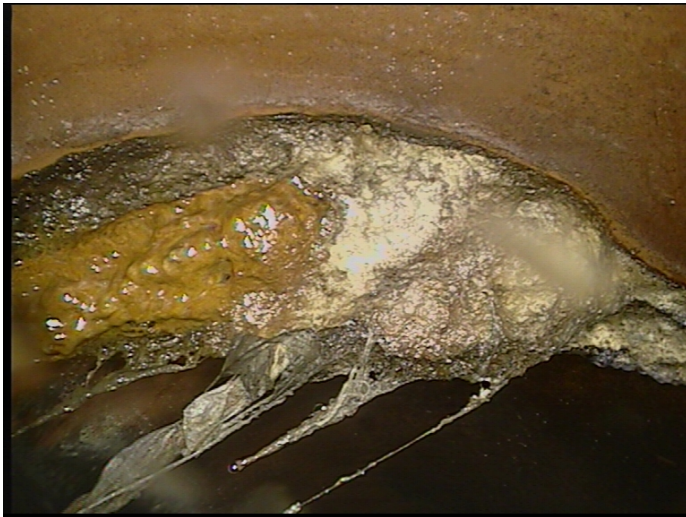
Code: **DAE**
Description: **Deposits Attached Encrustation**

Distance (ft): **280.5**
Structural Grade: **0**
O&M Grade: **2**
Clock Start/From: **7**
Clock To: **11**
1st Value:
2nd Value:
Value Percent: **10.000**
Continuous Index:
Within 8" of Joint: **YES**
Remarks:

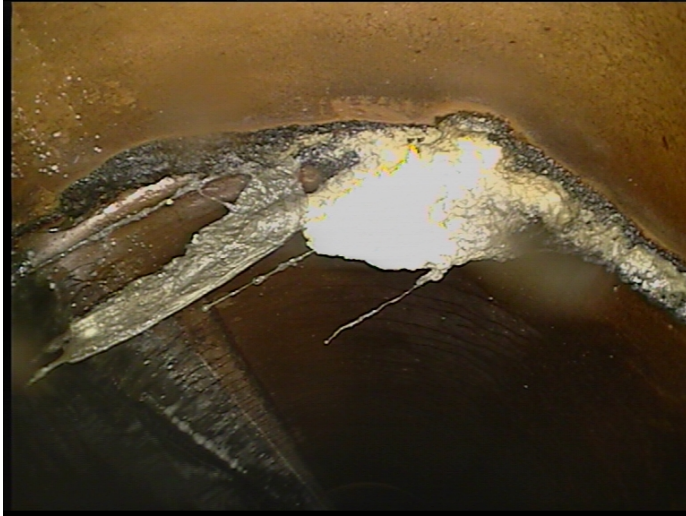
Code:	DAE
Description:	Deposits Attached Encrustation
Distance (ft):	321.0
Structural Grade:	0
O&M Grade:	2
Clock Start/From:	7
Clock To:	10
1st Value:	
2nd Value:	
Value Percent:	10.000
Continuous Index:	
Within 8" of Joint:	YES
Remarks:
