Profile/Photo Observation Report

Date:	04/08/2018	Weather:		Coding:	PACP 6.0
Pipe Length (ft):		Owner:	City of Hobart	Pre Clean:	No Pre-Cleaning
P.O.#:	19-1	Surveyor:	M. Pielacha	PSR:	M-404-025-M-404-014
Customer:	City of Hobart	Clean Date:		Shape:	C

Street:	Old Ridge Road	Flow Control:	Not Controlled
City:	Hobart, IN	Year Renewed:	
Location:	Light Highway	Tape/Media #:	DEP 19
Purpose:	Routine Assessment	Dia/Height:	18"
Use:	Sanitary	Material:	VCP
Drain Area:		Lining:

US MH: **M-404-025** DS MH: **M-404-014** Total Length Surveyed (ft): **339.7**

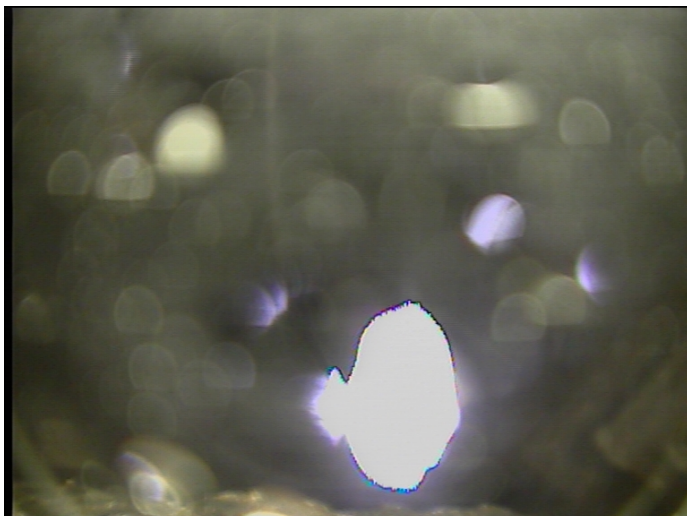
Code: **AMH**
 Description: **Manhole**

Distance (ft): **.0**
 Structural Grade: **0**
 O&M Grade: **0**
 Clock Start/From:
 Clock To:
 1st Value:
 2nd Value:
 Value Percent:
 Continuous Index:
 Within 8" of Joint: **NO**
 Remarks: **M-404-025**

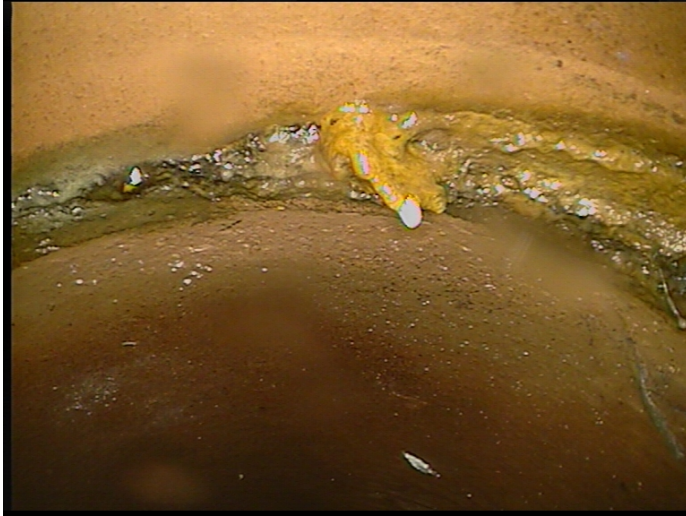
Code:	ID
Description:	Infil Dripper
Distance (ft):	91.6
Structural Grade:	0
O&M Grade:	3
Clock Start/From:	1
Clock To:	
1st Value:	
2nd Value:	
Value Percent:	
Continuous Index:	
Within 8" of Joint:	YES
Remarks:

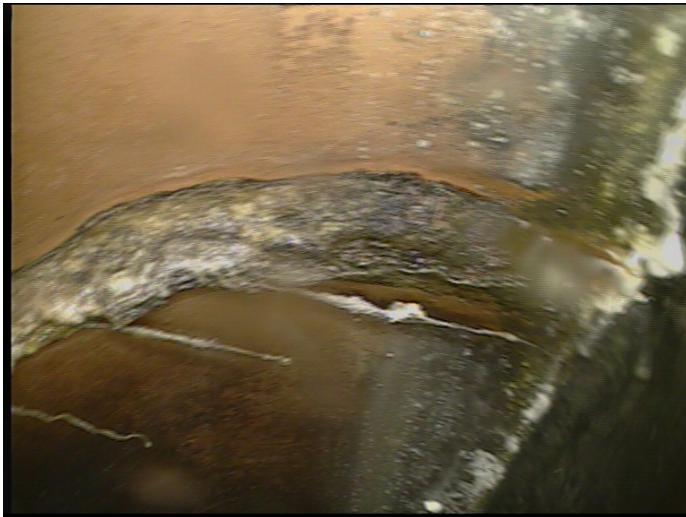
Code:	DAE
Description:	Deposits Attached Encrustation
Distance (ft):	101.6
Structural Grade:	0
O&M Grade:	2
Clock Start/From:	7
Clock To:	5
1st Value:	
2nd Value:	
Value Percent:	5.000
Continuous Index:	
Within 8" of Joint:	YES
Remarks:
