Profile/Photo Observation Report

Street:	DEARBORN ST & W OLD RIDGE RD	Flow Control:	Not Controlled
City:	Hobart, IN	Year Renewed:	
Location:	Light Highway	Tape/Media #:	
Purpose:	Not Known	Dia/Height:	10"
Use:	Sanitary	Material:	VCP
Drain Area:	NA	Lining:	
Category:	NA		
Comment:

Location Details:		Direction of Survey:	Downstream
US MH:	M-404-025	DS MH:	M-404-026
		Total Length Surveyed (ft):	211.2

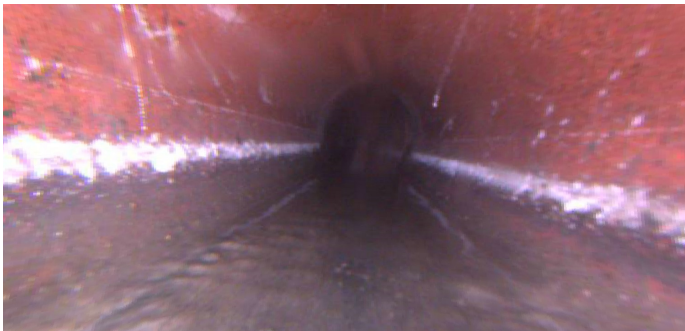
Code: **AMH**
Description: **Manhole**

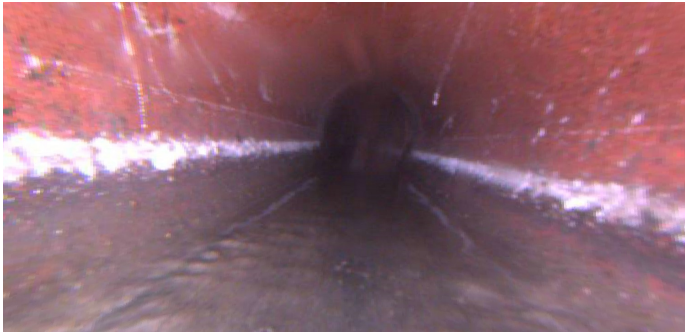
Code:	MWL
Description:	Water Level

Distance (ft):	.0
Structural Grade:	0
O&M Grade:	0
Clock Start/From:	
Clock To:	
1st Value:	
2nd Value:	
Value Percent:	5.000
Continuous Index:	
Within 8" of Joint:	NO
Remarks:

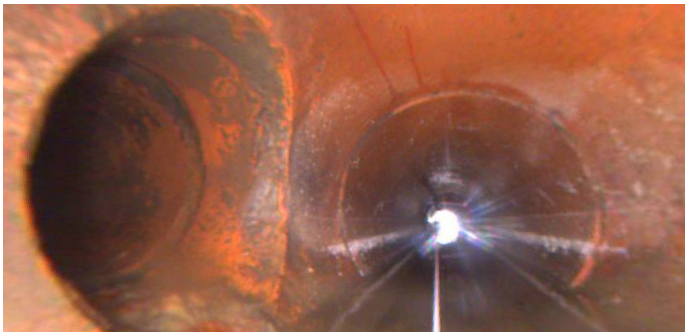
Code:	TFA
Description:	Tap Factory Active

Distance (ft):	4.4
Structural Grade:	0
O&M Grade:	0
Clock Start/From:	3
Clock To:	
1st Value:	4.000
2nd Value:	
Value Percent:	
Continuous Index:	
Within 8" of Joint:	
Remarks:

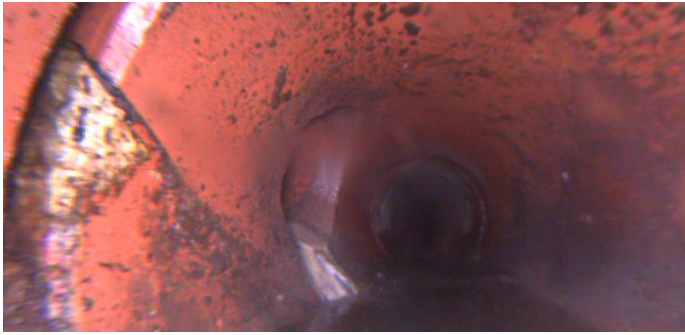
Code: **FS**
Description: **Fracture Spiral**

Distance (ft): **30.6**
Structural Grade: **3**
O&M Grade: **0**
Clock Start/From: **9**
Clock To: **10**
1st Value:
2nd Value:
Value Percent:
Continuous Index:
Within 8" of Joint: **YES**
Remarks:

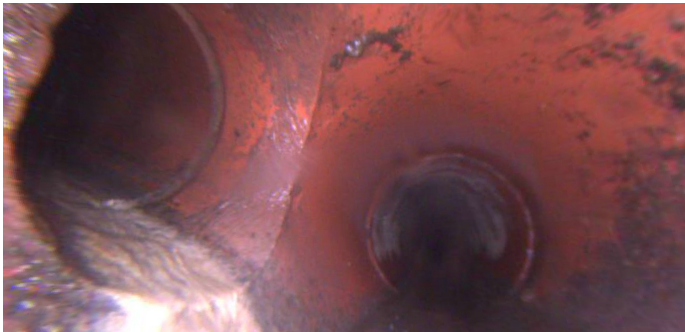
Code: **TFA**
Description: **Tap Factory Active**

Distance (ft): **31.2**
Structural Grade: **0**
O&M Grade: **0**
Clock Start/From: **9**
Clock To:
1st Value: **4.000**
2nd Value:
Value Percent:
Continuous Index:
Within 8" of Joint:
Remarks:

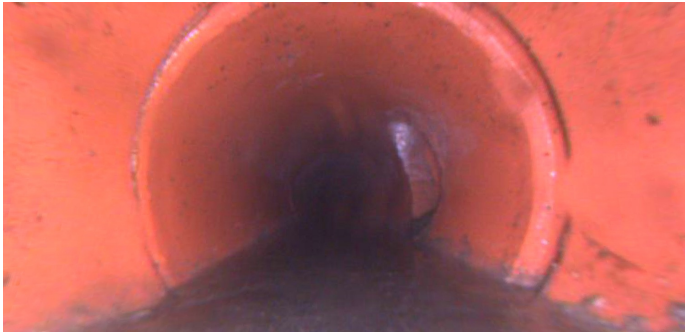
Code: **FL**
Description: **Fracture Longitudinal**

Distance (ft): **73.0**
Structural Grade: **3**
O&M Grade: **0**
Clock Start/From: **4**
Clock To:
1st Value:
2nd Value:
Value Percent:
Continuous Index:
Within 8" of Joint: **YES**
Remarks:

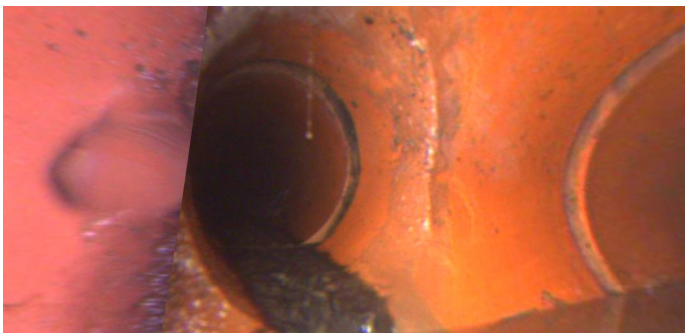
Code: **TFA**
Description: **Tap Factory Active**

Distance (ft): **74.6**
Structural Grade: **0**
O&M Grade: **0**
Clock Start/From: **3**
Clock To:
1st Value: **4.000**
2nd Value:
Value Percent:
Continuous Index:
Within 8" of Joint:
Remarks:

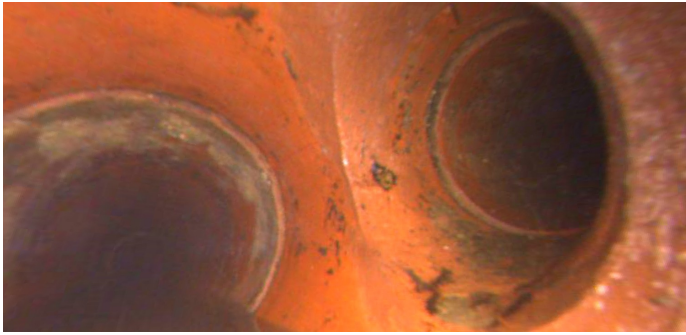
Code: **TF**
Description: **Tap Factory**

Distance (ft): **102.1**
Structural Grade: **0**
O&M Grade: **0**
Clock Start/From: **9**
Clock To:
1st Value: **4.000**
2nd Value:
Value Percent:
Continuous Index:
Within 8" of Joint:
Remarks:

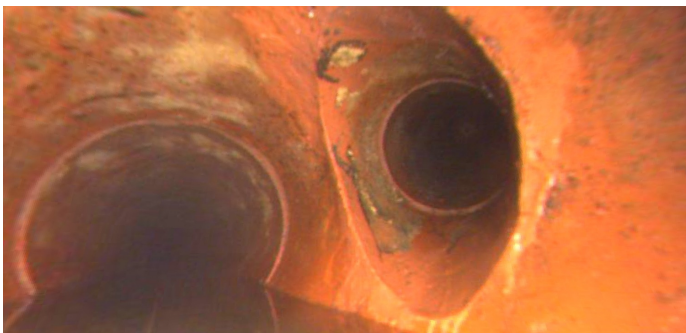
Code: **TF**
Description: **Tap Factory**

Distance (ft): **170.5**
Structural Grade: **0**
O&M Grade: **0**
Clock Start/From: **9**
Clock To:
1st Value: **4.000**
2nd Value:
Value Percent:
Continuous Index:
Within 8" of Joint:
Remarks:

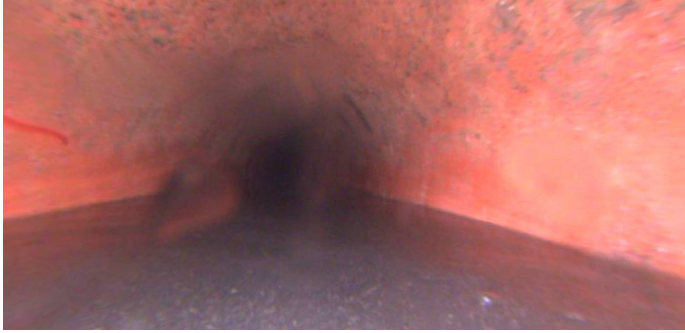
Code: **MWL**
Description: **Water Level**

Distance (ft): **188.7**
Structural Grade: **0**
O&M Grade: **0**
Clock Start/From:
Clock To:
1st Value:
2nd Value:
Value Percent: **40.000**
Continuous Index:
Within 8" of Joint: **NO**
Remarks:

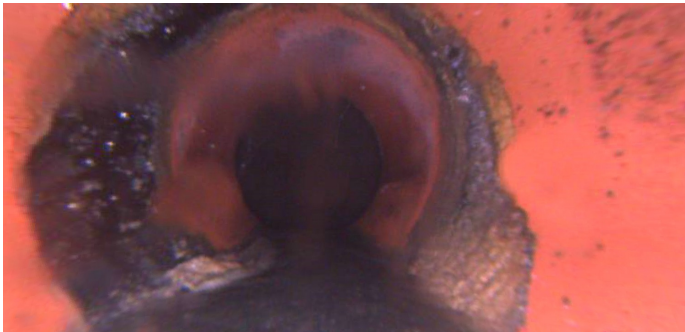
Code: **DAE**
Description: **Deposits Attached Encrustation**

Distance (ft): **205.4**
Structural Grade: **0**
O&M Grade: **2**
Clock Start/From: **8**
Clock To: **4**
1st Value:
2nd Value:
Value Percent: **10.000**
Continuous Index:
Within 8" of Joint: **YES**
Remarks:

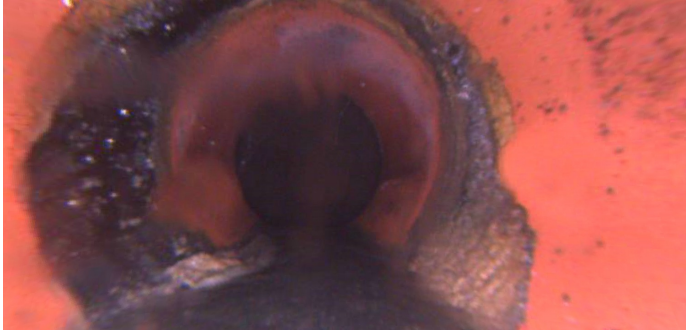
Code: **IW**
Description: **Infil Weeper**

Distance (ft): **205.4**
Structural Grade: **0**
O&M Grade: **2**
Clock Start/From: **7**
Clock To: **5**
1st Value:
2nd Value:
Value Percent:
Continuous Index:
Within 8" of Joint: **YES**
Remarks:
