## Profile/Photo Observation Report

Date:	<b>04/16/2018</b>	Weather:		Coding:	<b>PACP 6.0</b>
Pipe Length (ft):	<b>213.5</b>	Owner:	<b>NA</b>	Pre Clean:	<b>Not Known</b>
P.O.#:		Surveyor:	<b>Selasie Honu</b>	PSR:	<b>P-404-026-025</b>
Customer:		Clean Date:	<b>01/01/1900</b>	Shape:	<b>C</b>

Street:	<b>Summerlin</b>	Flow Control:	<b>Not Controlled</b>
City:	<b>Hobart, IN</b>	Year Renewed:	
Location:	<b>Light Highway</b>	Tape/Media #:	
Purpose:	<b>Not Known</b>	Dia/Height:	<b>10"</b>
Use:	<b>Sanitary</b>	Material:	<b>VCP</b>
Drain Area:	<b>NA</b>	Lining:	
Category:	<b>NA</b>		
Comment:

Location Details:		Direction of Survey:	<b>Downstream</b>
US MH:	<b>M-404-025</b>	DS MH:	<b>M-404-026</b>
		Total Length Surveyed (ft):	<b>211.2</b>

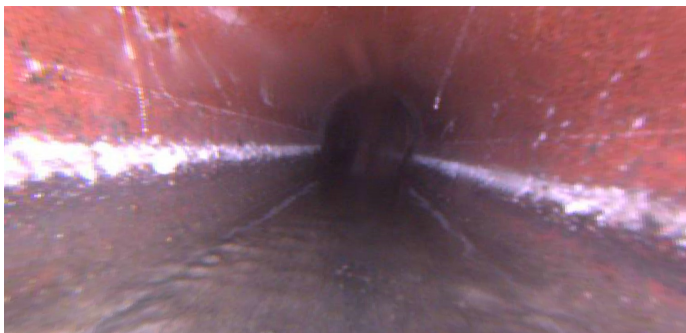
Code: **AMH**  
Description: **Manhole**

Distance (ft): **.0**  
Structural Grade: **0**  
O&M Grade: **0**  
Clock Start/From:  
Clock To:  
1st Value:  
2nd Value:  
Value Percent:  
Continuous Index:  
Within 8" of Joint: **NO**  
Remarks: **M-404-025**

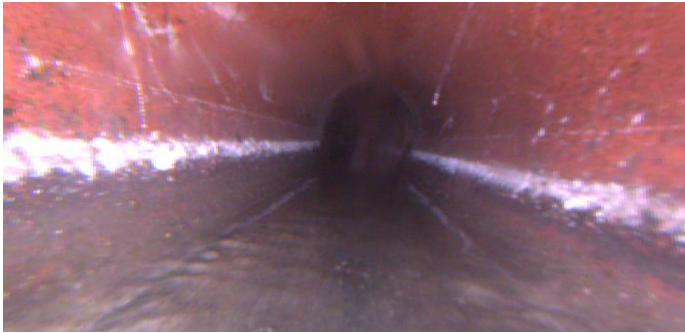
Code:	<b>MWL</b>
Description:	<b>Water Level</b>

Distance (ft):	<b>.0</b>
Structural Grade:	<b>0</b>
O&M Grade:	<b>0</b>
Clock Start/From:	
Clock To:	
1st Value:	
2nd Value:	
Value Percent:	<b>5.000</b>
Continuous Index:	
Within 8" of Joint:	<b>NO</b>
Remarks:

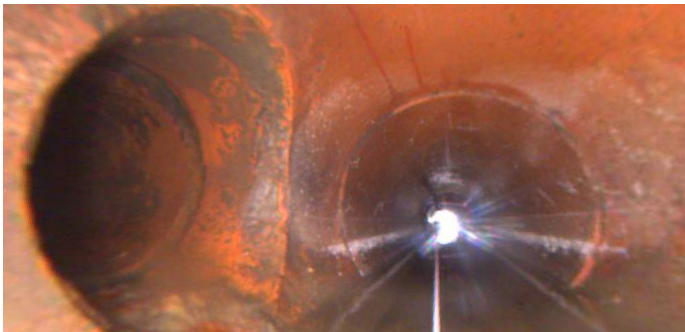
Code:	<b>TFA</b>
Description:	<b>Tap Factory Active</b>

Distance (ft):	<b>4.4</b>
Structural Grade:	<b>0</b>
O&M Grade:	<b>0</b>
Clock Start/From:	<b>3</b>
Clock To:	
1st Value:	<b>4.000</b>
2nd Value:	
Value Percent:	
Continuous Index:	
Within 8" of Joint:	
Remarks:

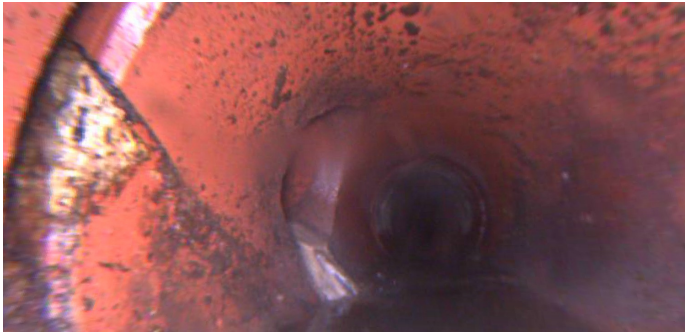
Code: **FS**  
Description: **Fracture Spiral**

Distance (ft): **30.6**  
Structural Grade: **3**  
O&M Grade: **0**  
Clock Start/From: **9**  
Clock To: **10**  
1st Value:  
2nd Value:  
Value Percent:  
Continuous Index:  
Within 8" of Joint: **YES**  
Remarks:

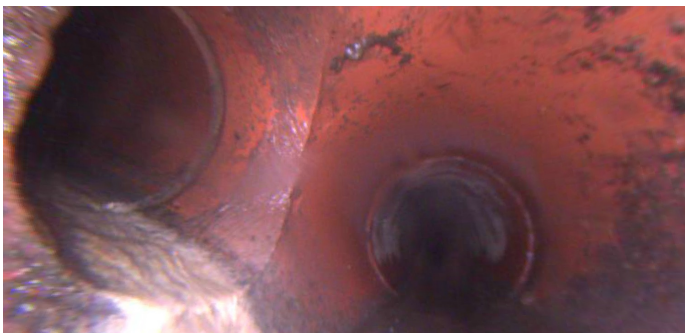
Code: **TFA**  
Description: **Tap Factory Active**

Distance (ft): **31.2**  
Structural Grade: **0**  
O&M Grade: **0**  
Clock Start/From: **9**  
Clock To:  
1st Value: **4.000**  
2nd Value:  
Value Percent:  
Continuous Index:  
Within 8" of Joint:  
Remarks:

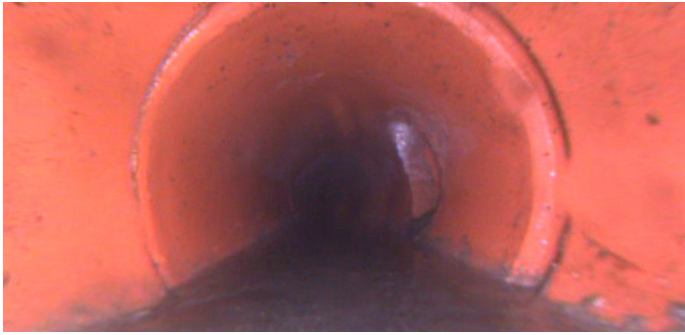
Code: **FL**  
Description: **Fracture Longitudinal**

Distance (ft): **73.0**  
Structural Grade: **3**  
O&M Grade: **0**  
Clock Start/From: **4**  
Clock To:  
1st Value:  
2nd Value:  
Value Percent:  
Continuous Index:  
Within 8" of Joint: **YES**  
Remarks:

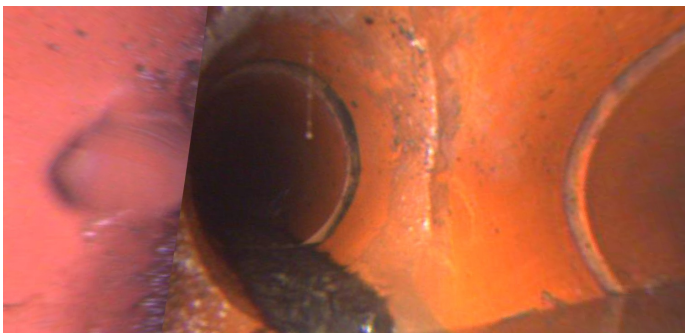
Code: **TFA**  
Description: **Tap Factory Active**

Distance (ft): **74.6**  
Structural Grade: **0**  
O&M Grade: **0**  
Clock Start/From: **3**  
Clock To:  
1st Value: **4.000**  
2nd Value:  
Value Percent:  
Continuous Index:  
Within 8" of Joint:  
Remarks:

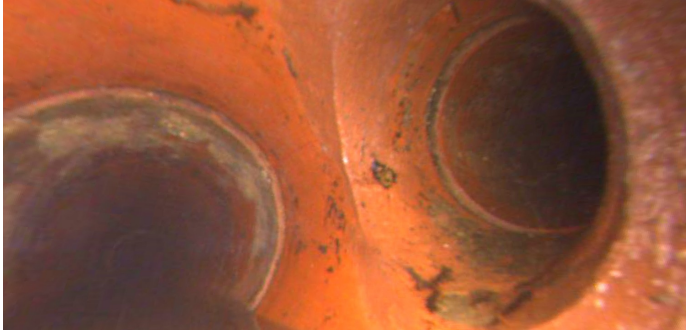
Code: **TF**  
Description: **Tap Factory**

Distance (ft): **102.1**  
Structural Grade: **0**  
O&M Grade: **0**  
Clock Start/From: **9**  
Clock To:  
1st Value: **4.000**  
2nd Value:  
Value Percent:  
Continuous Index:  
Within 8" of Joint:  
Remarks:

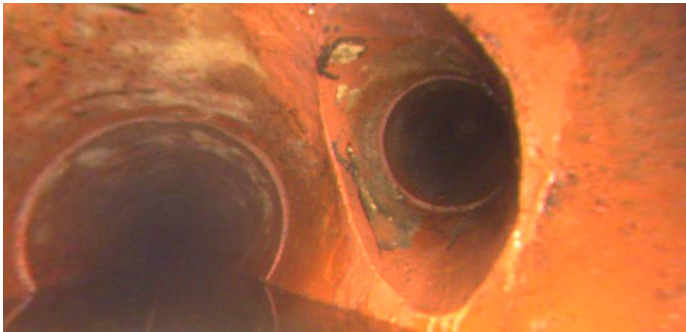
Code: **TF**  
Description: **Tap Factory**

Distance (ft): **170.5**  
Structural Grade: **0**  
O&M Grade: **0**  
Clock Start/From: **9**  
Clock To:  
1st Value: **4.000**  
2nd Value:  
Value Percent:  
Continuous Index:  
Within 8" of Joint:  
Remarks:

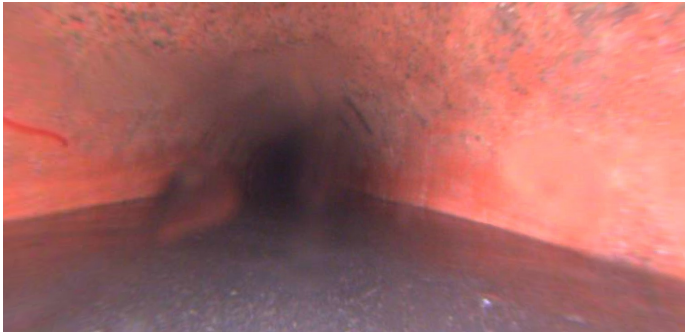
Code: **MWL**  
Description: **Water Level**

Distance (ft): **188.7**  
Structural Grade: **0**  
O&M Grade: **0**  
Clock Start/From:  
Clock To:  
1st Value:  
2nd Value:  
Value Percent: **40.000**  
Continuous Index:  
Within 8" of Joint: **NO**  
Remarks:

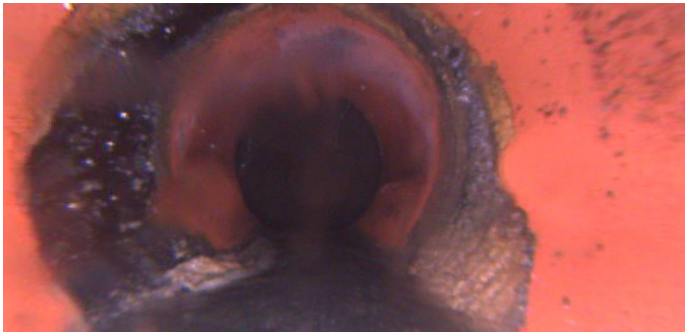
Code: **DAE**  
Description: **Deposits Attached Encrustation**

Distance (ft): **205.4**  
Structural Grade: **0**  
O&M Grade: **2**  
Clock Start/From: **8**  
Clock To: **4**  
1st Value:  
2nd Value:  
Value Percent: **10.000**  
Continuous Index:  
Within 8" of Joint: **YES**  
Remarks:

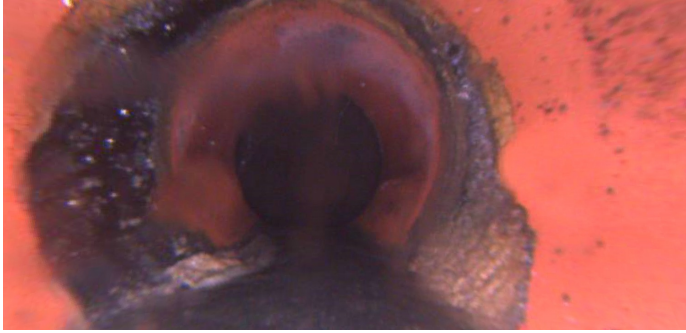
Code: **IW**  
Description: **Infil Weeper**

Distance (ft): **205.4**  
Structural Grade: **0**  
O&M Grade: **2**  
Clock Start/From: **7**  
Clock To: **5**  
1st Value:  
2nd Value:  
Value Percent:  
Continuous Index:  
Within 8" of Joint: **YES**  
Remarks:
