Profile/Photo Observation Report

Street:	Old Ridge Road	Flow Control:	Not Controlled
City:	Hobart, IN	Year Renewed:	
Location:	Light Highway	Tape/Media #:	DEP 18
Purpose:	Reversal	Dia/Height:	18"
Use:	Sanitary	Material:	VCP
Drain Area:		Lining:	
Category:	NA		
Comment:			
Location Details:		Direction of Survey:	Upstream
US MH:	M-404-028	DS MH:	M-404-025
		Total Length Surveyed (ft):	15.4

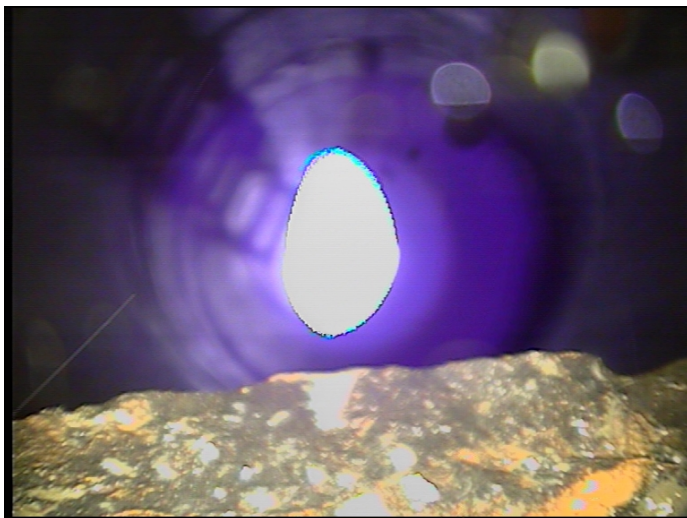
Code: **AMH**
Description: **Manhole**

Distance (ft): **.0**
Structural Grade: **0**
O&M Grade: **0**
Clock Start/From:
Clock To:
1st Value:
2nd Value:
Value Percent:
Continuous Index:
Within 8" of Joint: **NO**
Remarks: **M-404-025**
