## Profile/Photo Observation Report

Date:	<b>04/08/2018</b>	Weather:		Coding:	<b>PACP 6.0</b>
Pipe Length (ft):		Owner:	<b>City of Hobart</b>	Pre Clean:	<b>No Pre-Cleaning</b>
P.O.#:	<b>18-1</b>	Surveyor:	<b>M. Pielacha</b>	PSR:	<b>M-404-028-M-404-025</b>
Customer:	<b>City of Hobart</b>	Clean Date:		Shape:	<b>C</b>

Street:	<b>Old Ridge Road</b>	Flow Control:	<b>Not Controlled</b>
City:	<b>Hobart, IN</b>	Year Renewed:	
Location:	<b>Light Highway</b>	Tape/Media #:	<b>DEP 18</b>
Purpose:	<b>Reversal</b>	Dia/Height:	<b>18"</b>
Use:	<b>Sanitary</b>	Material:	<b>VCP</b>
Drain Area:		Lining:

US MH: **M-404-028** DS MH: **M-404-025** Total Length Surveyed (ft): **15.4**

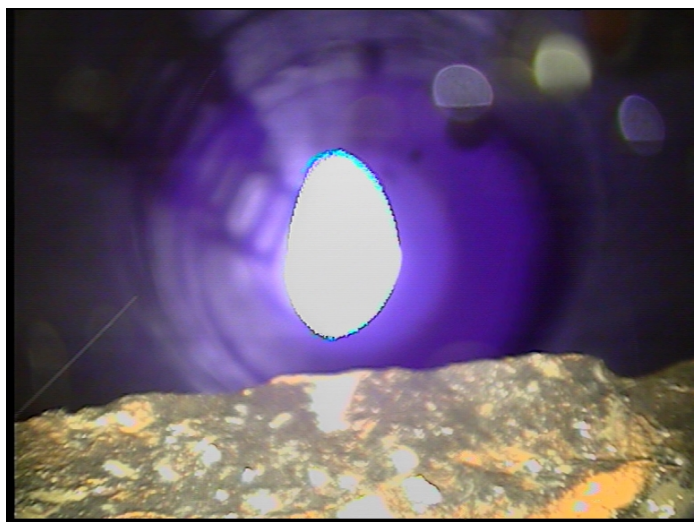
Code: **AMH**  
Description: **Manhole**

Distance (ft): **.0**  
Structural Grade: **0**  
O&M Grade: **0**  
Clock Start/From:  
Clock To:  
1st Value:  
2nd Value:  
Value Percent:  
Continuous Index:  
Within 8" of Joint: **NO**  
Remarks: **M-404-025**

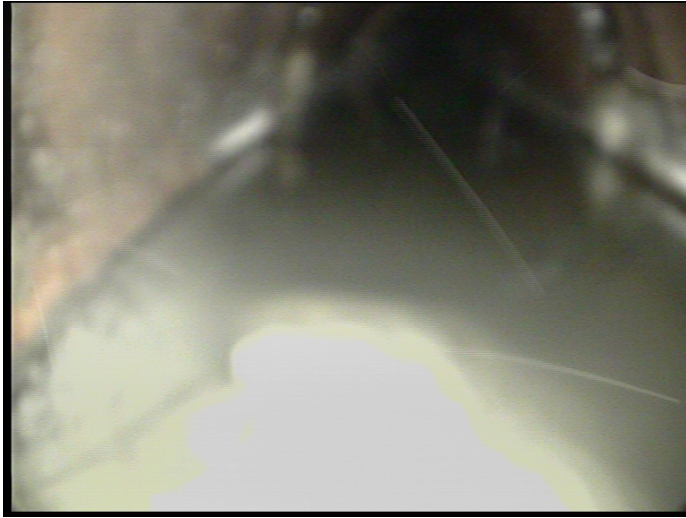
Code: **MWL**  
Description: **Water Level**

Distance (ft): **.0**  
Structural Grade: **0**  
O&M Grade: **0**  
Clock Start/From:  
Clock To:  
1st Value:  
2nd Value:  
Value Percent: **15.000**  
Continuous Index:  
Within 8" of Joint: **NO**  
Remarks:

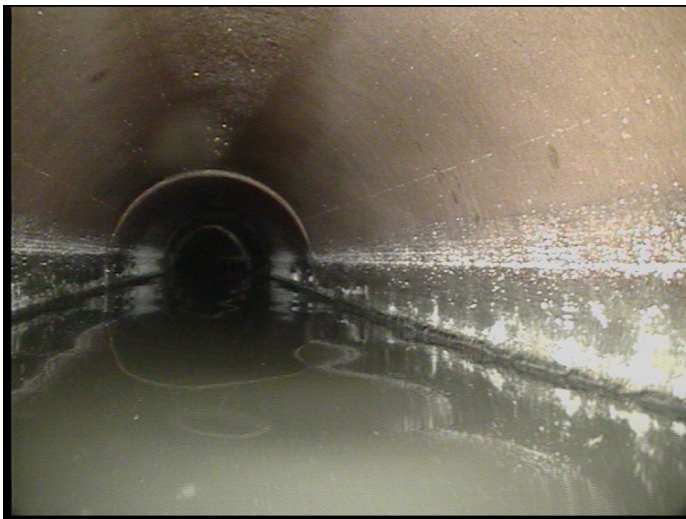
Code: **MSA**  
Description: **Abandoned Survey**

Distance (ft): **15.0**  
Structural Grade: **0**  
O&M Grade: **0**  
Clock Start/From:  
Clock To:  
1st Value:  
2nd Value:  
Value Percent:  
Continuous Index:  
Within 8" of Joint: **NO**  
Remarks: **underwater debris**
