## Profile/Photo Observation Report

Date:	<b>09/10/2021</b>	Weather:		Coding:	<b>PACP 7.0</b>
Pipe Length (ft):	<b>165.4</b>	Owner:	<b>City of Hobart</b>	Pre Clean:	<b>Light Cleaning</b>
P.O.#:	<b>YES502259</b>	Surveyor:	<b>S. Bucklin</b>	PSR:	<b>P-404-028.1-028</b>
Customer:	<b>City of Hobart</b>	Clean Date:	<b>09/10/2021</b>	Shape:	<b>C</b>

Street:	<b>Old Ridge Road</b>	Flow Control:	<b>Not Controlled</b>
City:	<b>Hobart, IN</b>	Year Renewed:	
Location:	<b>Woods</b>	Tape/Media #:	
Purpose:	<b>Routine Assessment</b>	Dia/Height:	<b>8"</b>
Use:	<b>Sanitary Sewage Pipe</b>	Material:	<b>PVC</b>
Drain Area:		Lining:	<b>None</b>
Category:	<b>NA</b>		
Comment:			
Location Details:		Direction of Survey:	<b>Downstream</b>
US MH:	<b>M-404-028</b>	DS MH:	<b>M-404-028.1</b>
		Total Length Surveyed (ft):	<b>165.4</b>

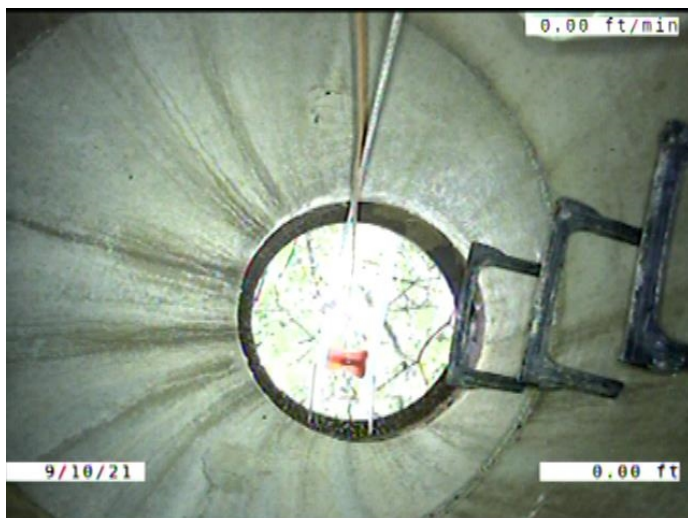
Code: **AMH**  
 Description: **Manhole**

Distance (ft): **.0**  
 Structural Grade: **0**  
 O&M Grade: **0**  
 Clock Start/From:  
 Clock To:  
 1st Value:  
 2nd Value:  
 Value Percent:  
 Continuous Index:  
 Within 8" of Joint: **NO**  
 Remarks: **M-404-028**

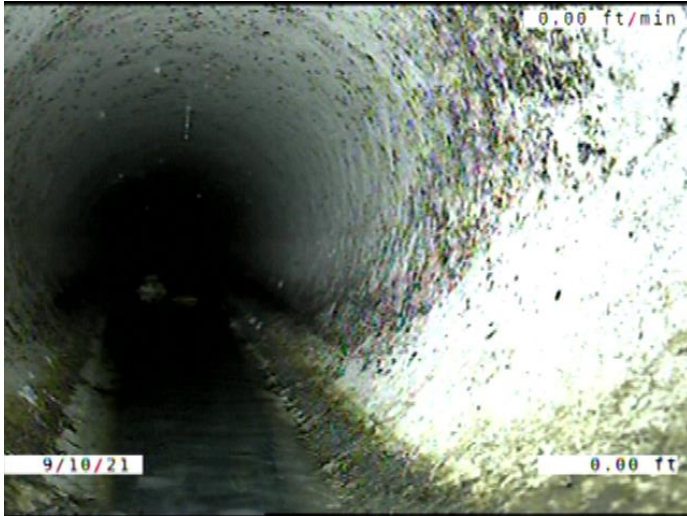
Code:	<b>MWL</b>
Description:	<b>Miscellaneous Water Level</b>
Distance (ft):	<b>.0</b>
Structural Grade:	<b>0</b>
O&M Grade:	<b>0</b>
Clock Start/From:	
Clock To:	
1st Value:	
2nd Value:	
Value Percent:	<b>5.000</b>
Continuous Index:	
Within 8" of Joint:	<b>NO</b>
Remarks:

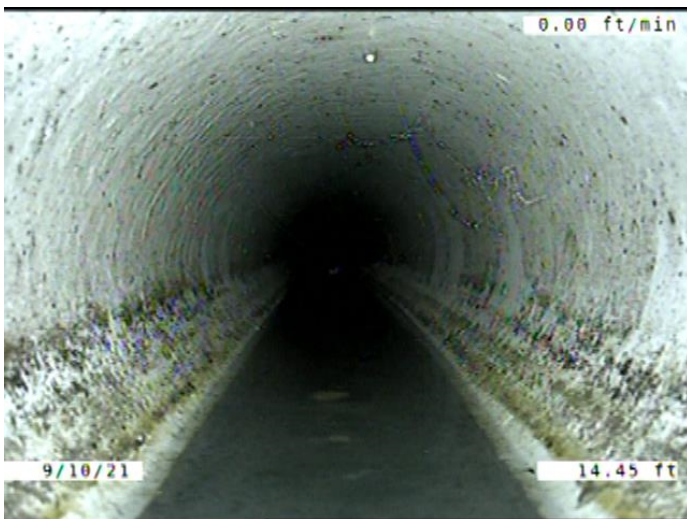
Code:	<b>MWLS</b>
Description:	<b>Miscellaneous Water Level Sag</b>
Distance (ft):	<b>14.4</b>
Structural Grade:	<b>2</b>
O&M Grade:	<b>0</b>
Clock Start/From:	
Clock To:	
1st Value:	
2nd Value:	
Value Percent:	<b>5.000</b>
Continuous Index:	<b>S01</b>
Within 8" of Joint:	<b>NO</b>
Remarks:

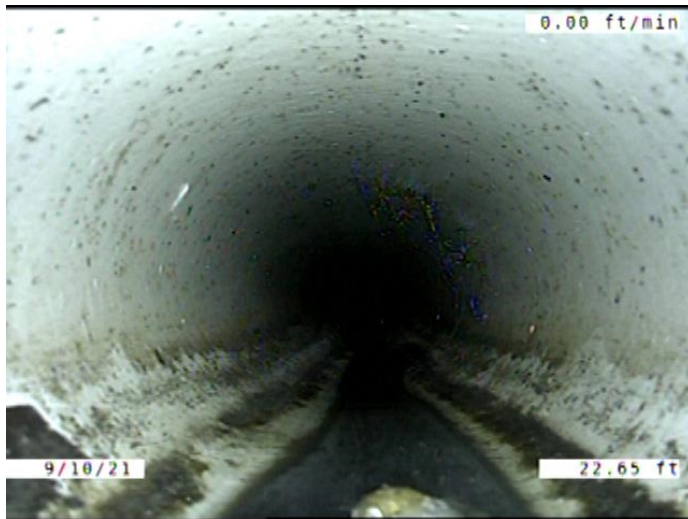
Code: **MWLS**  
Description: **Miscellaneous Water Level Sag**

Distance (ft): **22.7**  
Structural Grade: **2**  
O&M Grade: **0**  
Clock Start/From:  
Clock To:  
1st Value:  
2nd Value:  
Value Percent: **5.000**  
Continuous Index: **F01**  
Within 8" of Joint: **NO**  
Remarks:

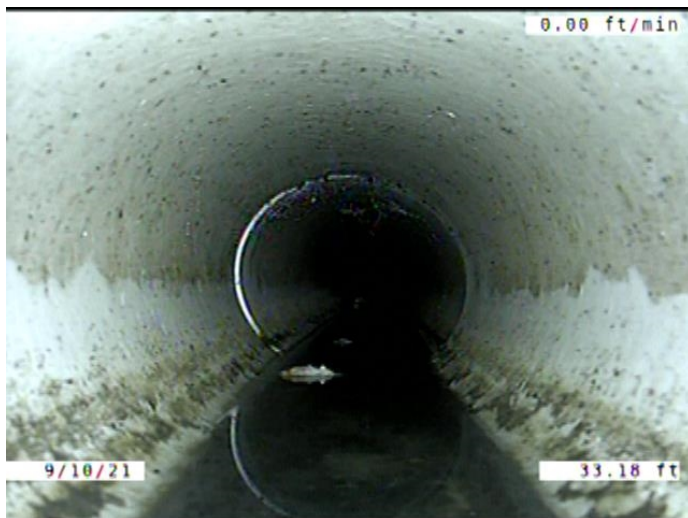
Code: **MWLS**  
Description: **Miscellaneous Water Level Sag**

Distance (ft): **33.2**  
Structural Grade: **2**  
O&M Grade: **0**  
Clock Start/From:  
Clock To:  
1st Value:  
2nd Value:  
Value Percent: **5.000**  
Continuous Index: **S02**  
Within 8" of Joint: **NO**  
Remarks:

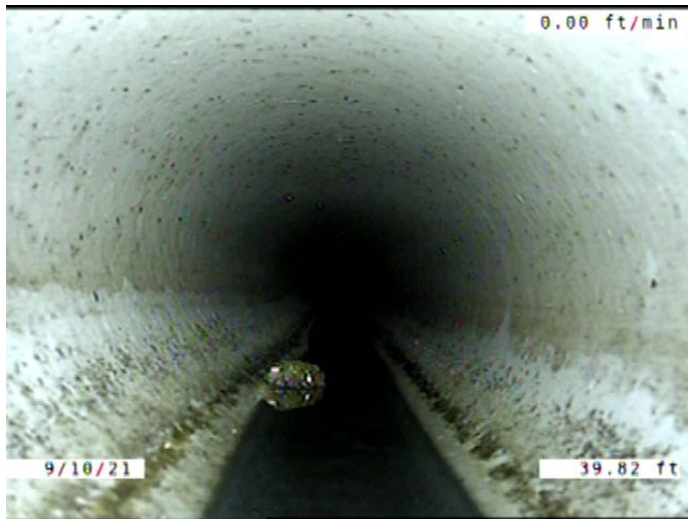
Code: **MWLS**  
Description: **Miscellaneous Water Level Sag**

Distance (ft): **39.8**  
Structural Grade: **2**  
O&M Grade: **0**  
Clock Start/From:  
Clock To:  
1st Value:  
2nd Value:  
Value Percent: **5.000**  
Continuous Index: **F02**  
Within 8" of Joint: **NO**  
Remarks:

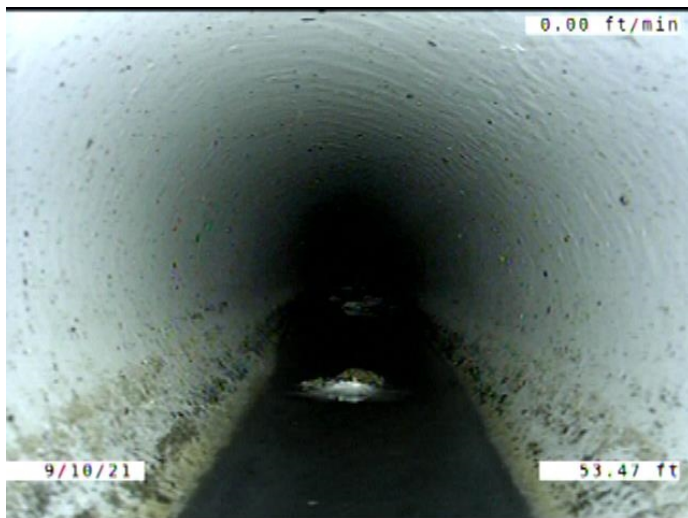
Code: **DSF**  
Description: **Deposits Settled Fine**

Distance (ft): **53.5**  
Structural Grade: **0**  
O&M Grade: **2**  
Clock Start/From: **5**  
Clock To: **7**  
1st Value:  
2nd Value:  
Value Percent: **5.000**  
Continuous Index: **S03**  
Within 8" of Joint: **YES**  
Remarks:

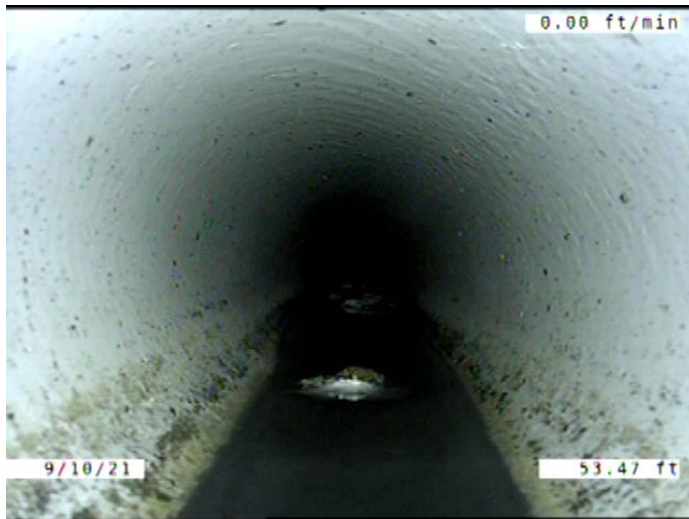
Code: **MWLS**  
Description: **Miscellaneous Water Level Sag**

Distance (ft): **53.5**  
Structural Grade: **2**  
O&M Grade: **0**  
Clock Start/From:  
Clock To:  
1st Value:  
2nd Value:  
Value Percent: **10.000**  
Continuous Index: **S04**  
Within 8" of Joint: **NO**  
Remarks:

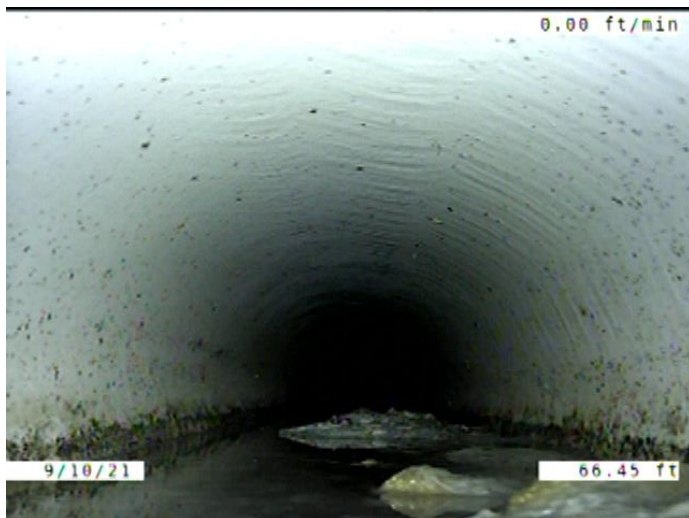
Code: **DSF**  
Description: **Deposits Settled Fine**

Distance (ft): **66.4**  
Structural Grade: **0**  
O&M Grade: **2**  
Clock Start/From: **5**  
Clock To: **7**  
1st Value:  
2nd Value:  
Value Percent: **5.000**  
Continuous Index: **F03**  
Within 8" of Joint: **YES**  
Remarks:

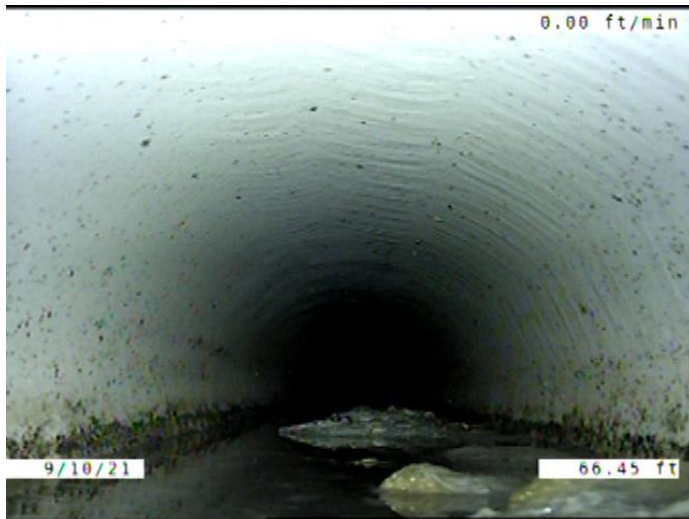
Code: **DSF**  
Description: **Deposits Settled Fine**

Distance (ft): **66.4**  
Structural Grade: **0**  
O&M Grade: **3**  
Clock Start/From: **4**  
Clock To: **8**  
1st Value:  
2nd Value:  
Value Percent: **15.000**  
Continuous Index: **S05**  
Within 8" of Joint: **YES**  
Remarks:

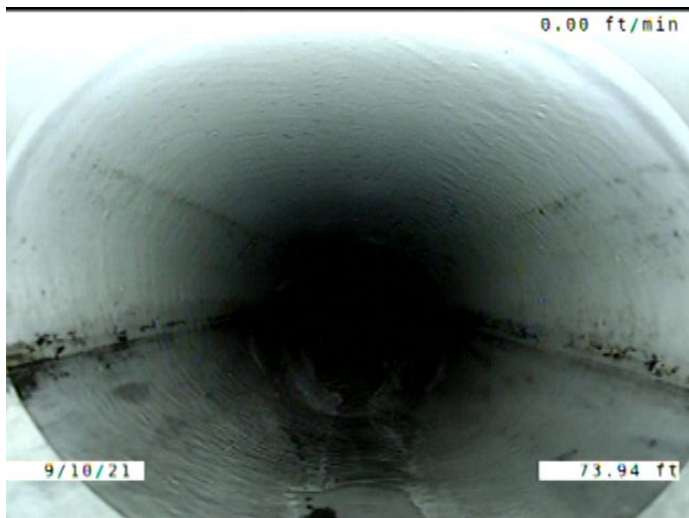
Code: **DSF**  
Description: **Deposits Settled Fine**

Distance (ft): **73.9**  
Structural Grade: **0**  
O&M Grade: **3**  
Clock Start/From: **4**  
Clock To: **8**  
1st Value:  
2nd Value:  
Value Percent: **15.000**  
Continuous Index: **F05**  
Within 8" of Joint: **YES**  
Remarks:

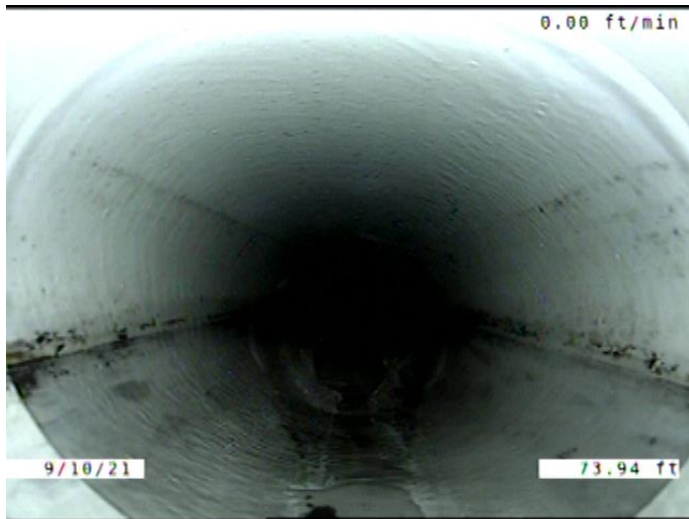
Code: **MWLS**  
Description: **Miscellaneous Water Level Sag**

Distance (ft): **73.9**  
Structural Grade: **2**  
O&M Grade: **0**  
Clock Start/From:  
Clock To:  
1st Value:  
2nd Value:  
Value Percent: **10.000**  
Continuous Index: **F04**  
Within 8" of Joint: **NO**  
Remarks:

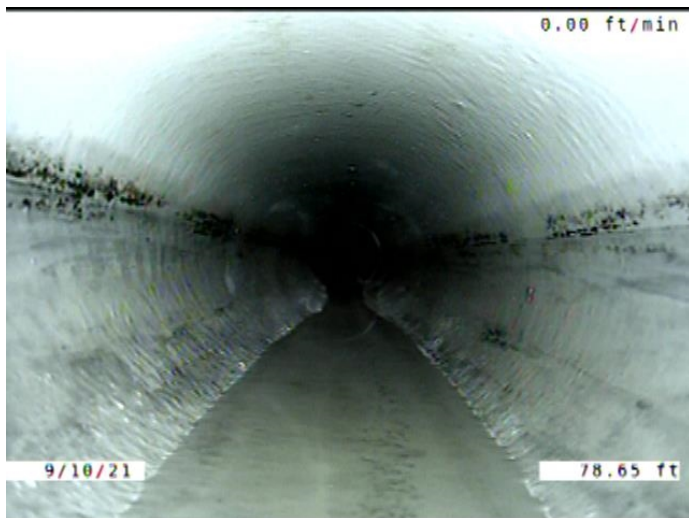
Code: **MWLS**  
Description: **Miscellaneous Water Level Sag**

Distance (ft): **78.6**  
Structural Grade: **2**  
O&M Grade: **0**  
Clock Start/From:  
Clock To:  
1st Value:  
2nd Value:  
Value Percent: **5.000**  
Continuous Index:  
Within 8" of Joint: **NO**  
Remarks:

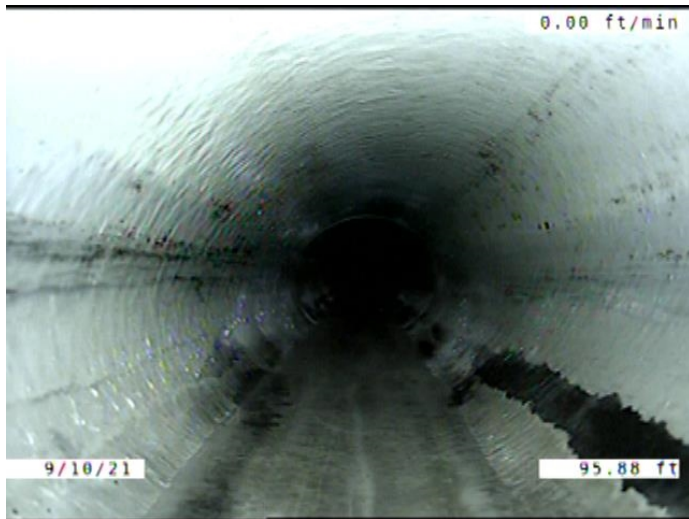
Code: **MWLS**  
Description: **Miscellaneous Water Level Sag**

Distance (ft): **95.9**  
Structural Grade: **2**  
O&M Grade: **0**  
Clock Start/From:  
Clock To:  
1st Value:  
2nd Value:  
Value Percent: **5.000**  
Continuous Index: **S06**  
Within 8" of Joint: **NO**  
Remarks:

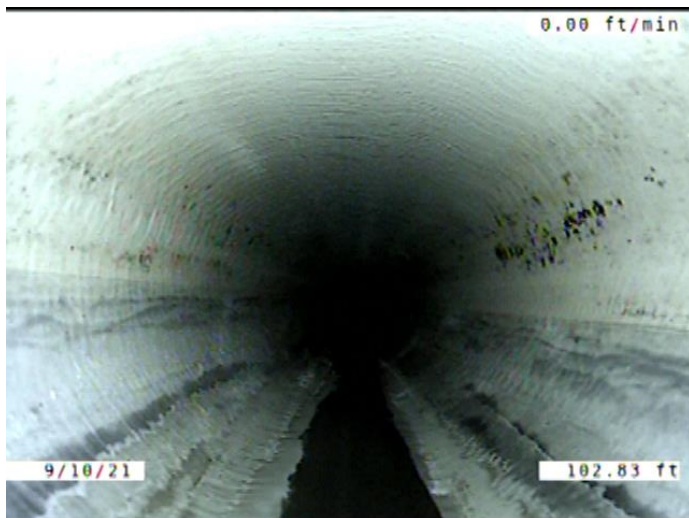
Code: **MWLS**  
Description: **Miscellaneous Water Level Sag**

Distance (ft): **102.8**  
Structural Grade: **2**  
O&M Grade: **0**  
Clock Start/From:  
Clock To:  
1st Value:  
2nd Value:  
Value Percent: **5.000**  
Continuous Index: **F06**  
Within 8" of Joint: **NO**  
Remarks:

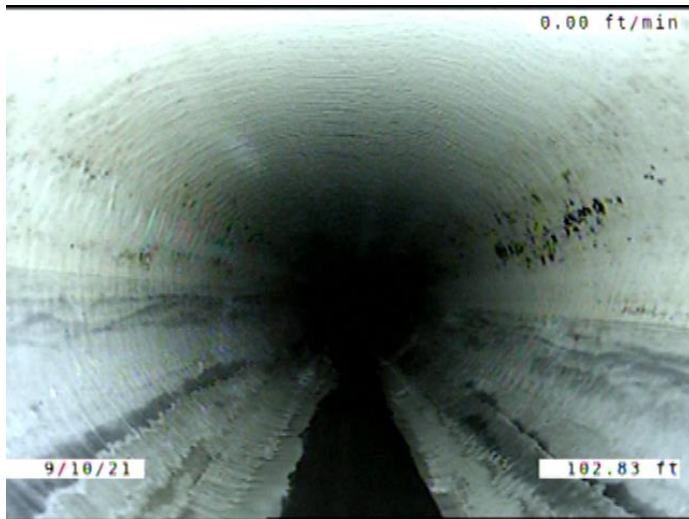
Code: **DSF**  
Description: **Deposits Settled Fine**

Distance (ft): **102.8**  
Structural Grade: **0**  
O&M Grade: **2**  
Clock Start/From: **5**  
Clock To: **7**  
1st Value:  
2nd Value:  
Value Percent: **5.000**  
Continuous Index: **S07**  
Within 8" of Joint: **YES**  
Remarks:

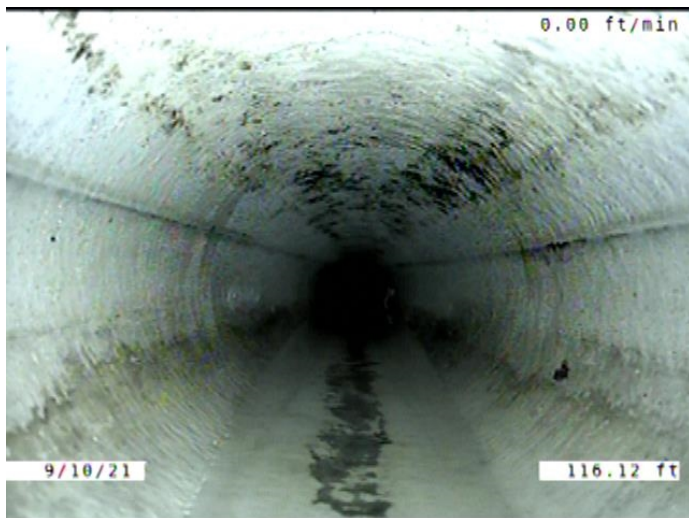
Code: **MWLS**  
Description: **Miscellaneous Water Level Sag**

Distance (ft): **116.1**  
Structural Grade: **2**  
O&M Grade: **0**  
Clock Start/From:  
Clock To:  
1st Value:  
2nd Value:  
Value Percent: **10.000**  
Continuous Index: **S08**  
Within 8" of Joint: **NO**  
Remarks:

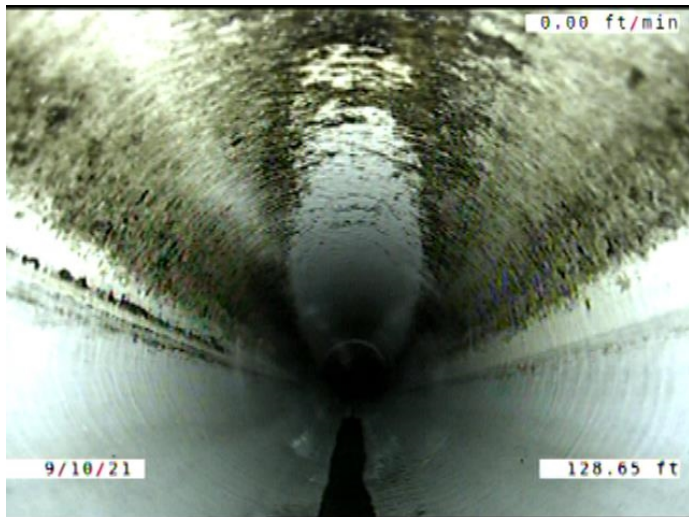
Code: **MWLS**  
Description: **Miscellaneous Water Level Sag**

Distance (ft): **128.7**  
Structural Grade: **2**  
O&M Grade: **0**  
Clock Start/From:  
Clock To:  
1st Value:  
2nd Value:  
Value Percent: **10.000**  
Continuous Index: **F08**  
Within 8" of Joint: **NO**  
Remarks:

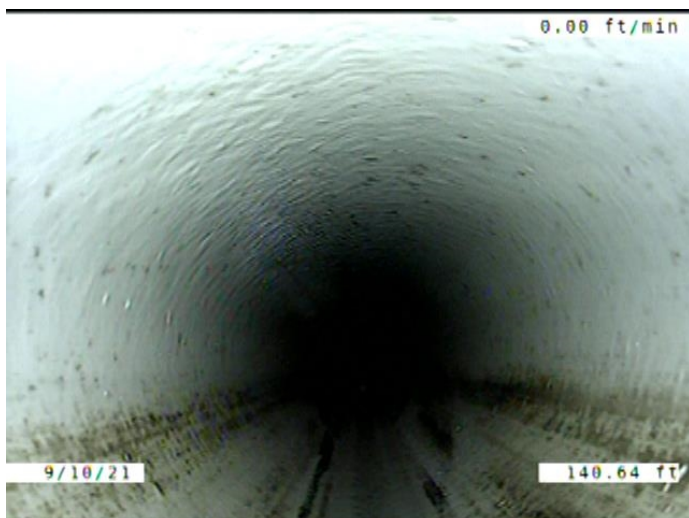
Code: **MGO**  
Description: **Miscellaneous General Observation**

Distance (ft): **140.6**  
Structural Grade: **0**  
O&M Grade: **0**  
Clock Start/From:  
Clock To:  
1st Value:  
2nd Value:  
Value Percent:  
Continuous Index:  
Within 8" of Joint: **NO**  
Remarks: **LINE SHOWS FALL AGAIN AT THIS POINT**

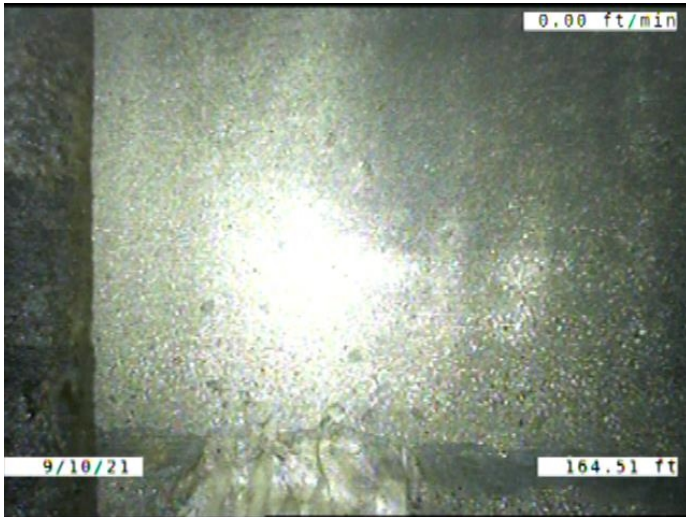
Code: **DSF**  
 Description: **Deposits Settled Fine**

Distance (ft): **164.5**  
 Structural Grade: **0**  
 O&M Grade: **2**  
 Clock Start/From: **5**  
 Clock To: **7**  
 1st Value:  
 2nd Value:  
 Value Percent: **5.000**  
 Continuous Index: **F07**  
 Within 8" of Joint: **YES**  
 Remarks:

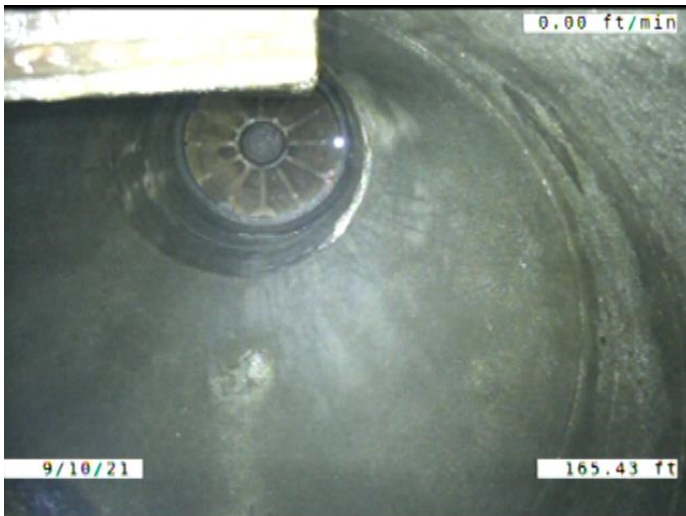
Code: **AMH**  
 Description: **Manhole**

Distance (ft): **165.4**  
 Structural Grade: **0**  
 O&M Grade: **0**  
 Clock Start/From:  
 Clock To:  
 1st Value:  
 2nd Value:  
 Value Percent:  
 Continuous Index:  
 Within 8" of Joint: **NO**  
 Remarks: **M-404-028.1**
