Profile/Photo Observation Report

Date:	09/10/2021	Weather:		Coding:	PACP 7.0
Pipe Length (ft):	165.4	Owner:	City of Hobart	Pre Clean:	Light Cleaning
P.O.#:	YES502259	Surveyor:	S. Bucklin	PSR:	P-404-028.1-028
Customer:	City of Hobart	Clean Date:	09/10/2021	Shape:	C

Street:	Old Ridge Road	Flow Control:	Not Controlled
City:	Hobart, IN	Year Renewed:	
Location:	Woods	Tape/Media #:	
Purpose:	Routine Assessment	Dia/Height:	8"
Use:	Sanitary Sewage Pipe	Material:	PVC
Drain Area:		Lining:	None
Category:	NA		
Comment:

Location Details:		Direction of Survey:	Downstream
US MH:	M-404-028	DS MH:	M-404-028.1
		Total Length Surveyed (ft):	165.4

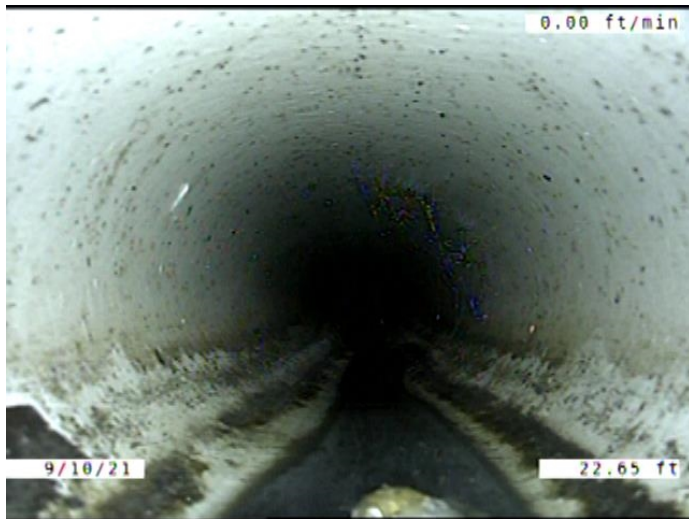
Code: **MWLS**
Description: **Miscellaneous Water Level Sag**

Distance (ft): **22.7**
Structural Grade: **2**
O&M Grade: **0**
Clock Start/From:
Clock To:
1st Value:
2nd Value:
Value Percent: **5.000**
Continuous Index: **F01**
Within 8" of Joint: **NO**
Remarks:

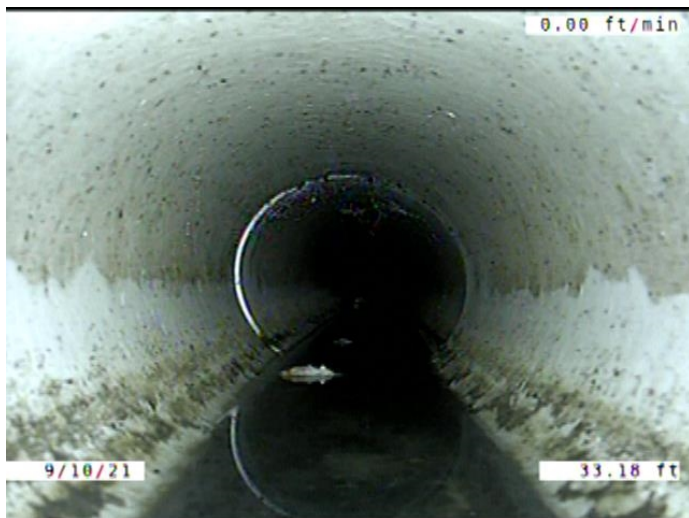
Code: **MWLS**
Description: **Miscellaneous Water Level Sag**

Distance (ft): **33.2**
Structural Grade: **2**
O&M Grade: **0**
Clock Start/From:
Clock To:
1st Value:
2nd Value:
Value Percent: **5.000**
Continuous Index: **S02**
Within 8" of Joint: **NO**
Remarks:

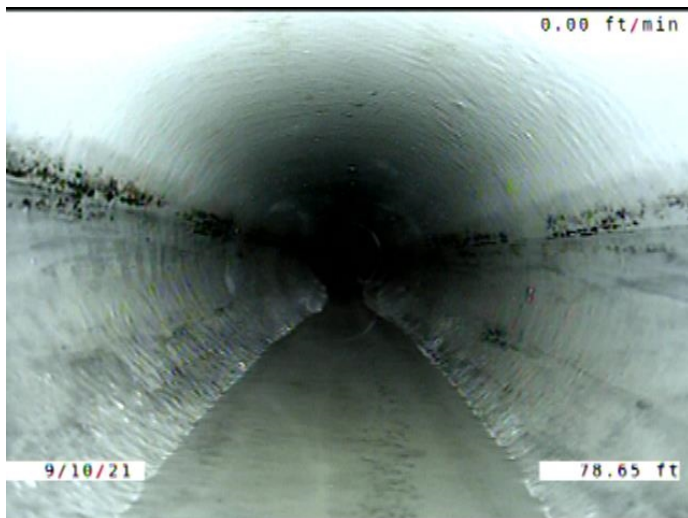
Code: **MWLS**
Description: **Miscellaneous Water Level Sag**

Distance (ft): **78.6**
Structural Grade: **2**
O&M Grade: **0**
Clock Start/From:
Clock To:
1st Value:
2nd Value:
Value Percent: **5.000**
Continuous Index:
Within 8" of Joint: **NO**
Remarks:
