## Profile/Photo Observation Report

Street:	<b>N CLARK ST &amp; W OLD RIDGE RD</b>	Flow Control:	<b>Not Controlled</b>
City:	<b>Hobart, IN</b>	Year Renewed:	
Location:	<b>Light Highway</b>	Tape/Media #:	
Purpose:	<b>Not Known</b>	Dia/Height:	<b>12"</b>
Use:	<b>Sanitary</b>	Material:	<b>VCP</b>
Drain Area:	<b>NA</b>	Lining:	
Category:	<b>NA</b>		
Comment:

Location Details:		Direction of Survey:	<b>Downstream</b>
US MH:	<b>M-404-028</b>	DS MH:	<b>M-404-029</b>
		Total Length Surveyed (ft):	<b>24.1</b>

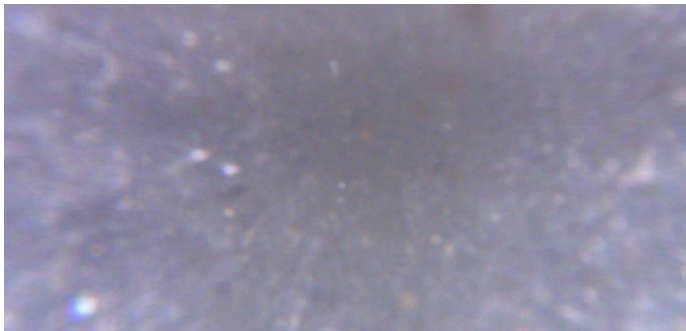
Code: **AMH**  
Description: **Manhole**

Distance (ft): **.0**  
Structural Grade: **0**  
O&M Grade: **0**  
Clock Start/From:  
Clock To:  
1st Value:  
2nd Value:  
Value Percent:  
Continuous Index:  
Within 8" of Joint: **NO**  
Remarks: **M-404-028**

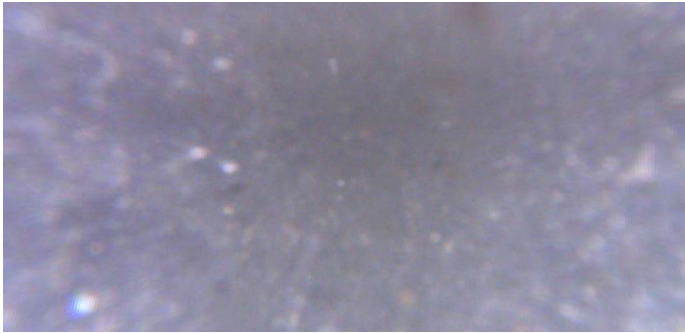
Code:	<b>MWL</b>
Description:	<b>Water Level</b>

Distance (ft):	<b>.0</b>
Structural Grade:	<b>0</b>
O&M Grade:	<b>0</b>
Clock Start/From:	
Clock To:	
1st Value:	
2nd Value:	
Value Percent:	<b>5.000</b>
Continuous Index:	
Within 8" of Joint:	<b>NO</b>
Remarks:

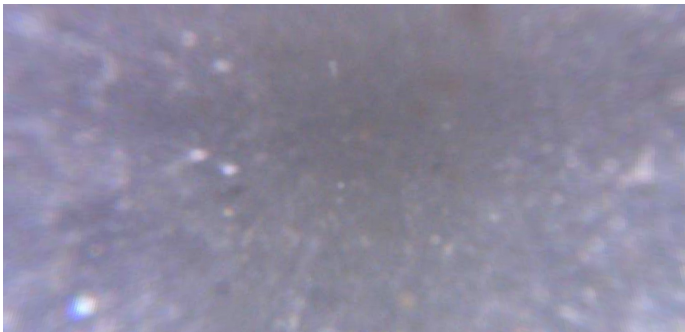
Code:	<b>MWLS</b>
Description:	<b>Water Level Sag</b>

Distance (ft):	<b>.0</b>
Structural Grade:	<b>2</b>
O&M Grade:	<b>3</b>
Clock Start/From:	
Clock To:	
1st Value:	
2nd Value:	
Value Percent:	<b>10.000</b>
Continuous Index:	<b>S01</b>
Within 8" of Joint:	<b>NO</b>
Remarks:

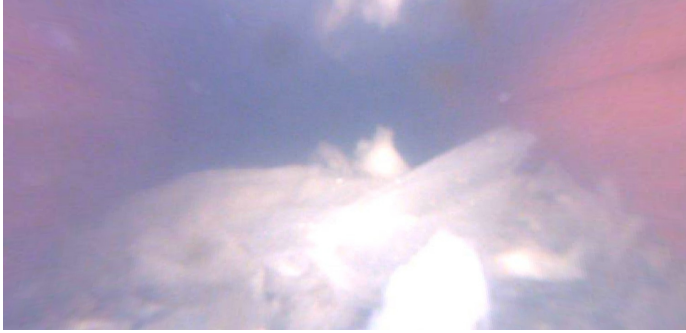
Code: **MWLS**  
Description: **Water Level Sag**

Distance (ft): **15.5**  
Structural Grade: **2**  
O&M Grade: **3**  
Clock Start/From:  
Clock To:  
1st Value:  
2nd Value:  
Value Percent: **10.000**  
Continuous Index: **F01**  
Within 8" of Joint: **NO**  
Remarks:
