Profile/Photo Observation Report

Street:	N CLARK ST & W OLD RIDGE RD	Flow Control:	Not Controlled
City:	Hobart, IN	Year Renewed:	
Location:	Light Highway	Tape/Media #:	
Purpose:	Not Known	Dia/Height:	12"
Use:	Sanitary	Material:	VCP
Drain Area:	NA	Lining:	
Category:	NA		
Comment:

Location Details:		Direction of Survey:	Upstream
US MH:	M-404-028	DS MH:	M-404-029
		Total Length Surveyed (ft):	38.7

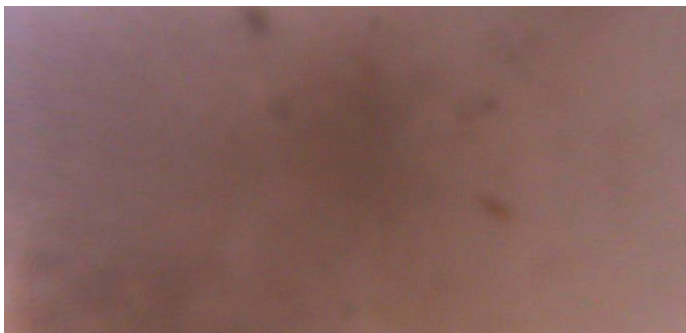
Code: **MCU**
Description: **Camera Underwater**

Distance (ft): **.0**
Structural Grade: **0**
O&M Grade: **4**
Clock Start/From:
Clock To:
1st Value:
2nd Value:
Value Percent:
Continuous Index: **S01**
Within 8" of Joint: **NO**
Remarks:

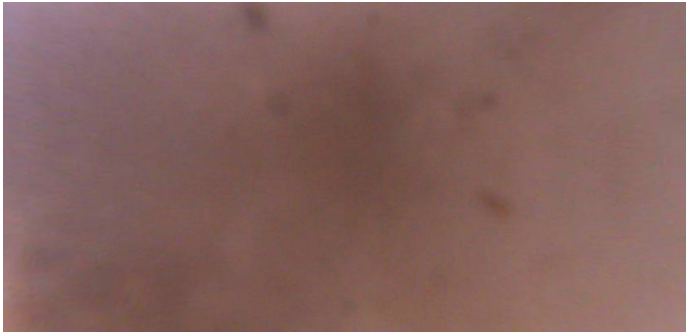
Code:	AMH
Description:	Manhole

Distance (ft):	.0
Structural Grade:	0
O&M Grade:	0
Clock Start/From:	
Clock To:	
1st Value:	
2nd Value:	
Value Percent:	
Continuous Index:	
Within 8" of Joint:	NO
Remarks:	M-404-028

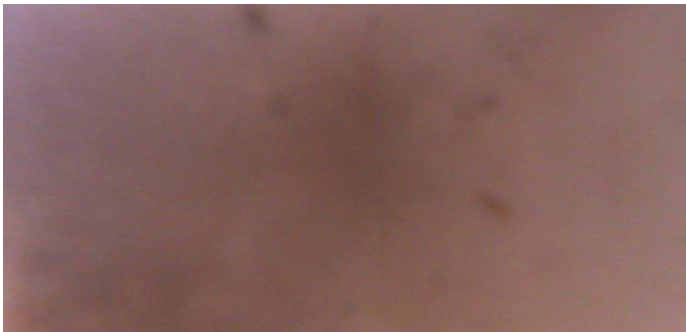
Code:	MWL
Description:	Water Level

Distance (ft):	.0
Structural Grade:	0
O&M Grade:	0
Clock Start/From:	
Clock To:	
1st Value:	
2nd Value:	
Value Percent:	100.000
Continuous Index:	
Within 8" of Joint:	NO
Remarks:
