## Profile/Photo Observation Report

Date:	<b>09/10/2021</b>	Weather:		Coding:	<b>PACP 7.0</b>
Pipe Length (ft):	<b>88.0</b>	Owner:	<b>City of Hobart</b>	Pre Clean:	<b>No Pre-Cleaning</b>
P.O.#:	<b>YES502259</b>	Surveyor:	<b>S. Bucklin</b>	PSR:	<b>P-404-040-028.1</b>
Customer:	<b>City of Hobart</b>	Clean Date:		Shape:	<b>C</b>

Street:	<b>Old Ridge Road</b>	Flow Control:	<b>Not Controlled</b>
City:	<b>Hobart, IN</b>	Year Renewed:	
Location:	<b>Woods</b>	Tape/Media #:	
Purpose:	<b>Routine Assessment</b>	Dia/Height:	<b>8"</b>
Use:	<b>Sanitary Sewage Pipe</b>	Material:	<b>PVC</b>
Drain Area:		Lining:	<b>None</b>
Category:	<b>NA</b>		
Comment:			
Location Details:		Direction of Survey:	<b>Upstream</b>
US MH:	<b>M-404-028.1</b>	DS MH:	<b>M-404-040</b>
		Total Length Surveyed (ft):	<b>88.0</b>

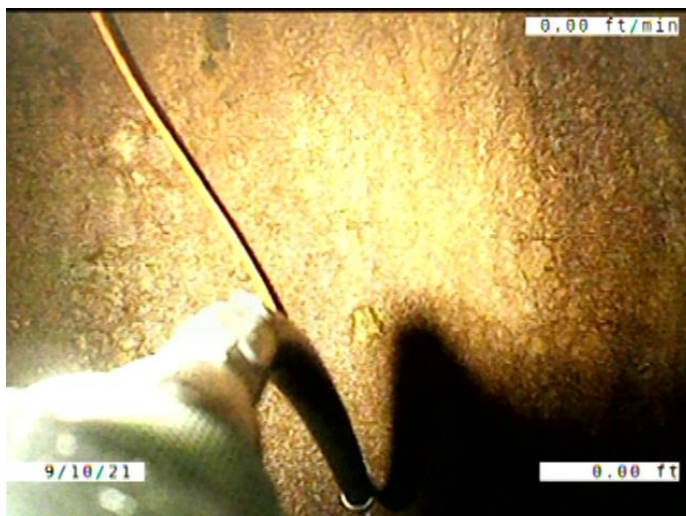
Code: **AMH**  
 Description: **Manhole**

Distance (ft): **.0**  
 Structural Grade: **0**  
 O&M Grade: **0**  
 Clock Start/From:  
 Clock To:  
 1st Value:  
 2nd Value:  
 Value Percent:  
 Continuous Index:  
 Within 8" of Joint: **NO**  
 Remarks: **M-404-040**
