Profile/Photo Observation Report

Date:	04/07/2018	Weather:		Coding:	PACP 6.0
Pipe Length (ft):		Owner:	City of Hobart	Pre Clean:	No Pre-Cleaning
P.O.#:	17-2	Surveyor:	M. Pielacha	PSR:	M-404-031-M-404-028
Customer:	City of Hobart	Clean Date:		Shape:	C

Street:	Old Ridge Road	Flow Control:	Not Controlled
City:	Hobart, IN	Year Renewed:	
Location:	Light Highway	Tape/Media #:	DEP 17
Purpose:	Routine Assessment	Dia/Height:	18"
Use:	Sanitary	Material:	VCP
Drain Area:		Lining:

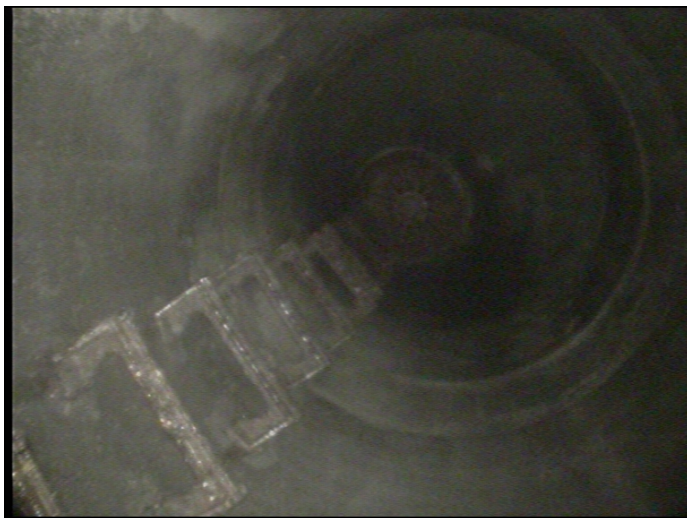
Code: **AMH**
Description: **Manhole**

Distance (ft): **.0**
Structural Grade: **0**
O&M Grade: **0**
Clock Start/From:
Clock To:
1st Value:
2nd Value:
Value Percent:
Continuous Index:
Within 8" of Joint: **NO**
Remarks: **M-404-031**

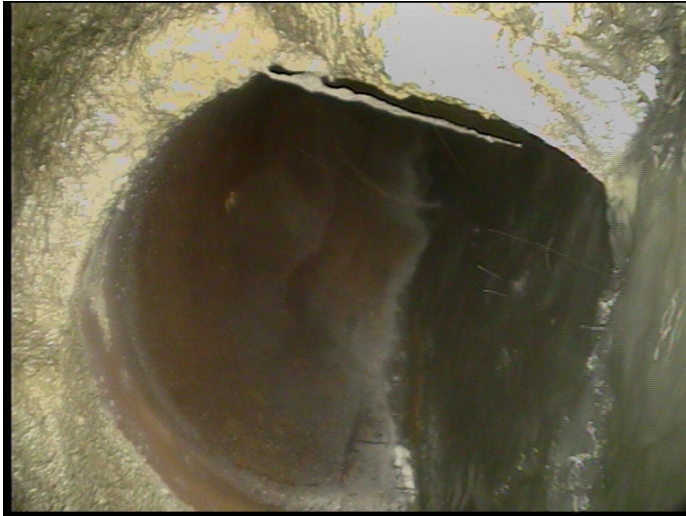
Code: **MWL**
Description: **Water Level**

Distance (ft): **.0**
Structural Grade: **0**
O&M Grade: **0**
Clock Start/From:
Clock To:
1st Value:
2nd Value:
Value Percent: **15.000**
Continuous Index:
Within 8" of Joint: **NO**
Remarks:

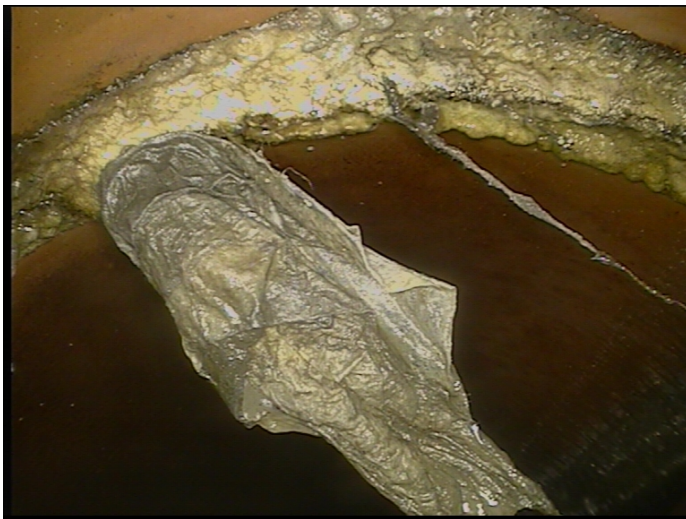
Code: **DAE**
Description: **Deposits Attached Encrustation**

Distance (ft): **14.7**
Structural Grade: **0**
O&M Grade: **2**
Clock Start/From: **7**
Clock To: **5**
1st Value:
2nd Value:
Value Percent: **5.000**
Continuous Index:
Within 8" of Joint: **YES**
Remarks:

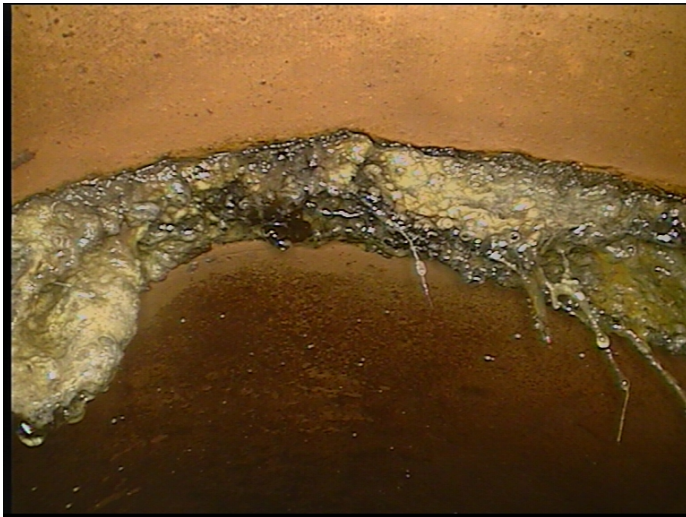
Code:	ID
Description:	Infil Dripper
Distance (ft):	30.1
Structural Grade:	0
O&M Grade:	3
Clock Start/From:	1
Clock To:	
1st Value:	
2nd Value:	
Value Percent:	
Continuous Index:	
Within 8" of Joint:	YES
Remarks:

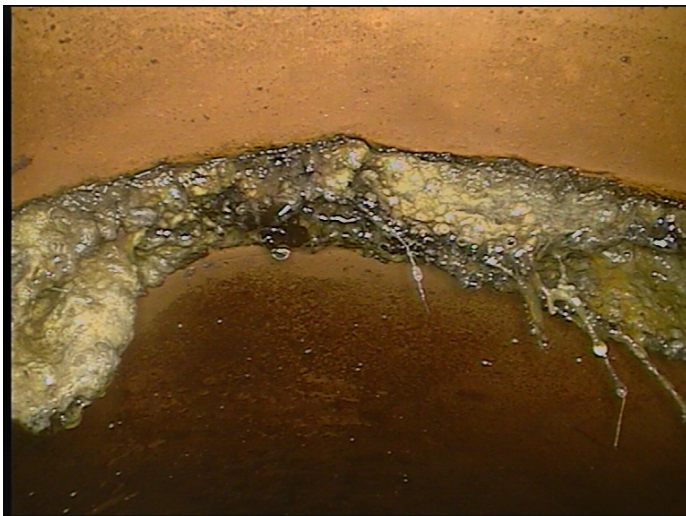
Code:	DAE
Description:	Deposits Attached Encrustation
Distance (ft):	30.1
Structural Grade:	0
O&M Grade:	2
Clock Start/From:	9
Clock To:	3
1st Value:	
2nd Value:	
Value Percent:	5.000
Continuous Index:	
Within 8" of Joint:	YES
Remarks:

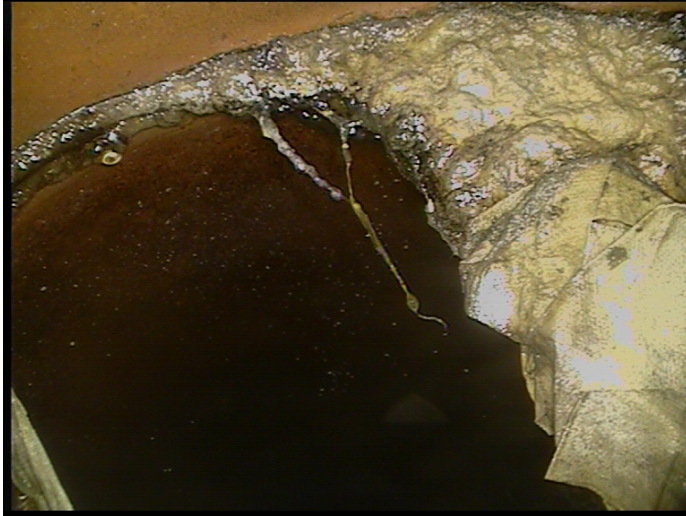
Code: **ID**
Description: **Infil Dripper**

Distance (ft): **50.3**
Structural Grade: **0**
O&M Grade: **3**
Clock Start/From: **12**
Clock To:
1st Value:
2nd Value:
Value Percent:
Continuous Index:
Within 8" of Joint: **YES**
Remarks:

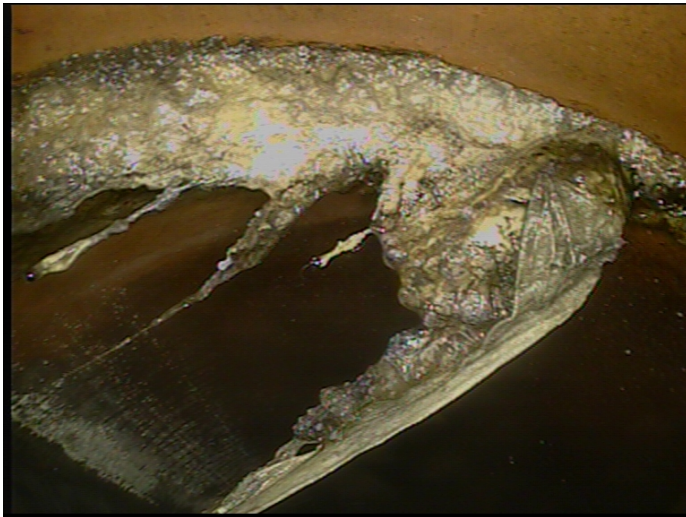
Code: **DAE**
Description: **Deposits Attached Encrustation**

Distance (ft): **50.3**
Structural Grade: **0**
O&M Grade: **2**
Clock Start/From: **7**
Clock To: **5**
1st Value:
2nd Value:
Value Percent: **10.000**
Continuous Index:
Within 8" of Joint: **YES**
Remarks:

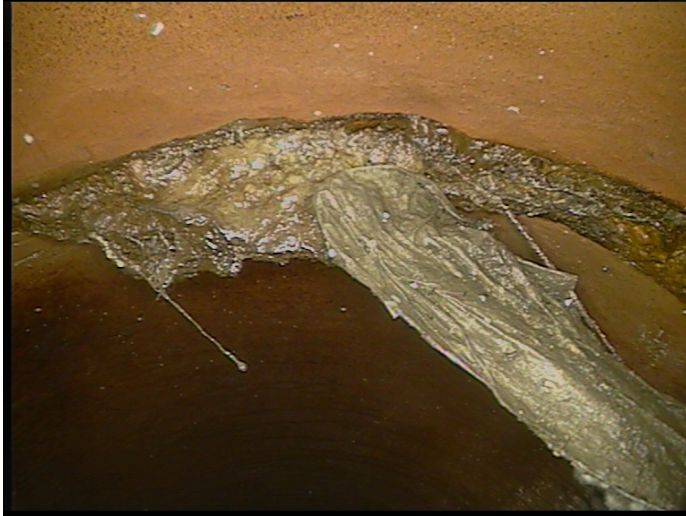
Code:	DAE
Description:	Deposits Attached Encrustation
Distance (ft):	146.7
Structural Grade:	0
O&M Grade:	2
Clock Start/From:	1
Clock To:	4
1st Value:	
2nd Value:	
Value Percent:	5.000
Continuous Index:	
Within 8" of Joint:	YES
Remarks:

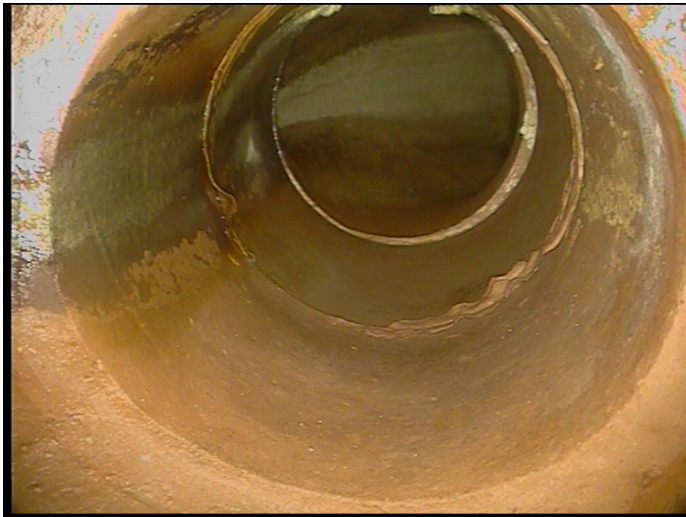
Code:	TF
Description:	Tap Factory
Distance (ft):	153.3
Structural Grade:	0
O&M Grade:	0
Clock Start/From:	10
Clock To:	
1st Value:	4.000
2nd Value:	
Value Percent:	
Continuous Index:	
Within 8" of Joint:	NO
Remarks:

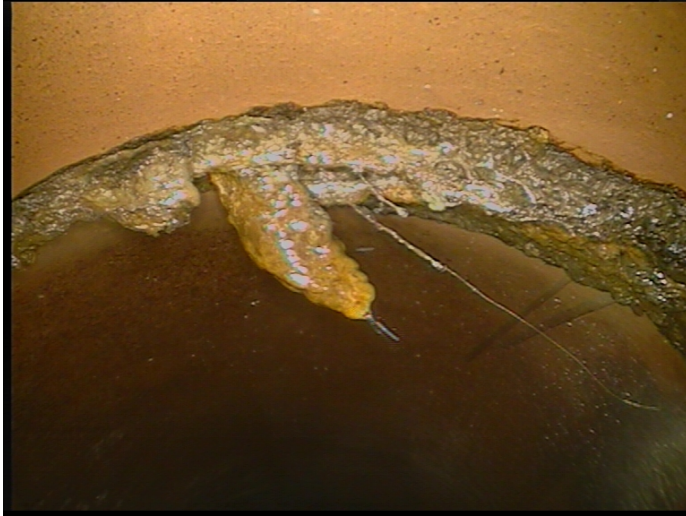
Code: **ID**
Description: **Infil Dripper**

Distance (ft): **185.0**
Structural Grade: **0**
O&M Grade: **3**
Clock Start/From: **1**
Clock To:
1st Value:
2nd Value:
Value Percent:
Continuous Index:
Within 8" of Joint: **YES**
Remarks:

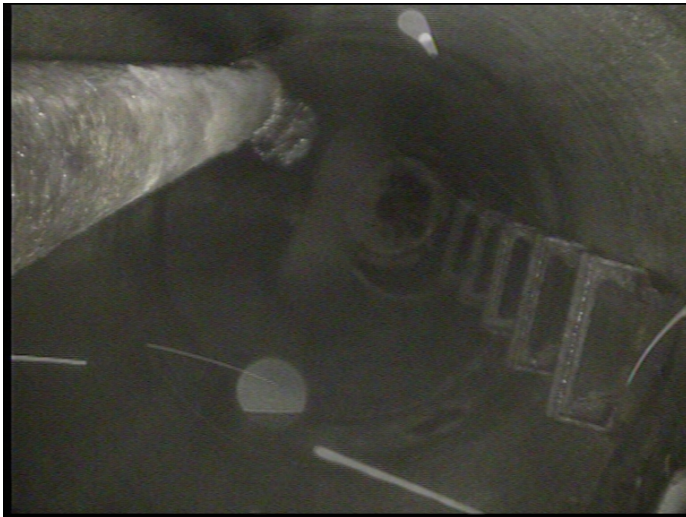
Code: **AMH**
Description: **Manhole**

Distance (ft): **259.2**
Structural Grade: **0**
O&M Grade: **0**
Clock Start/From:
Clock To:
1st Value:
2nd Value:
Value Percent:
Continuous Index:
Within 8" of Joint: **NO**
Remarks: **M-404-028**
