## Profile/Photo Observation Report

Date:	<b>04/07/2018</b>	Weather:		Coding:	<b>PACP 6.0</b>
Pipe Length (ft):		Owner:	<b>City of Hobart</b>	Pre Clean:	<b>No Pre-Cleaning</b>
P.O.#:	<b>17-2</b>	Surveyor:	<b>M. Pielacha</b>	PSR:	<b>M-404-031-M-404-028</b>
Customer:	<b>City of Hobart</b>	Clean Date:		Shape:	<b>C</b>

Street:	<b>Old Ridge Road</b>	Flow Control:	<b>Not Controlled</b>
City:	<b>Hobart, IN</b>	Year Renewed:	
Location:	<b>Light Highway</b>	Tape/Media #:	<b>DEP 17</b>
Purpose:	<b>Routine Assessment</b>	Dia/Height:	<b>18"</b>
Use:	<b>Sanitary</b>	Material:	<b>VCP</b>
Drain Area:		Lining:	
Category:	<b>NA</b>		
Comment:			
Location Details:		Direction of Survey:	<b>Downstream</b>
US MH:	<b>M-404-031</b>	DS MH:	<b>M-404-028</b>
		Total Length Surveyed (ft):	<b>259.2</b>

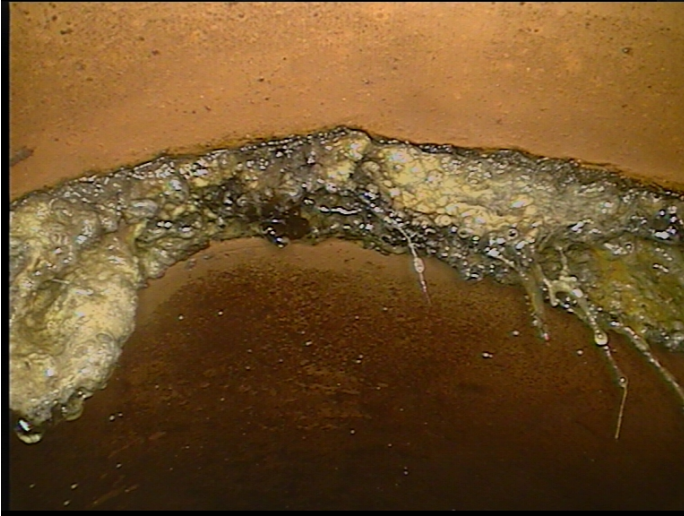
Code:	ID
Description:	Infil Dripper
Distance (ft):	30.1
Structural Grade:	0
O&M Grade:	3
Clock Start/From:	1
Clock To:	
1st Value:	
2nd Value:	
Value Percent:	
Continuous Index:	
Within 8" of Joint:	YES
Remarks:

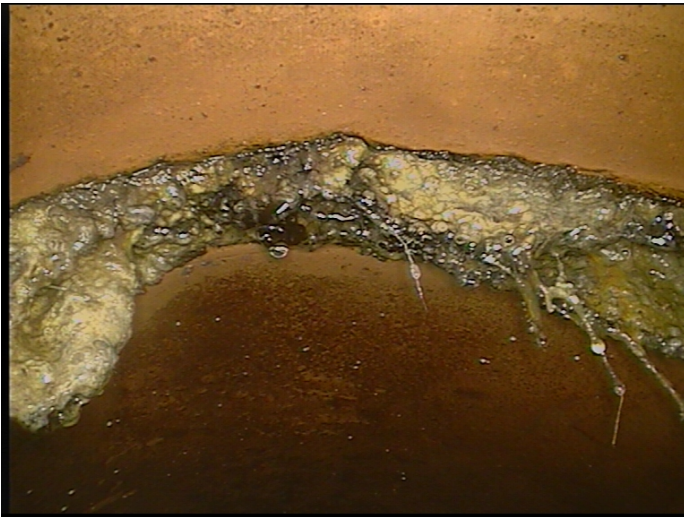
Code:	DAE
Description:	Deposits Attached Encrustation
Distance (ft):	30.1
Structural Grade:	0
O&M Grade:	2
Clock Start/From:	9
Clock To:	3
1st Value:	
2nd Value:	
Value Percent:	5.000
Continuous Index:	
Within 8" of Joint:	YES
Remarks:

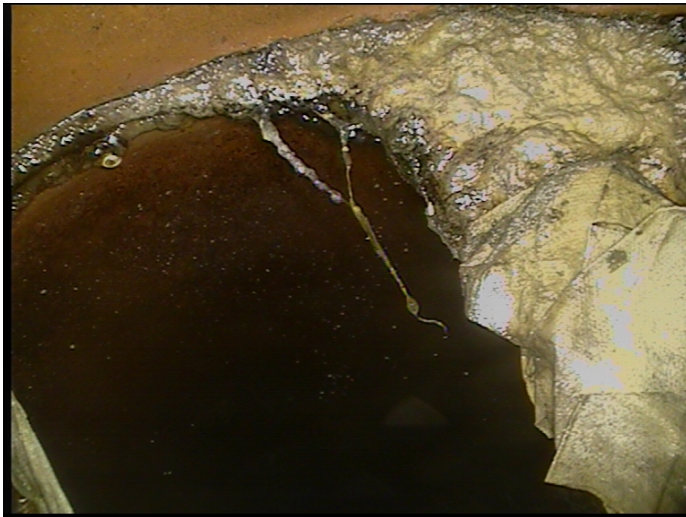
Code: **ID**  
Description: **Infil Dripper**

Distance (ft): **50.3**  
Structural Grade: **0**  
O&M Grade: **3**  
Clock Start/From: **12**  
Clock To:  
1st Value:  
2nd Value:  
Value Percent:  
Continuous Index:  
Within 8" of Joint: **YES**  
Remarks:

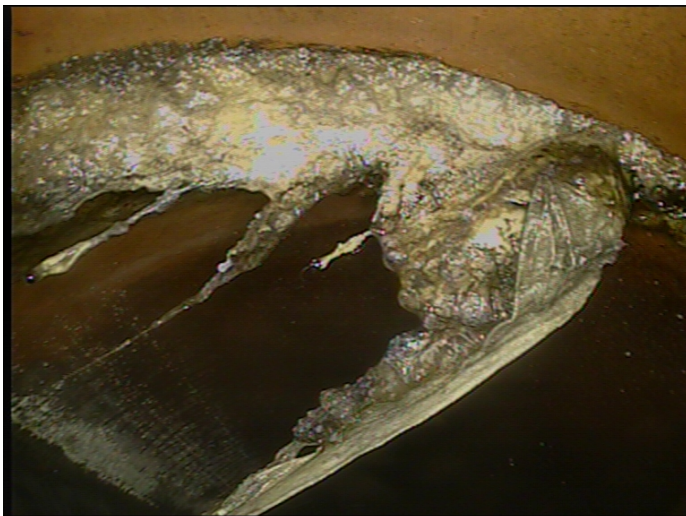
Code: **DAE**  
Description: **Deposits Attached Encrustation**

Distance (ft): **50.3**  
Structural Grade: **0**  
O&M Grade: **2**  
Clock Start/From: **7**  
Clock To: **5**  
1st Value:  
2nd Value:  
Value Percent: **10.000**  
Continuous Index:  
Within 8" of Joint: **YES**  
Remarks:

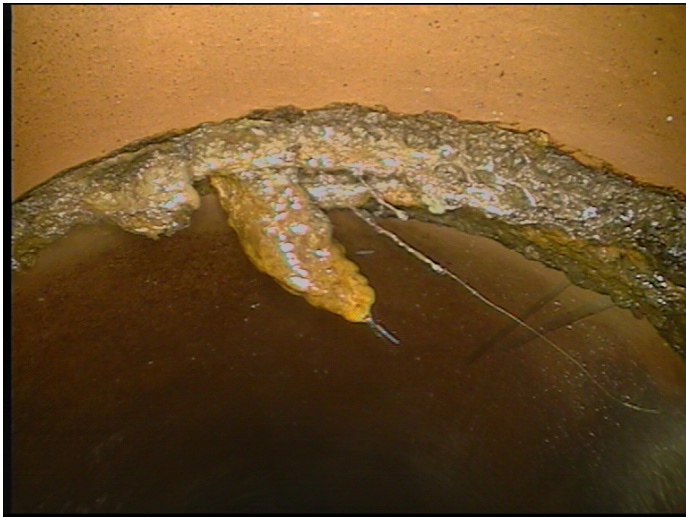
Code:	<b>ID</b>
Description:	<b>Infil Dripper</b>
Distance (ft):	<b>185.0</b>
Structural Grade:	<b>0</b>
O&M Grade:	<b>3</b>
Clock Start/From:	<b>1</b>
Clock To:	
1st Value:	
2nd Value:	
Value Percent:	
Continuous Index:	
Within 8" of Joint:	<b>YES</b>
Remarks:

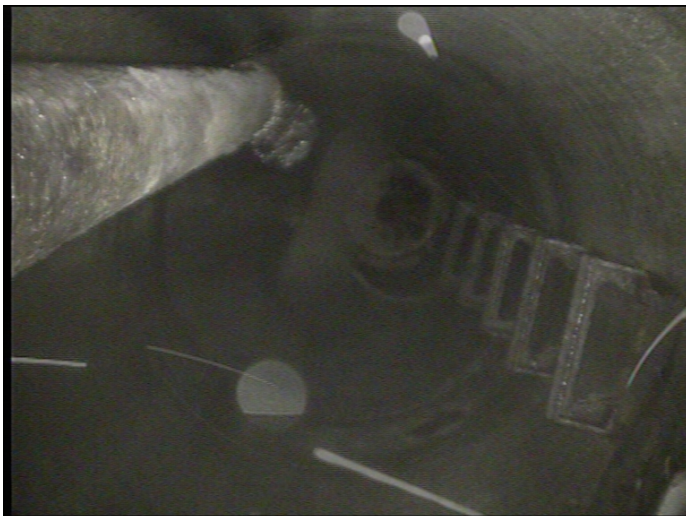
Code:	<b>AMH</b>
Description:	<b>Manhole</b>
Distance (ft):	<b>259.2</b>
Structural Grade:	<b>0</b>
O&M Grade:	<b>0</b>
Clock Start/From:	
Clock To:	
1st Value:	
2nd Value:	
Value Percent:	
Continuous Index:	
Within 8" of Joint:	<b>NO</b>
Remarks:	<b>M-404-028</b>
