Profile/Photo Observation Report

Date:	04/07/2018	Weather:		Coding:	PACP 6.0
Pipe Length (ft):		Owner:	City of Hobart	Pre Clean:	No Pre-Cleaning
P.O.#:	16-2	Surveyor:	M. Pielacha	PSR:	M-404-034-M-404-033
Customer:	City of Hobart	Clean Date:		Shape:	C

Street:	Old Ridge Road	Flow Control:	Not Controlled
City:	Hobart, IN	Year Renewed:	
Location:	Light Highway	Tape/Media #:	DEP 16
Purpose:	Routine Assessment	Dia/Height:	18"
Use:	Sanitary	Material:	VCP
Drain Area:		Lining:	
Category:	NA		
Comment:			
Location Details:		Direction of Survey:	Upstream
US MH:	M-404-034	DS MH:	M-404-033
		Total Length Surveyed (ft):	9.1

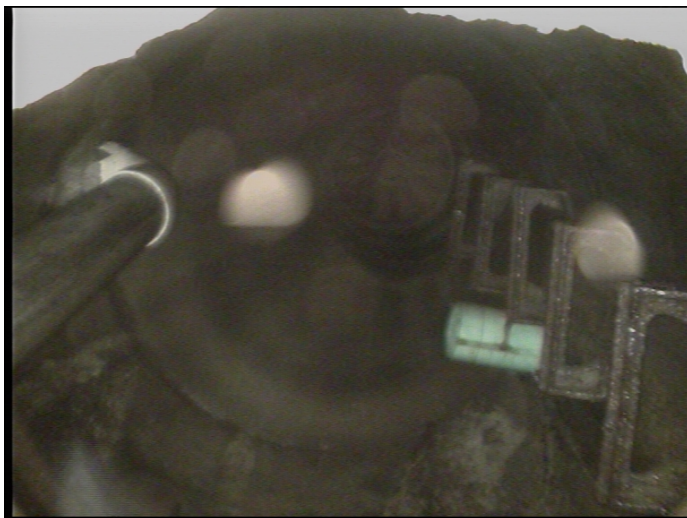
Code: **AMH**
 Description: **Manhole**

Distance (ft): **.0**
 Structural Grade: **0**
 O&M Grade: **0**
 Clock Start/From:
 Clock To:
 1st Value:
 2nd Value:
 Value Percent:
 Continuous Index:
 Within 8" of Joint: **NO**
 Remarks: **M-404-033**

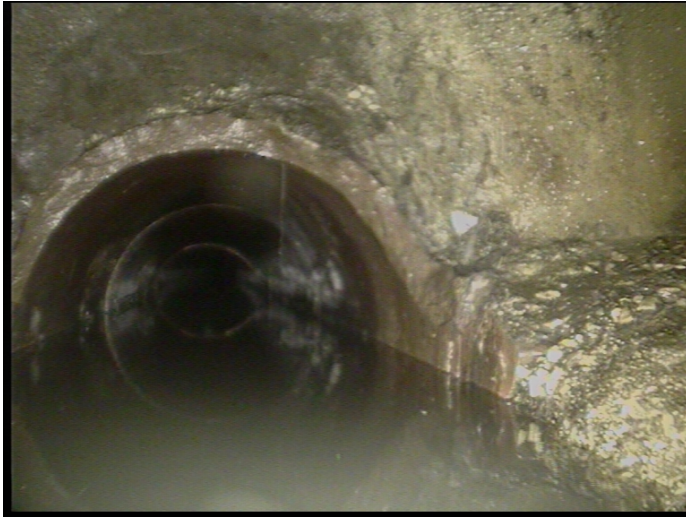
Code: **MWL**
Description: **Water Level**

Distance (ft): **.0**
Structural Grade: **0**
O&M Grade: **0**
Clock Start/From:
Clock To:
1st Value:
2nd Value:
Value Percent: **15.000**
Continuous Index:
Within 8" of Joint: **NO**
Remarks:

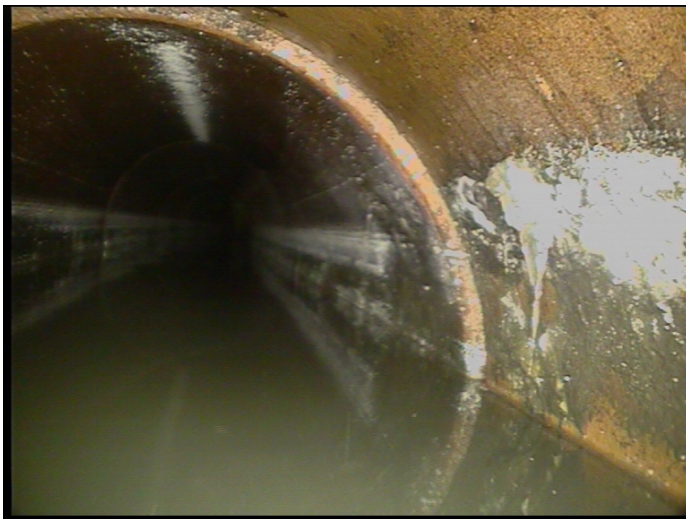
Code: **MSA**
Description: **Abandoned Survey**

Distance (ft): **9.1**
Structural Grade: **0**
O&M Grade: **0**
Clock Start/From:
Clock To:
1st Value:
2nd Value:
Value Percent:
Continuous Index:
Within 8" of Joint: **NO**
Remarks: **under water debris**
