## Profile/Photo Observation Report

Date:	<b>04/27/2018</b>	Weather:		Coding:	<b>PACP 6.0</b>
Pipe Length (ft):		Owner:	<b>City of Hobart</b>	Pre Clean:	<b>No Pre-Cleaning</b>
P.O.#:	<b>118</b>	Surveyor:	<b>M. Pielacha</b>	PSR:	<b>P-404-041-012</b>
Customer:	<b>City of Hobart</b>	Clean Date:		Shape:	<b>C</b>

Street:	<b>Deer Born Street</b>	Flow Control:	<b>Not Controlled</b>
City:	<b>Hobart, IN</b>	Year Renewed:	
Location:	<b>Light Highway</b>	Tape/Media #:	<b>DEP 118</b>
Purpose:	<b>Routine Assessment</b>	Dia/Height:	<b>6"</b>
Use:	<b>Sanitary</b>	Material:	<b>VCP</b>
Drain Area:		Lining:	
Category:	<b>NA</b>		
Comment:	<b>YES501824 Submittal 2</b>		
Location Details:		Direction of Survey:	<b>Upstream</b>
US MH:	<b>M404-041</b>	DS MH:	<b>M-404-012</b>
		Total Length Surveyed (ft):	<b>156.9</b>

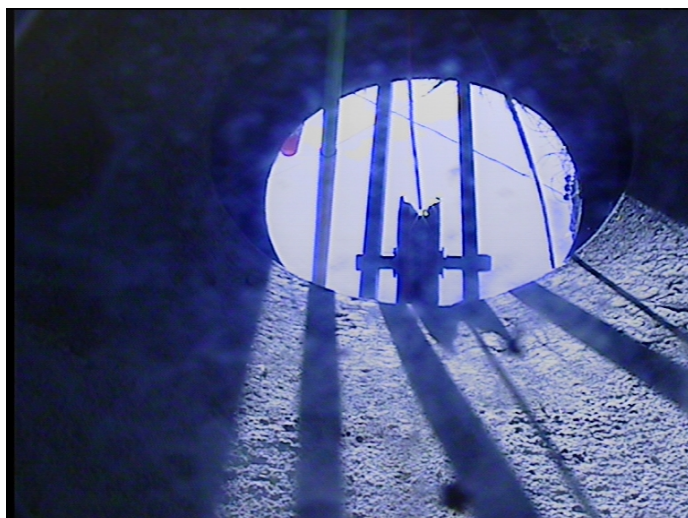
Code: **AMH**  
Description: **Manhole**

Distance (ft): **.0**  
Structural Grade: **0**  
O&M Grade: **0**  
Clock Start/From:  
Clock To:  
1st Value:  
2nd Value:  
Value Percent:  
Continuous Index:  
Within 8" of Joint: **NO**  
Remarks: **M-404-012**

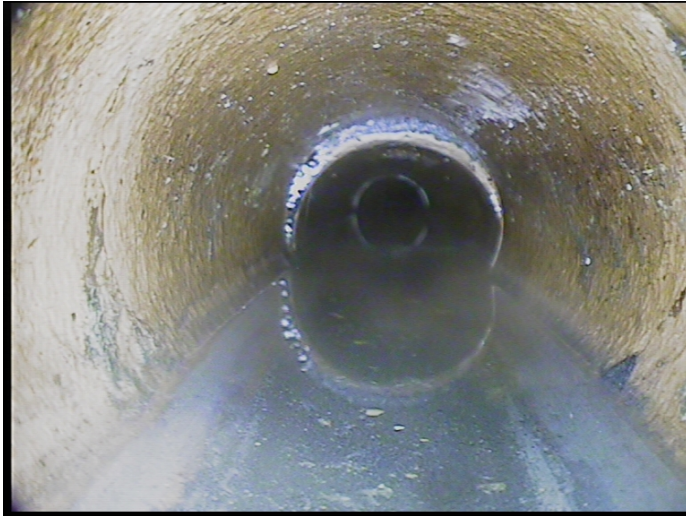
Code: **MWL**  
Description: **Water Level**

Distance (ft): **.0**  
Structural Grade: **0**  
O&M Grade: **0**  
Clock Start/From:  
Clock To:  
1st Value:  
2nd Value:  
Value Percent: **5.000**  
Continuous Index:  
Within 8" of Joint: **NO**  
Remarks:

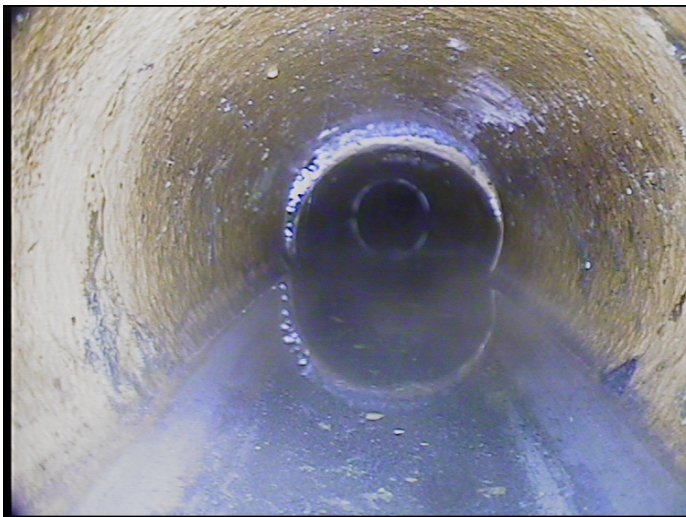
Code: **DSF**  
Description: **Deposits Settled Fine**

Distance (ft): **.0**  
Structural Grade: **0**  
O&M Grade: **2**  
Clock Start/From: **5**  
Clock To: **7**  
1st Value:  
2nd Value:  
Value Percent: **10.000**  
Continuous Index: **S01**  
Within 8" of Joint: **YES**  
Remarks:

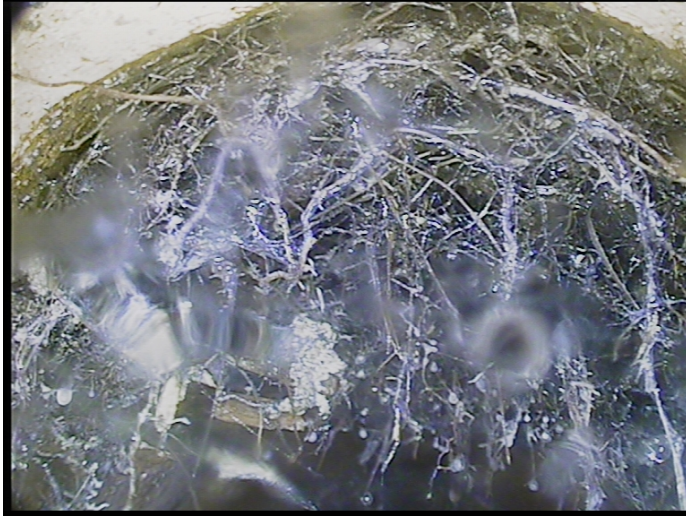
Code:	<b>RML</b>
Description:	<b>Roots Medium Lateral</b>
Distance (ft):	<b>93.9</b>
Structural Grade:	<b>0</b>
O&M Grade:	<b>3</b>
Clock Start/From:	<b>12</b>
Clock To:	
1st Value:	
2nd Value:	
Value Percent:	<b>5.000</b>
Continuous Index:	
Within 8" of Joint:	<b>NO</b>
Remarks:

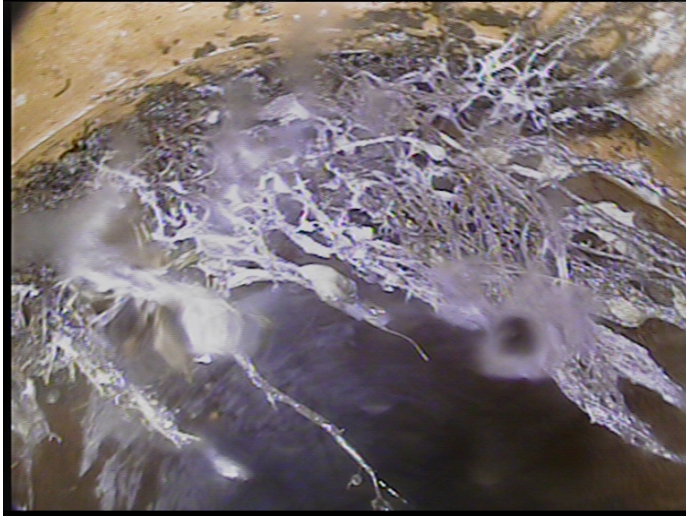
Code:	<b>RFJ</b>
Description:	<b>Roots Fine Joint</b>
Distance (ft):	<b>110.7</b>
Structural Grade:	<b>0</b>
O&M Grade:	<b>1</b>
Clock Start/From:	<b>10</b>
Clock To:	<b>2</b>
1st Value:	
2nd Value:	
Value Percent:	
Continuous Index:	<b>S02</b>
Within 8" of Joint:	<b>YES</b>
Remarks:

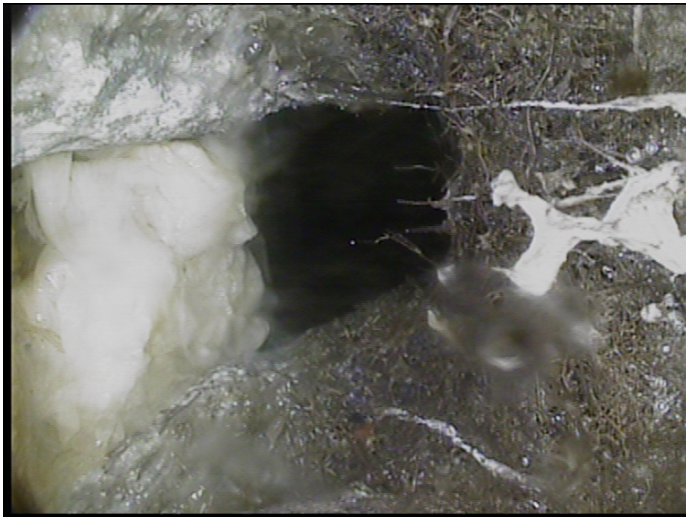
Code:	<b>TF</b>
Description:	<b>Tap Factory</b>
Distance (ft):	<b>135.7</b>
Structural Grade:	<b>0</b>
O&M Grade:	<b>0</b>
Clock Start/From:	<b>9</b>
Clock To:	
1st Value:	<b>4.000</b>
2nd Value:	
Value Percent:	
Continuous Index:	
Within 8" of Joint:	<b>NO</b>
Remarks:

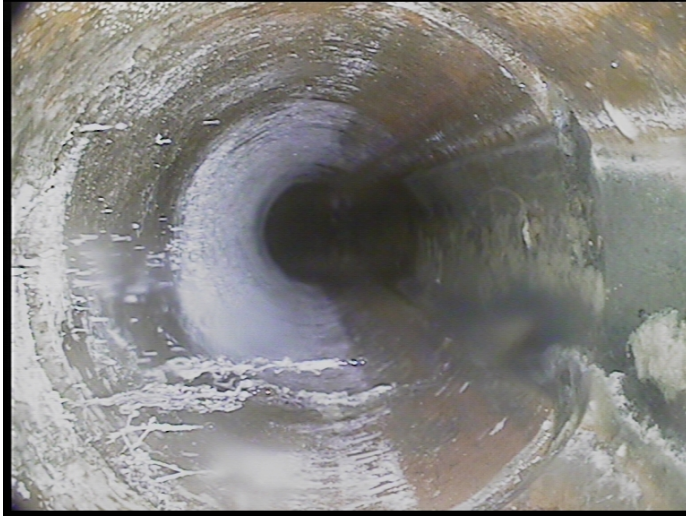
Code: **TF**  
Description: **Tap Factory**

Distance (ft): **146.1**  
Structural Grade: **0**  
O&M Grade: **0**  
Clock Start/From: **3**  
Clock To:  
1st Value: **6.000**  
2nd Value:  
Value Percent:  
Continuous Index:  
Within 8" of Joint: **NO**  
Remarks:

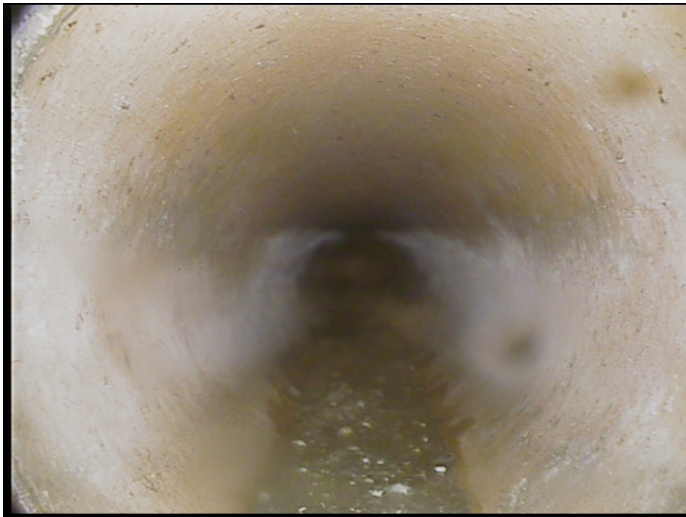
Code: **RFJ**  
Description: **Roots Fine Joint**

Distance (ft): **150.2**  
Structural Grade: **0**  
O&M Grade: **1**  
Clock Start/From: **10**  
Clock To: **2**  
1st Value:  
2nd Value:  
Value Percent:  
Continuous Index: **F02**  
Within 8" of Joint: **YES**  
Remarks:
