Profile/Photo Observation Report

Street:	W 4TH PL & S WABASH PL	Flow Control:	Not Controlled
City:	Hobart, IN	Year Renewed:	
Location:	Yard	Tape/Media #:	
Purpose:	Routine Assessment	Dia/Height:	10"
Use:	Sanitary	Material:	VCP
Drain Area:	NA	Lining:	Cured in Place
Category:	NA		
Comment:	Flow direction is marked wrong.		
Location Details:		Direction of Survey:	Upstream
US MH:	M-405-001	DS MH:	M-505-091
		Total Length Surveyed (ft):	75.5

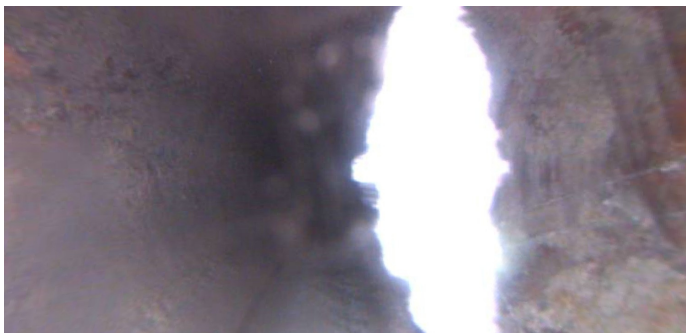
Code: **AMH**
Description: **Manhole**

Distance (ft): **.0**
Structural Grade: **0**
O&M Grade: **0**
Clock Start/From:
Clock To:
1st Value:
2nd Value:
Value Percent:
Continuous Index:
Within 8" of Joint: **NO**
Remarks: **M-505-091**

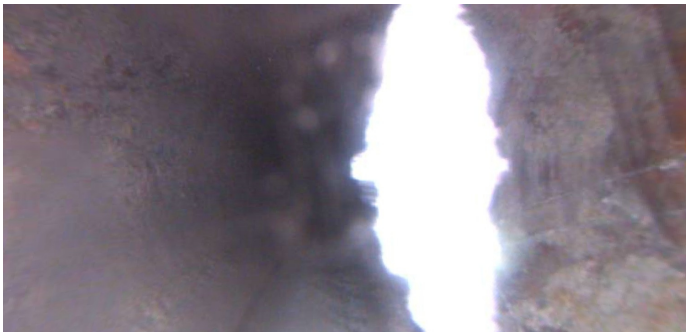
Code:	DAGS
Description:	Deposits Attached Grease

Distance (ft):	.0
Structural Grade:	0
O&M Grade:	2
Clock Start/From:	8
Clock To:	4
1st Value:	
2nd Value:	
Value Percent:	5.000
Continuous Index:	S01
Within 8" of Joint:	NO
Remarks:
