## Profile/Photo Observation Report

Date:	<b>04/14/2018</b>	Weather:		Coding:	<b>PACP 6.0</b>
Pipe Length (ft):	<b>229.4</b>	Owner:	<b>NA</b>	Pre Clean:	<b>No Pre-Cleaning</b>
P.O.#:		Surveyor:	<b>Jen Costello</b>	PSR:	<b>P-505-091-001</b>
Customer:		Clean Date:	<b>01/01/1900</b>	Shape:	<b>C</b>

Street:	<b>FOXCROFT STREET</b>	Flow Control:	<b>Not Controlled</b>
City:	<b>Hobart, IN</b>	Year Renewed:	
Location:	<b>Yard</b>	Tape/Media #:	
Purpose:	<b>Routine Assessment</b>	Dia/Height:	<b>10"</b>
Use:	<b>Sanitary</b>	Material:	<b>VCP</b>
Drain Area:	<b>NA</b>	Lining:	<b>Cured in Place</b>
Category:	<b>NA</b>		
Comment:	<b>Flow direction is marked wrong.</b>		
Location Details:		Direction of Survey:	<b>Upstream</b>
US MH:	<b>M-405-001</b>	DS MH:	<b>M-505-091</b>
		Total Length Surveyed (ft):	<b>75.5</b>

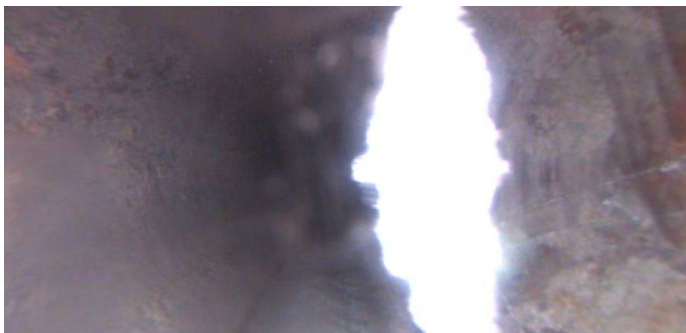
Code: **AMH**  
Description: **Manhole**

Distance (ft): **.0**  
Structural Grade: **0**  
O&M Grade: **0**  
Clock Start/From:  
Clock To:  
1st Value:  
2nd Value:  
Value Percent:  
Continuous Index:  
Within 8" of Joint: **NO**  
Remarks: **M-505-091**

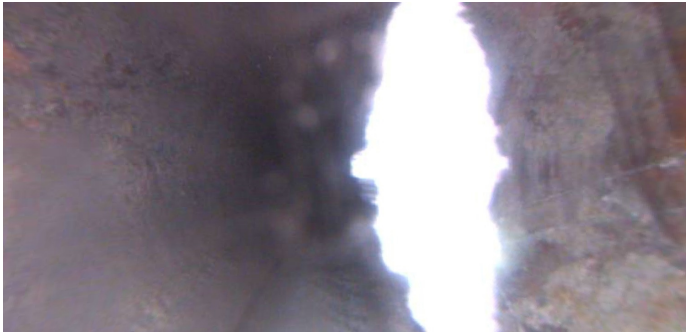
Code:	<b>MWL</b>
Description:	<b>Water Level</b>

Distance (ft):	<b>.0</b>
Structural Grade:	<b>0</b>
O&M Grade:	<b>0</b>
Clock Start/From:	
Clock To:	
1st Value:	
2nd Value:	
Value Percent:	<b>5.000</b>
Continuous Index:	
Within 8" of Joint:	<b>NO</b>
Remarks:

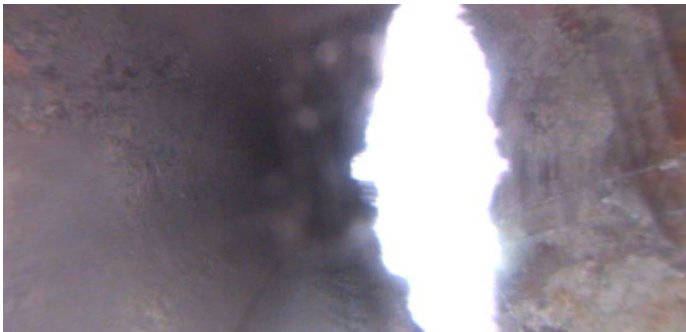
Code:	<b>DAGS</b>
Description:	<b>Deposits Attached Grease</b>

Distance (ft):	<b>.0</b>
Structural Grade:	<b>0</b>
O&M Grade:	<b>2</b>
Clock Start/From:	<b>8</b>
Clock To:	<b>4</b>
1st Value:	
2nd Value:	
Value Percent:	<b>5.000</b>
Continuous Index:	<b>S01</b>
Within 8" of Joint:	<b>NO</b>
Remarks:

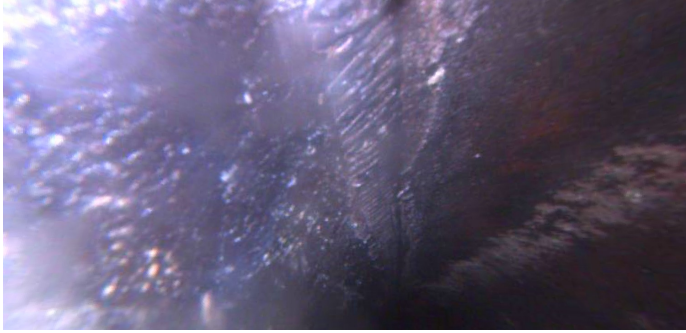
Code: **MSA**  
Description: **Abandoned Survey**

Distance (ft): **75.5**  
Structural Grade: **0**  
O&M Grade: **0**  
Clock Start/From:  
Clock To:  
1st Value:  
2nd Value:  
Value Percent:  
Continuous Index:  
Within 8" of Joint: **NO**  
Remarks: **overturned**

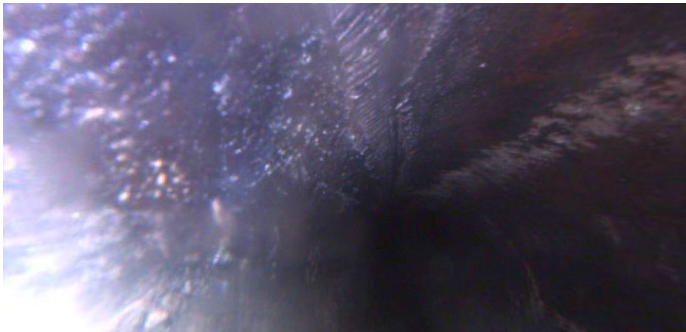
Code: **DAGS**  
Description: **Deposits Attached Grease**

Distance (ft): **75.5**  
Structural Grade: **0**  
O&M Grade: **2**  
Clock Start/From: **8**  
Clock To: **4**  
1st Value:  
2nd Value:  
Value Percent: **5.000**  
Continuous Index: **F01**  
Within 8" of Joint: **NO**  
Remarks:
