Profile/Photo Observation Report

Date:	11/04/2021	Weather:		Coding:	PACP 7.0
Pipe Length (ft):	295.8	Owner:	City of Hobart	Pre Clean:	Heavy Cleaning
P.O.#:	YES502259	Surveyor:	S. Bucklin	PSR:	P-405-002.3-002.2
Customer:	City of Hobart	Clean Date:	11/04/2021	Shape:	C

Street:	South Wabash Street	Flow Control:	Not Controlled
City:	Hobart, IN	Year Renewed:	
Location:	Sidewalk	Tape/Media #:	
Purpose:	Routine Assessment	Dia/Height:	10"
Use:	Sanitary Sewage Pipe	Material:	PVC
Drain Area:		Lining:	None
Category:	NA

US MH:	M-405-002.2	DS MH:	M-405-002.3	Total Length Surveyed (ft):	295.8
--------	--------------------	--------	--------------------	-----------------------------	--------------

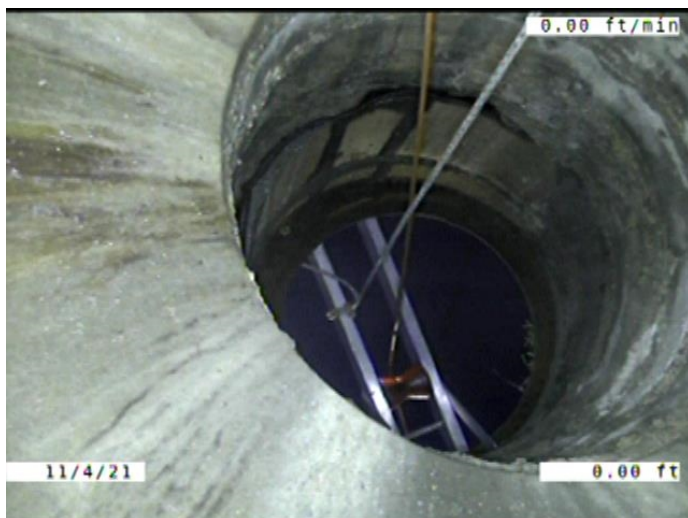
Code: **AMH**
Description: **Manhole**

Distance (ft): **.0**
Structural Grade: **0**
O&M Grade: **0**
Clock Start/From:
Clock To:
1st Value:
2nd Value:
Value Percent:
Continuous Index:
Within 8" of Joint: **NO**
Remarks: **M-405-002.2**

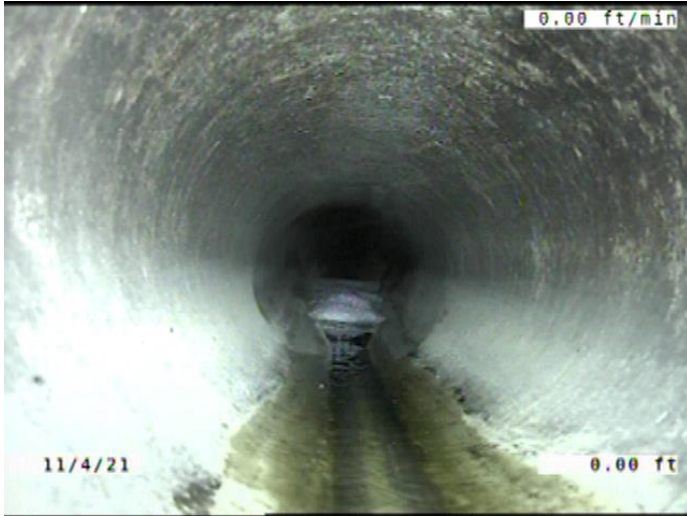
Code: **MWL**
Description: **Miscellaneous Water Level**

Distance (ft): **.0**
Structural Grade: **0**
O&M Grade: **0**
Clock Start/From:
Clock To:
1st Value:
2nd Value:
Value Percent: **5.000**
Continuous Index:
Within 8" of Joint: **NO**
Remarks:

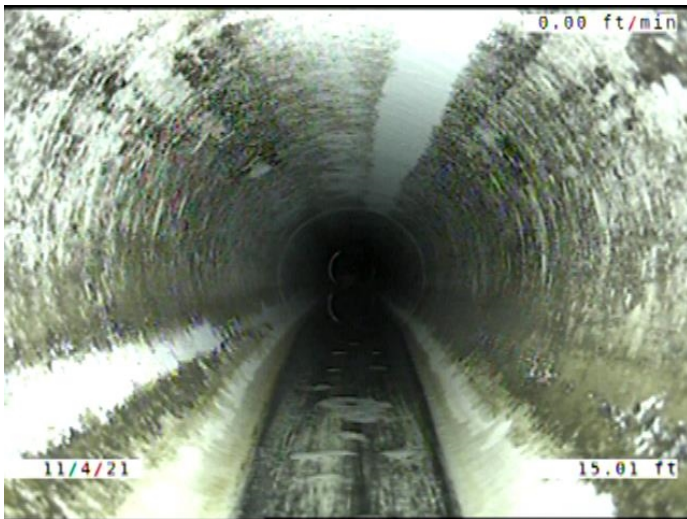
Code: **MWLS**
Description: **Miscellaneous Water Level Sag**

Distance (ft): **15.0**
Structural Grade: **2**
O&M Grade: **0**
Clock Start/From:
Clock To:
1st Value:
2nd Value:
Value Percent: **5.000**
Continuous Index: **S01**
Within 8" of Joint: **NO**
Remarks:

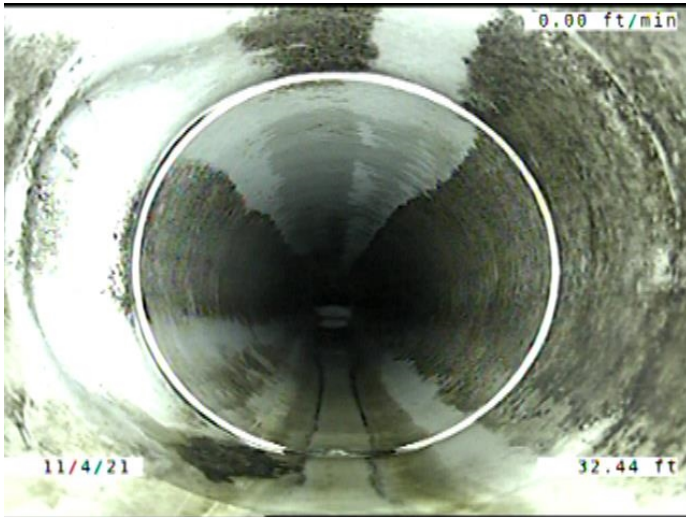
Code: **MWLS**
 Description: **Miscellaneous Water Level Sag**

Distance (ft): **32.4**
 Structural Grade: **2**
 O&M Grade: **0**
 Clock Start/From:
 Clock To:
 1st Value:
 2nd Value:
 Value Percent: **5.000**
 Continuous Index: **F01**
 Within 8" of Joint: **NO**
 Remarks:

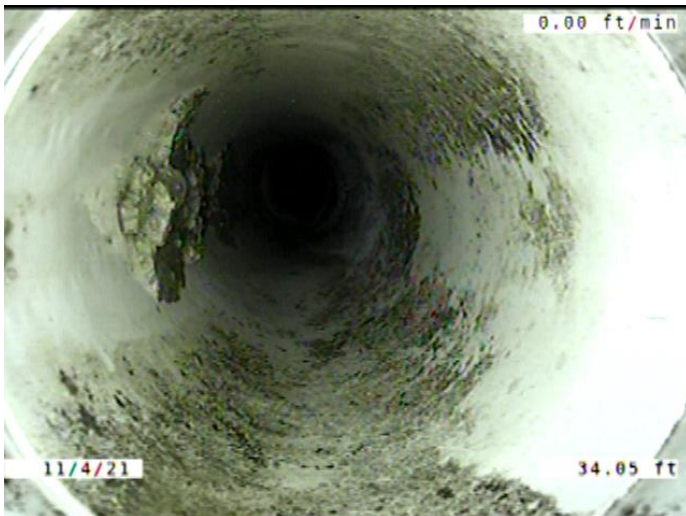
Code: **TF**
 Description: **Tap Factory**

Distance (ft): **34.0**
 Structural Grade: **0**
 O&M Grade: **0**
 Clock Start/From: **9**
 Clock To:
 1st Value: **4.000**
 2nd Value:
 Value Percent:
 Continuous Index:
 Within 8" of Joint: **YES**
 Remarks:

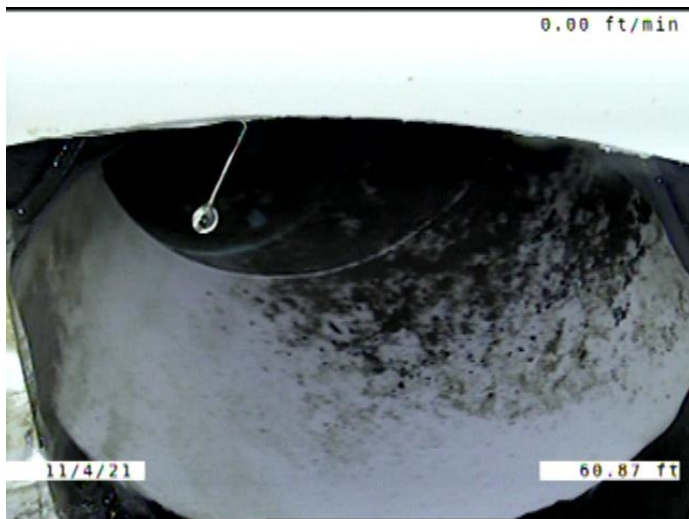
Code: **TBD**
Description: **Tap Break-in/Hammer Defective**

Distance (ft): **60.9**
Structural Grade: **0**
O&M Grade: **3**
Clock Start/From: **12**
Clock To:
1st Value: **4.000**
2nd Value:
Value Percent:
Continuous Index:
Within 8" of Joint: **YES**
Remarks: **Void visible around break in. Active.**

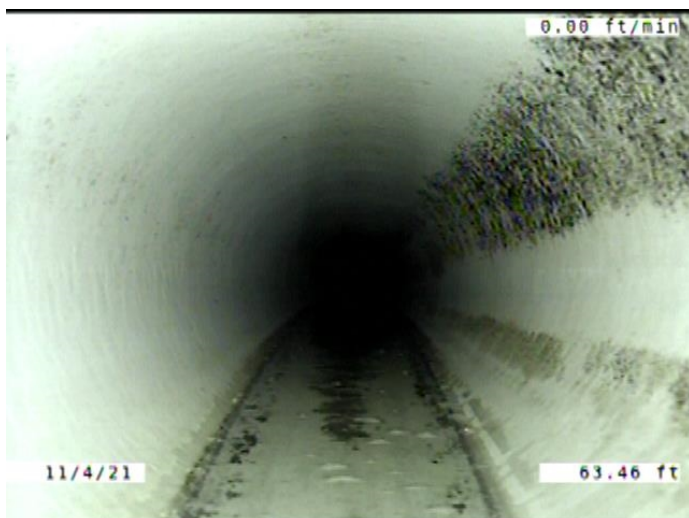
Code: **MWLS**
Description: **Miscellaneous Water Level Sag**

Distance (ft): **63.5**
Structural Grade: **2**
O&M Grade: **0**
Clock Start/From:
Clock To:
1st Value:
2nd Value:
Value Percent: **5.000**
Continuous Index: **S02**
Within 8" of Joint: **NO**
Remarks:

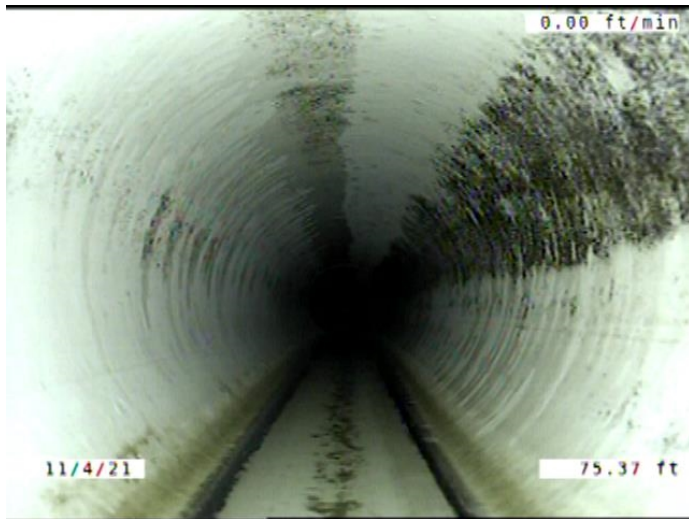
Code: **MWLS**
Description: **Miscellaneous Water Level Sag**

Distance (ft): **75.4**
Structural Grade: **2**
O&M Grade: **0**
Clock Start/From:
Clock To:
1st Value:
2nd Value:
Value Percent: **5.000**
Continuous Index: **F02**
Within 8" of Joint: **NO**
Remarks:

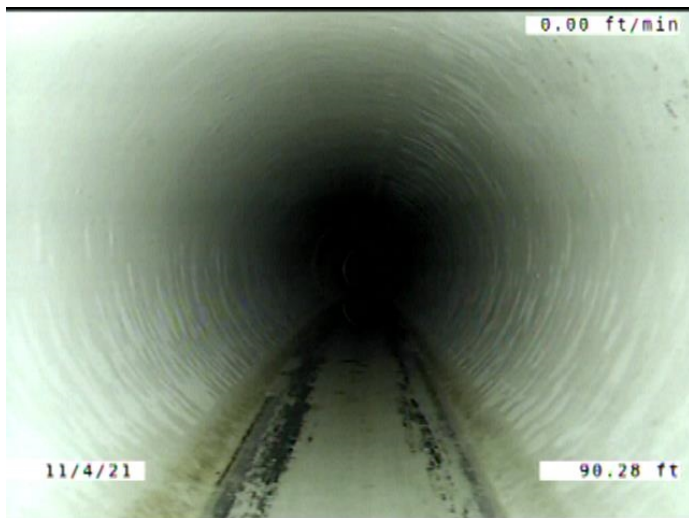
Code: **MWLS**
Description: **Miscellaneous Water Level Sag**

Distance (ft): **90.1**
Structural Grade: **2**
O&M Grade: **0**
Clock Start/From:
Clock To:
1st Value:
2nd Value:
Value Percent: **5.000**
Continuous Index: **S03**
Within 8" of Joint: **NO**
Remarks:

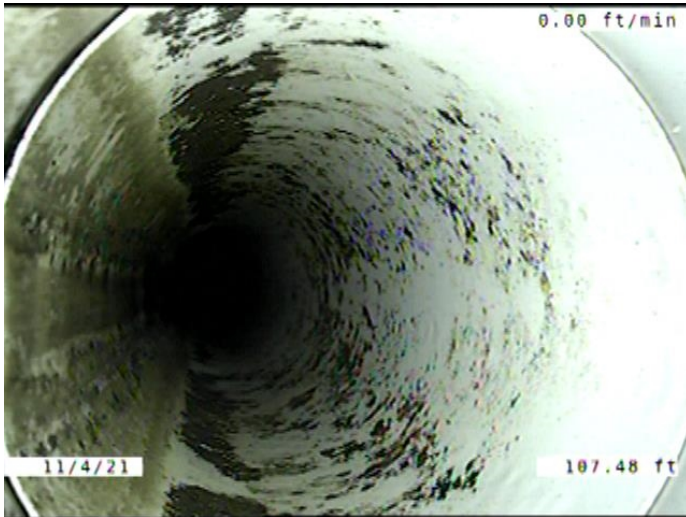
Code: **TF**
Description: **Tap Factory**

Distance (ft): **107.5**
Structural Grade: **0**
O&M Grade: **0**
Clock Start/From: **9**
Clock To:
1st Value: **4.000**
2nd Value:
Value Percent:
Continuous Index:
Within 8" of Joint: **YES**
Remarks:

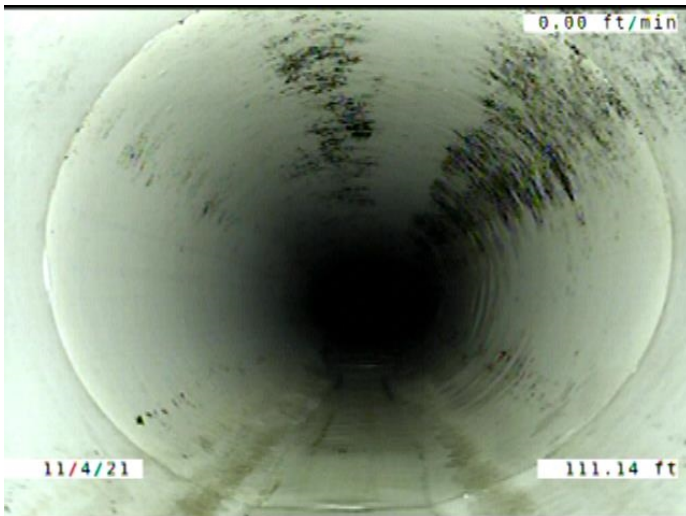
Code: **MWLS**
Description: **Miscellaneous Water Level Sag**

Distance (ft): **111.1**
Structural Grade: **2**
O&M Grade: **0**
Clock Start/From:
Clock To:
1st Value:
2nd Value:
Value Percent: **5.000**
Continuous Index: **F03**
Within 8" of Joint: **NO**
Remarks:

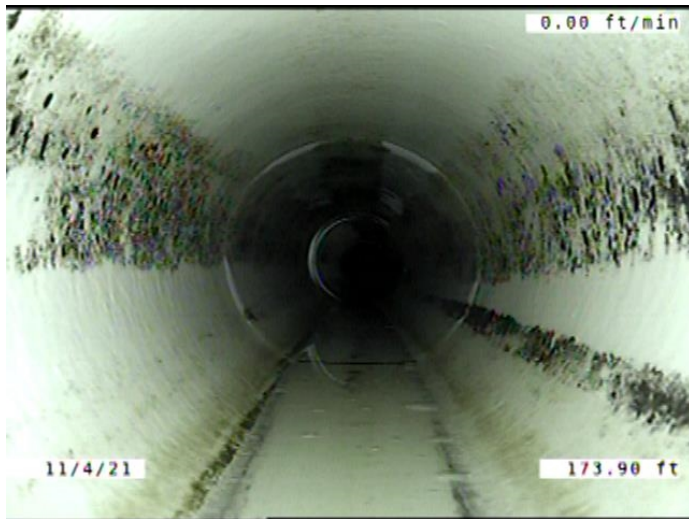
Code: **MWLS**
 Description: **Miscellaneous Water Level Sag**

Distance (ft): **173.9**
 Structural Grade: **2**
 O&M Grade: **0**
 Clock Start/From:
 Clock To:
 1st Value:
 2nd Value:
 Value Percent: **5.000**
 Continuous Index: **S04**
 Within 8" of Joint: **NO**
 Remarks:

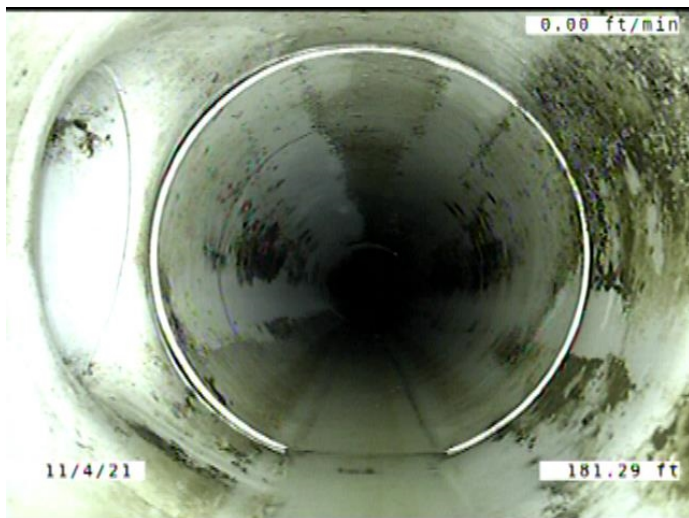
Code: **MWLS**
 Description: **Miscellaneous Water Level Sag**

Distance (ft): **181.3**
 Structural Grade: **2**
 O&M Grade: **0**
 Clock Start/From:
 Clock To:
 1st Value:
 2nd Value:
 Value Percent: **5.000**
 Continuous Index: **F04**
 Within 8" of Joint: **NO**
 Remarks:

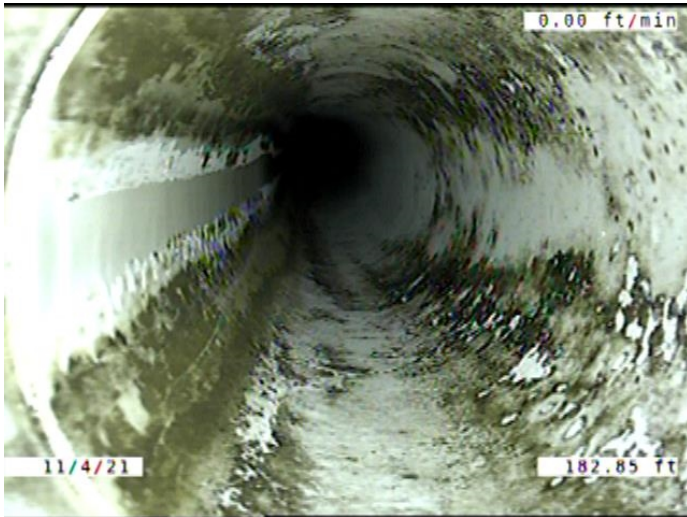
Code: **TF**
 Description: **Tap Factory**

Distance (ft): **182.8**
 Structural Grade: **0**
 O&M Grade: **0**
 Clock Start/From: **9**
 Clock To:
 1st Value: **4.000**
 2nd Value:
 Value Percent:
 Continuous Index:
 Within 8" of Joint: **YES**
 Remarks:

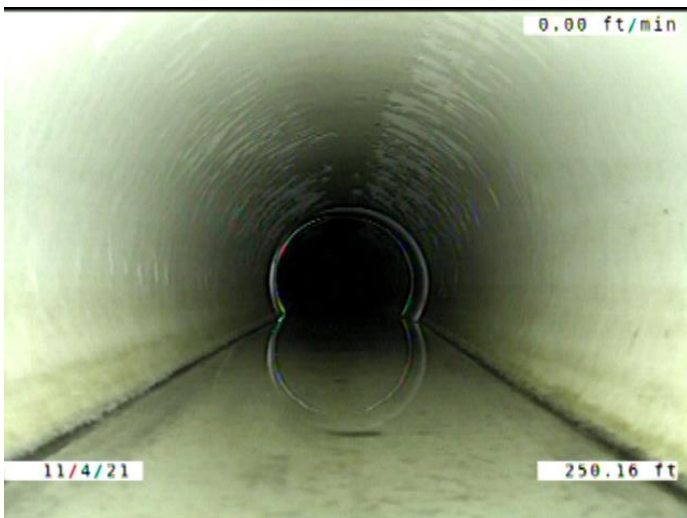
Code: **MWLS**
 Description: **Miscellaneous Water Level Sag**

Distance (ft): **250.2**
 Structural Grade: **2**
 O&M Grade: **0**
 Clock Start/From:
 Clock To:
 1st Value:
 2nd Value:
 Value Percent: **10.000**
 Continuous Index: **S05**
 Within 8" of Joint: **NO**
 Remarks:

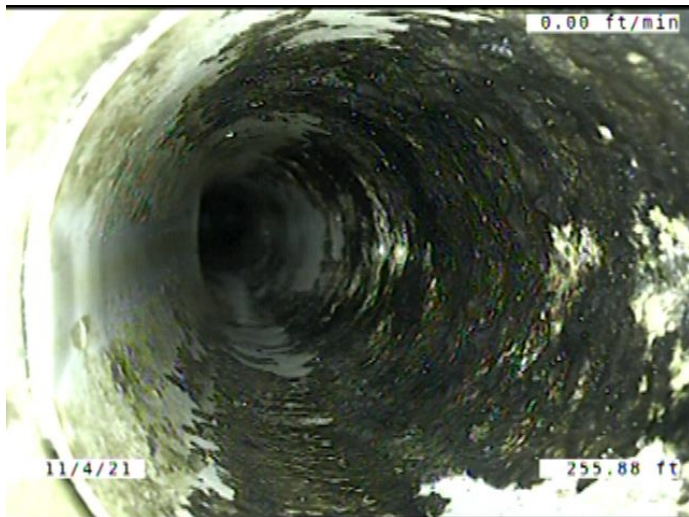
Code: **TF**
 Description: **Tap Factory**

Distance (ft): **255.9**
 Structural Grade: **0**
 O&M Grade: **0**
 Clock Start/From: **9**
 Clock To:
 1st Value: **4.000**
 2nd Value:
 Value Percent:
 Continuous Index:
 Within 8" of Joint: **YES**
 Remarks:

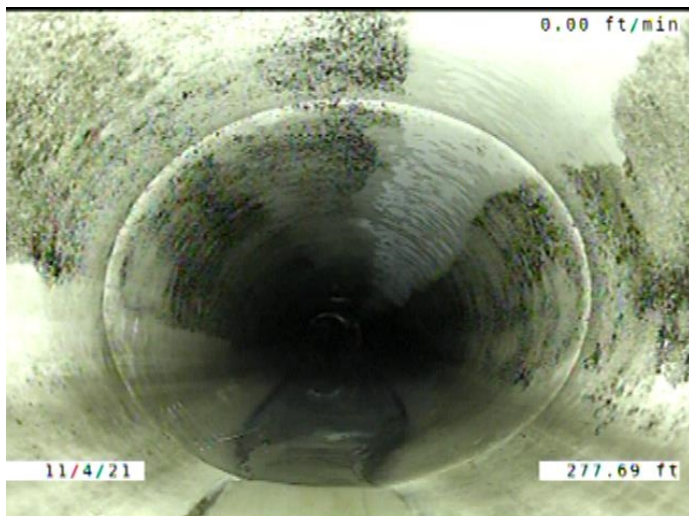
Code: **MWLS**
 Description: **Miscellaneous Water Level Sag**

Distance (ft): **277.7**
 Structural Grade: **2**
 O&M Grade: **0**
 Clock Start/From:
 Clock To:
 1st Value:
 2nd Value:
 Value Percent: **10.000**
 Continuous Index: **F05**
 Within 8" of Joint: **NO**
 Remarks:

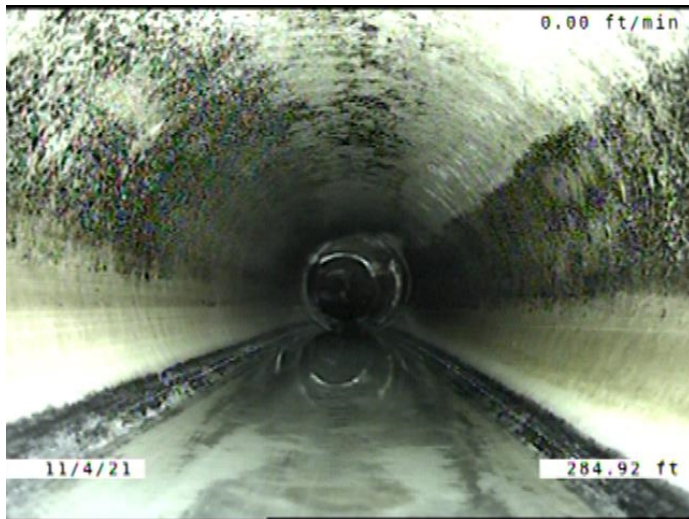
Code: **MWLS**
 Description: **Miscellaneous Water Level Sag**

Distance (ft): **284.9**
 Structural Grade: **2**
 O&M Grade: **0**
 Clock Start/From:
 Clock To:
 1st Value:
 2nd Value:
 Value Percent: **5.000**
 Continuous Index: **S06**
 Within 8" of Joint: **NO**
 Remarks:

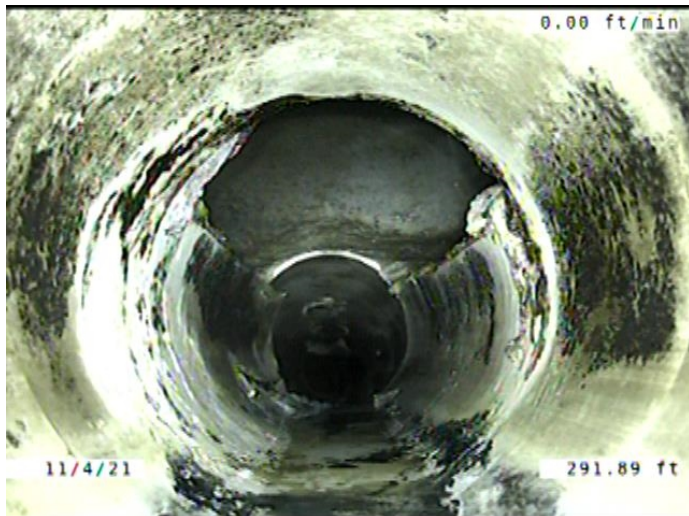
Code: **MWLS**
 Description: **Miscellaneous Water Level Sag**

Distance (ft): **291.9**
 Structural Grade: **2**
 O&M Grade: **0**
 Clock Start/From:
 Clock To:
 1st Value:
 2nd Value:
 Value Percent: **5.000**
 Continuous Index: **F06**
 Within 8" of Joint: **NO**
 Remarks:

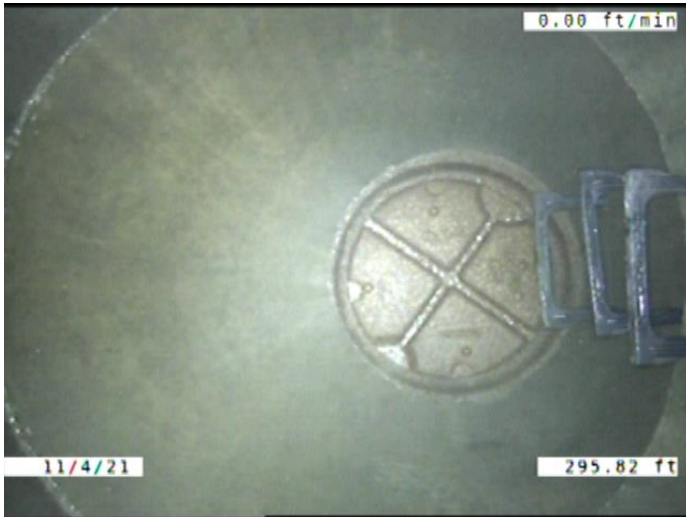
Code:	AMH
Description:	Manhole
Distance (ft):	295.8
Structural Grade:	0
O&M Grade:	0
Clock Start/From:	
Clock To:	
1st Value:	
2nd Value:	
Value Percent:	
Continuous Index:	
Within 8" of Joint:	NO
Remarks:	M-405-002.3
