RedZone  
ROBOTICS

Street:	West 4th Street		Flow Control:	Not Controlled	
City:	Hobart, IN		Year Renewed:		
Location:	Local rural streets with light traffic, t		Tape/Media #:		
Purpose:	Routine Assessment		Dia/Height:	8"	
Use:	Sanitary Sewage Pipe		Material:	VCP	
Drain Area:			Lining:	None	
Category:	NA				
Comment:					
Location Details:			Direction of Survey:	Upstream	
US MH:	M-405-005	DS MH:	M-505-082	Total Length Surveyed (ft):	255.8

O&M Index:	<u>1.93</u>	O&M Quick:	<b>312C</b>	O&M Rating:	<u>52.00</u>
Structural Index:	<u>2.52</u>	Structural Quick:	<b>5142</b>	Structural Rating:	<u>68.00</u>
Overall Index:	<u>2.22</u>	Overall Quick:	<b>5142</b>	Overall Rating:	<u>120.00</u>

**Tuesday, April 25, 2023**

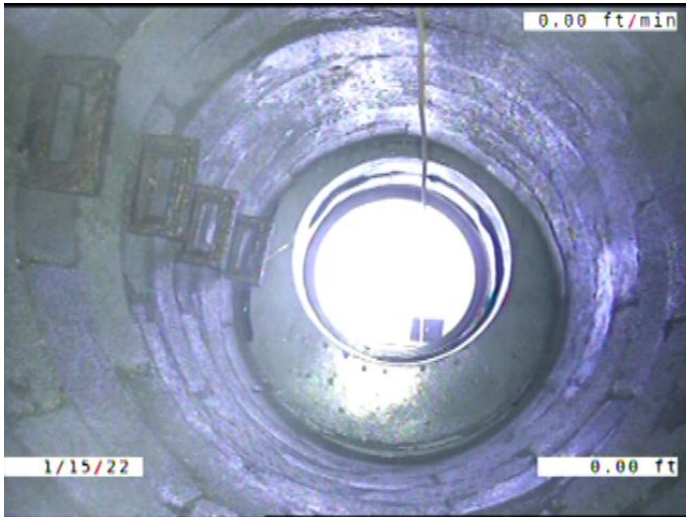
Code: **AMH**  
Description: **Manhole**

Distance (ft): **.0**  
Structural Grade: **0**  
O&M Grade: **0**  
Clock Start/From:  
Clock To:  
1st Value:  
2nd Value:  
Value Percent:  
Continuous Index:  
Within 8" of Joint: **NO**  
Remarks: **M-505-082**

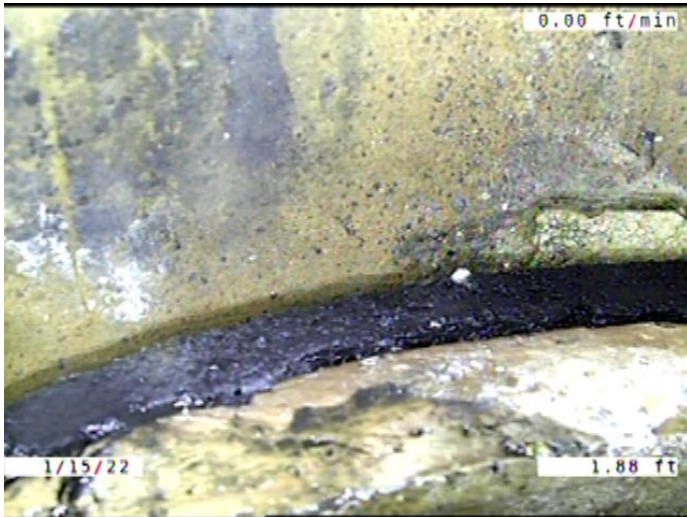
Code: **MGO**  
 Description: **Miscellaneous General Observation**

Distance (ft): **1.9**  
 Structural Grade: **0**  
 O&M Grade: **0**  
 Clock Start/From:  
 Clock To:  
 1st Value:  
 2nd Value:  
 Value Percent:  
 Continuous Index:  
 Within 8" of Joint: **NO**  
 Remarks: **10" TO 8"**

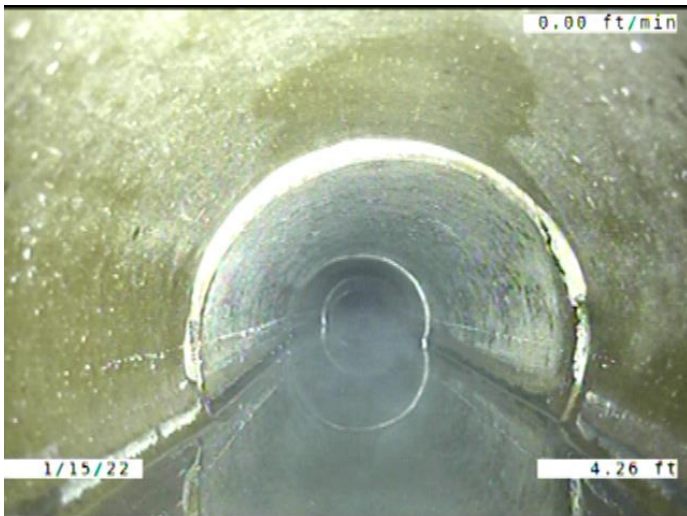
Code: **MWL**  
 Description: **Miscellaneous Water Level**

Distance (ft): **4.3**  
 Structural Grade: **0**  
 O&M Grade: **0**  
 Clock Start/From:  
 Clock To:  
 1st Value:  
 2nd Value:  
 Value Percent: **20.000**  
 Continuous Index:  
 Within 8" of Joint: **NO**  
 Remarks:

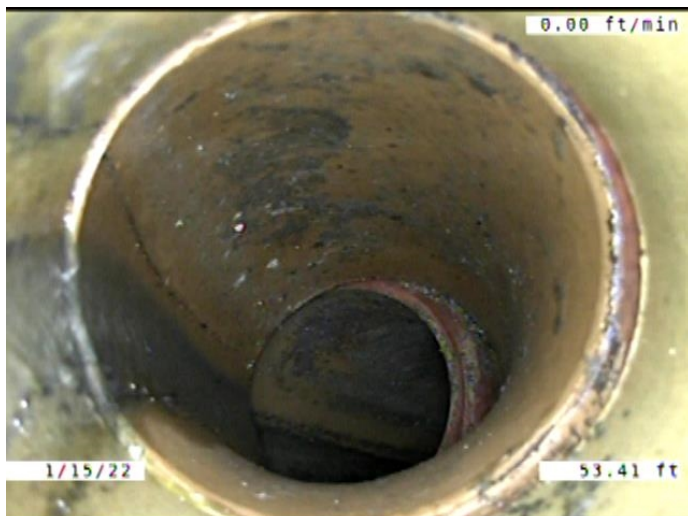
Code: **TF**  
 Description: **Tap Factory**

Distance (ft): **53.4**  
 Structural Grade: **0**  
 O&M Grade: **0**  
 Clock Start/From: **10**  
 Clock To:  
 1st Value: **4.000**  
 2nd Value:  
 Value Percent:  
 Continuous Index:  
 Within 8" of Joint: **YES**  
 Remarks: **CONSTANTLY RUNNING WATER.  
 SECOND JOINT BACK LARGE ANGLE**

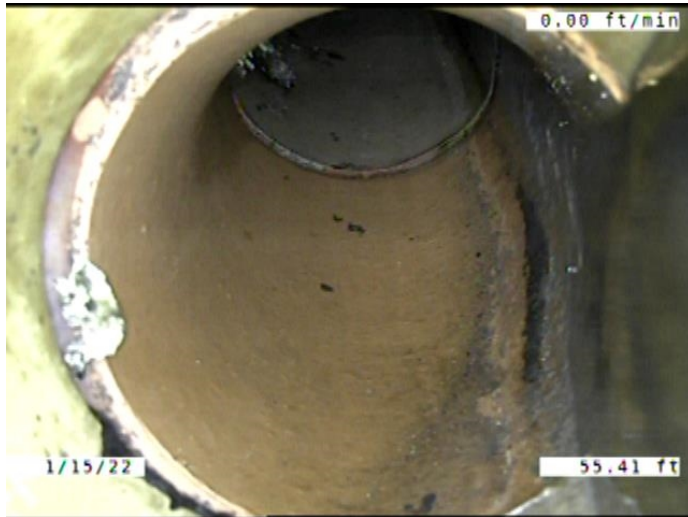
Code: **TF**  
 Description: **Tap Factory**

Distance (ft): **55.4**  
 Structural Grade: **0**  
 O&M Grade: **0**  
 Clock Start/From: **3**  
 Clock To:  
 1st Value: **4.000**  
 2nd Value:  
 Value Percent:  
 Continuous Index:  
 Within 8" of Joint: **YES**  
 Remarks:

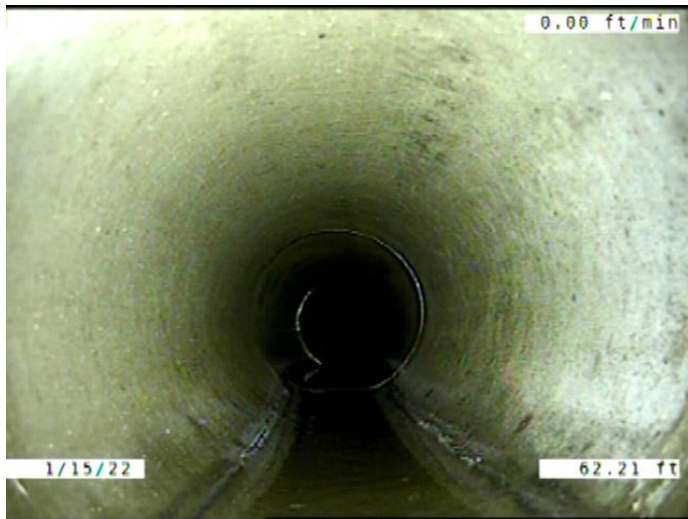
Code: **MWLS**  
Description: **Miscellaneous Water Level Sag**

Distance (ft): **62.2**  
Structural Grade: **2**  
O&M Grade: **0**  
Clock Start/From:  
Clock To:  
1st Value:  
2nd Value:  
Value Percent: **20.000**  
Continuous Index: **F02**  
Within 8" of Joint: **NO**  
Remarks:

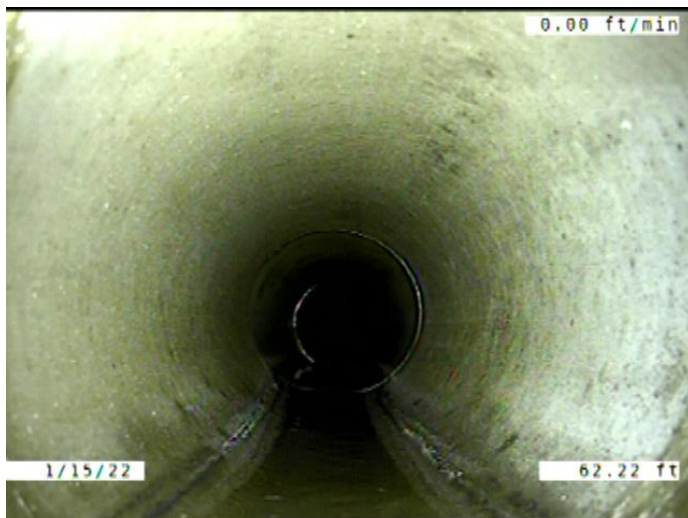
62.2	DSF(F03)	Deposits Settled Fine	948	M 2
62.4	DAE	Deposits Attached Encrustation	931	M 2
68.2	IW	Infiltration Weeper	987	M 2
68.2	IW	Infiltration Weeper	988	M 2

Code: **DSF**  
Description: **Deposits Settled Fine**

Distance (ft): **62.2**  
Structural Grade: **0**  
O&M Grade: **2**  
Clock Start/From: **5**  
Clock To: **7**  
1st Value:  
2nd Value:  
Value Percent: **5.000**  
Continuous Index: **F03**  
Within 8" of Joint: **YES**  
Remarks:

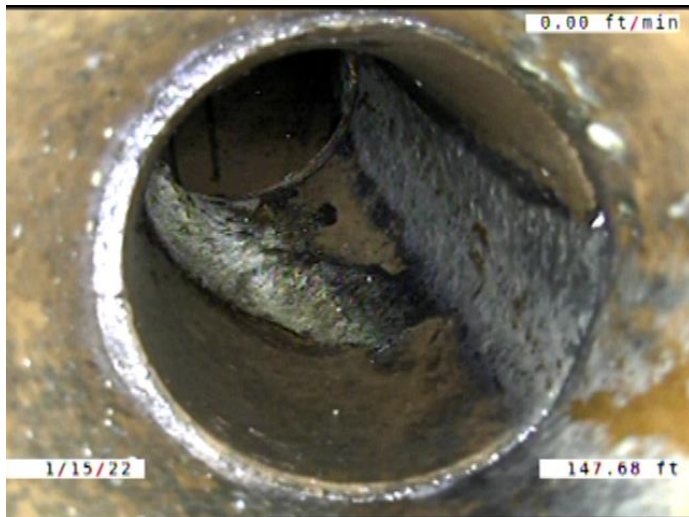
147.7	TF	Tap Factory	1505	NA
147.8	MWLS(F07)	Miscellaneous Water Level Sag	1523	S 2
150.0	TF	Tap Factory	1545	NA
152.1	MWLS(S08)	Miscellaneous Water Level Sag	1571	S 2

Code: **TF**  
 Description: **Tap Factory**

Distance (ft): **147.7**  
 Structural Grade: **0**  
 O&M Grade: **0**  
 Clock Start/From: **2**  
 Clock To:  
 1st Value: **4.000**  
 2nd Value:  
 Value Percent:  
 Continuous Index:  
 Within 8" of Joint: **YES**  
 Remarks: **CONSTANTLY RUNNING WATER.**

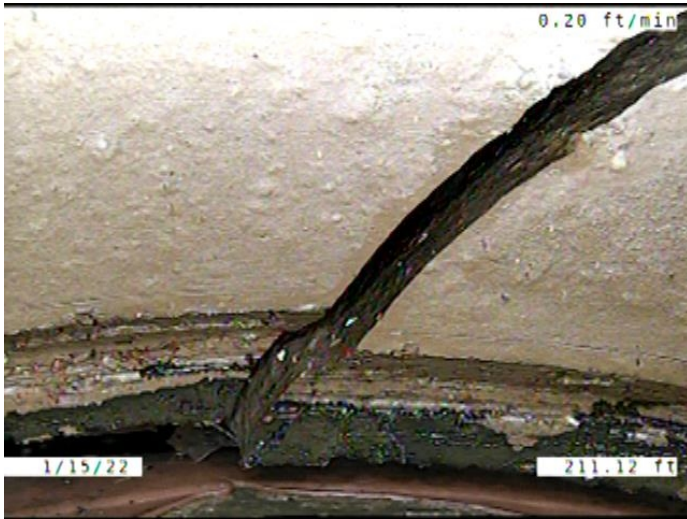
Code: **B**  
Description: **Broken**

Distance (ft): **211.1**  
Structural Grade: **4**  
O&M Grade: **0**  
Clock Start/From: **11**  
Clock To: **2**  
1st Value:  
2nd Value:  
Value Percent:  
Continuous Index:  
Within 8" of Joint: **YES**  
Remarks:
