Profile/Photo Observation Report

Date:	04/25/2018	Weather:		Coding:	PACP 6.0
Pipe Length (ft):		Owner:	City of Hobart	Pre Clean:	No Pre-Cleaning
P.O.#:	83	Surveyor:	M. Pielacha	PSR:	P-405-008-069
Customer:	City of Hobart	Clean Date:		Shape:	C

Street:	3rd Street	Flow Control:	Not Controlled
City:	Hobart, IN	Year Renewed:	
Location:	Light Highway	Tape/Media #:	DEP 83
Purpose:	Routine Assessment	Dia/Height:	15"
Use:	Sanitary	Material:	CP
Drain Area:		Lining:	
Category:	NA		
Comment:	YES501824 Submittal 2		
Location Details:		Direction of Survey:	Downstream
US MH:	M-405-008	DS MH:	M-405-069
		Total Length Surveyed (ft):	229.2

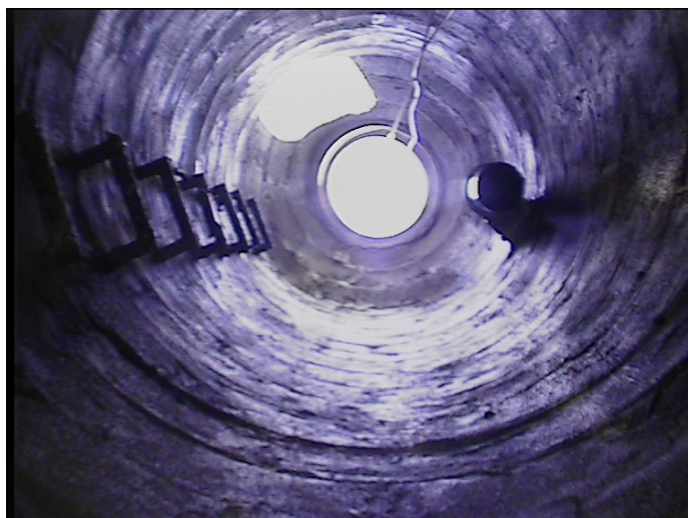
Code: **AMH**
 Description: **Manhole**

Distance (ft): **.0**
 Structural Grade: **0**
 O&M Grade: **0**
 Clock Start/From:
 Clock To:
 1st Value:
 2nd Value:
 Value Percent:
 Continuous Index:
 Within 8" of Joint: **NO**
 Remarks: **M-405-008**

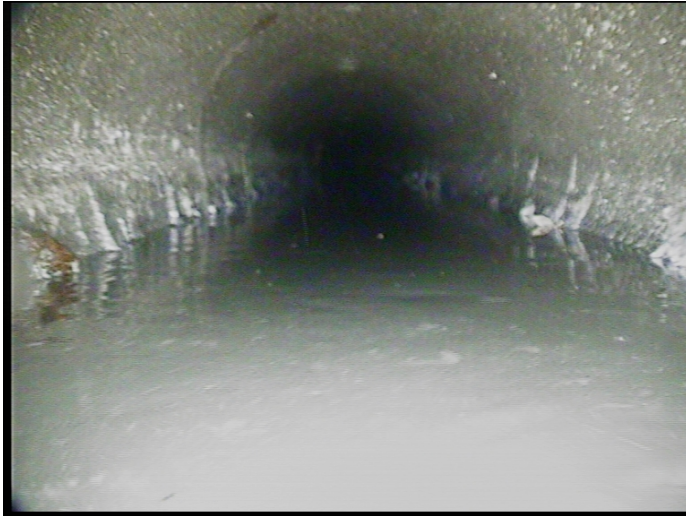
Code: **MWL**
Description: **Water Level**

Distance (ft): **.0**
Structural Grade: **0**
O&M Grade: **0**
Clock Start/From:
Clock To:
1st Value:
2nd Value:
Value Percent: **15.000**
Continuous Index:
Within 8" of Joint: **NO**
Remarks:

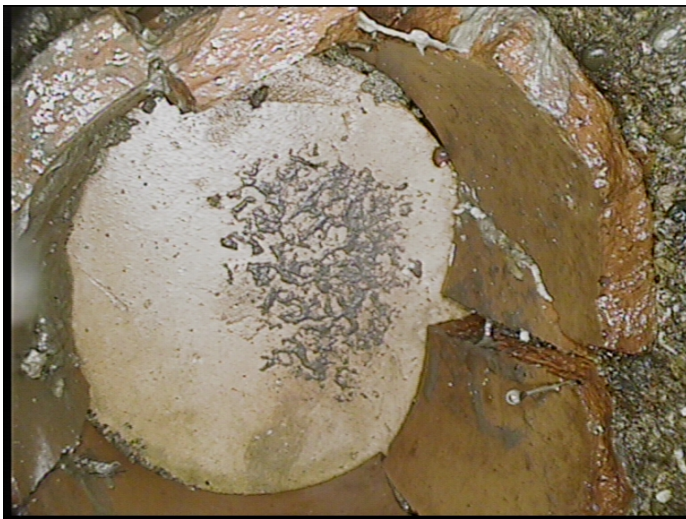
Code: **TBC**
Description: **Tap Break-in Capped**

Distance (ft): **20.7**
Structural Grade: **0**
O&M Grade: **2**
Clock Start/From: **9**
Clock To:
1st Value: **4.000**
2nd Value:
Value Percent:
Continuous Index:
Within 8" of Joint: **NO**
Remarks:

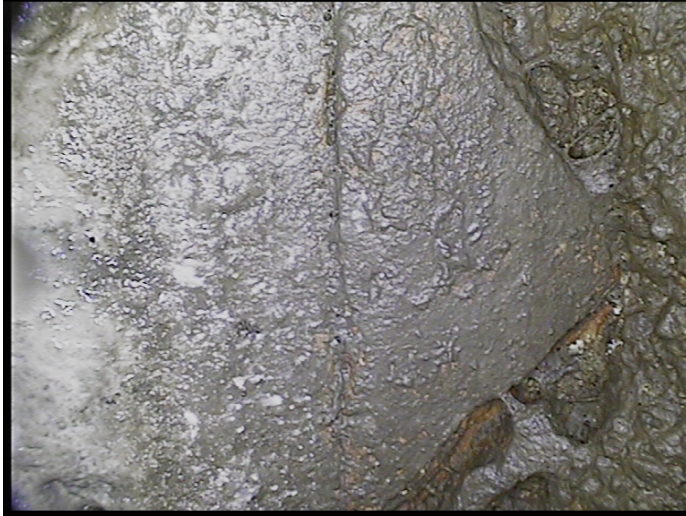
Code: **TBC**
Description: **Tap Break-in Capped**

Distance (ft): **84.9**
Structural Grade: **0**
O&M Grade: **2**
Clock Start/From: **9**
Clock To:
1st Value: **6.000**
2nd Value:
Value Percent:
Continuous Index:
Within 8" of Joint: **NO**
Remarks:

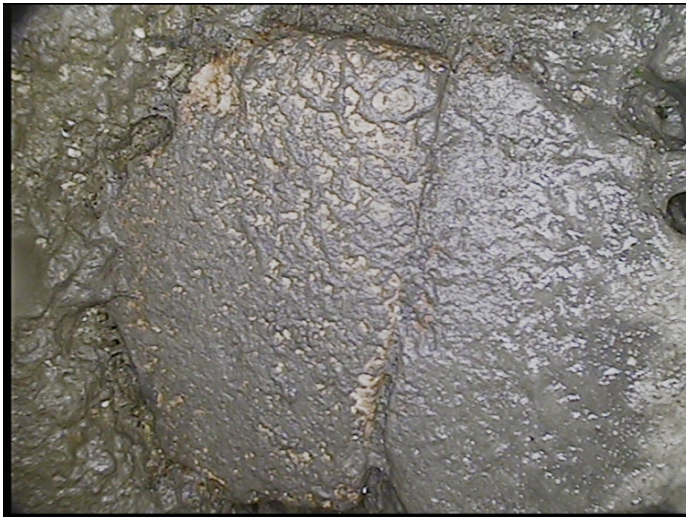
Code: **TBC**
Description: **Tap Break-in Capped**

Distance (ft): **87.8**
Structural Grade: **0**
O&M Grade: **2**
Clock Start/From: **3**
Clock To:
1st Value: **6.000**
2nd Value:
Value Percent:
Continuous Index:
Within 8" of Joint: **NO**
Remarks:

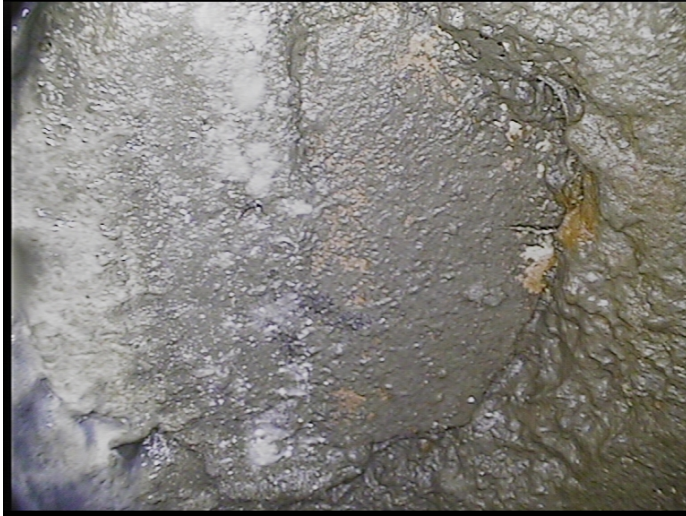
Code: **TBC**
Description: **Tap Break-in Capped**

Distance (ft): **102.9**
Structural Grade: **0**
O&M Grade: **2**
Clock Start/From: **9**
Clock To:
1st Value: **6.000**
2nd Value:
Value Percent:
Continuous Index:
Within 8" of Joint: **NO**
Remarks:

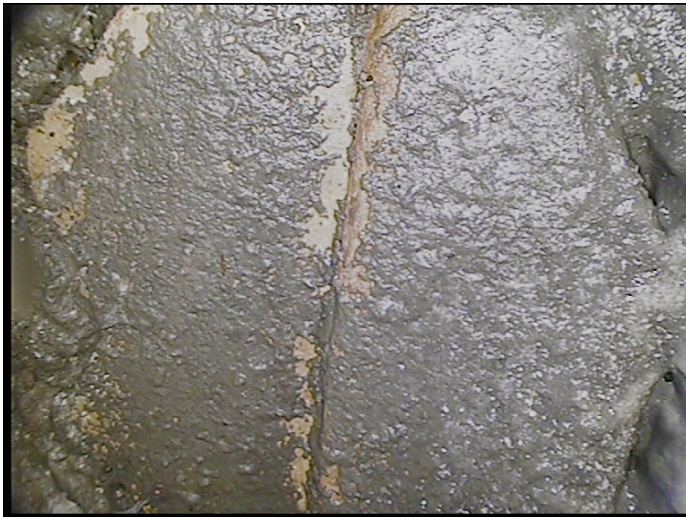
Code: **TBC**
Description: **Tap Break-in Capped**

Distance (ft): **106.1**
Structural Grade: **0**
O&M Grade: **2**
Clock Start/From: **3**
Clock To:
1st Value: **6.000**
2nd Value:
Value Percent:
Continuous Index:
Within 8" of Joint: **NO**
Remarks:

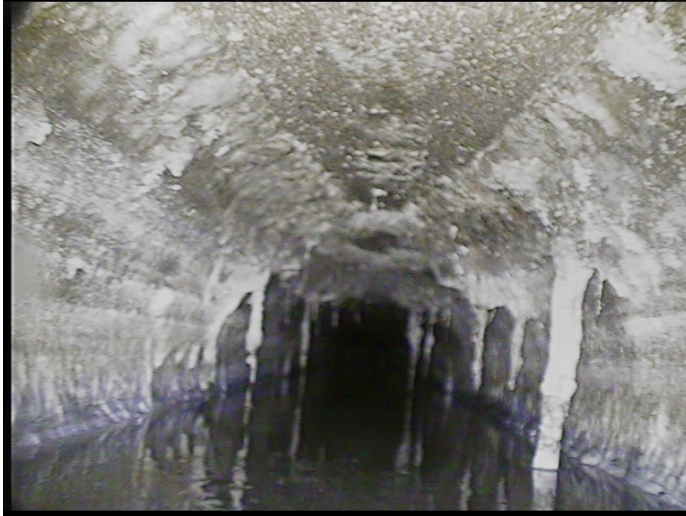
Code: **DAGS**
Description: **Deposits Attached Grease**

Distance (ft): **128.7**
Structural Grade: **0**
O&M Grade: **2**
Clock Start/From: **10**
Clock To: **2**
1st Value:
2nd Value:
Value Percent: **5.000**
Continuous Index: **S01**
Within 8" of Joint: **YES**
Remarks:

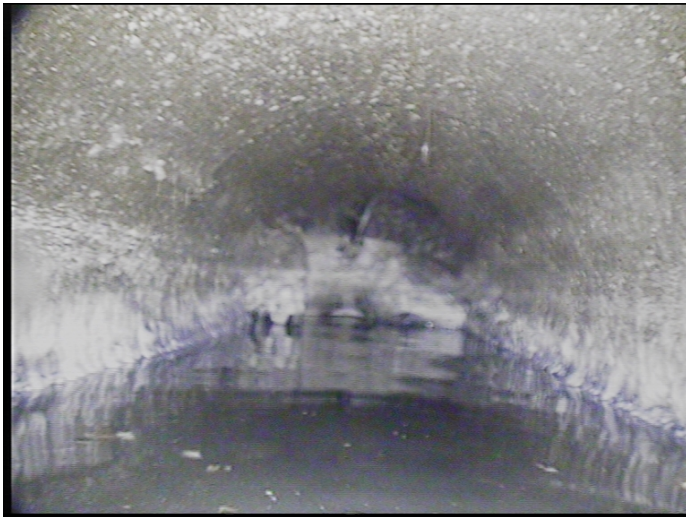
Code: **DAGS**
Description: **Deposits Attached Grease**

Distance (ft): **224.5**
Structural Grade: **0**
O&M Grade: **2**
Clock Start/From: **9**
Clock To: **3**
1st Value:
2nd Value:
Value Percent: **10.000**
Continuous Index: **F04**
Within 8" of Joint: **NO**
Remarks:

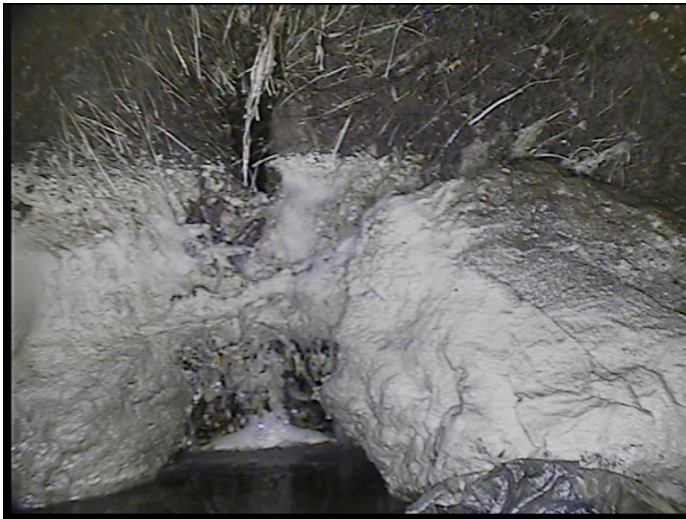
Code: **RMJ**
 Description: **Roots Medium Joint**

Distance (ft): **228.8**
 Structural Grade: **0**
 O&M Grade: **3**
 Clock Start/From: **8**
 Clock To: **4**
 1st Value:
 2nd Value:
 Value Percent: **50.000**
 Continuous Index:
 Within 8" of Joint: **YES**
 Remarks:

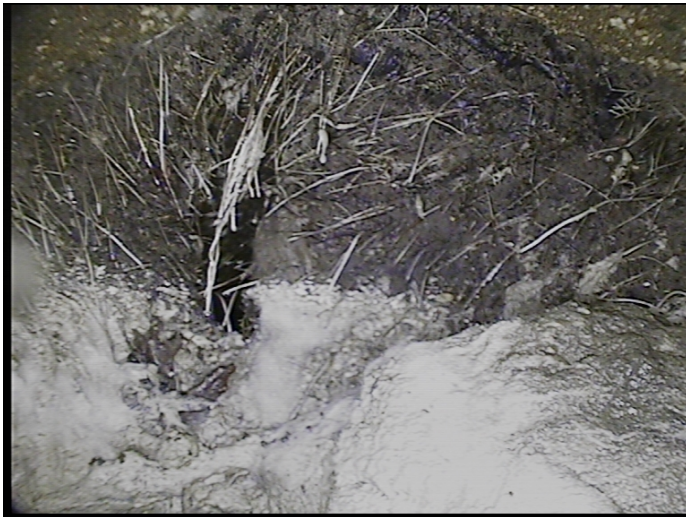
Code: **MSA**
 Description: **Abandoned Survey**

Distance (ft): **229.2**
 Structural Grade: **0**
 O&M Grade: **0**
 Clock Start/From:
 Clock To:
 1st Value:
 2nd Value:
 Value Percent:
 Continuous Index:
 Within 8" of Joint: **NO**
 Remarks: **root ball**
