Profile/Photo Observation Report

Date:	04/25/2018	Weather:		Coding:	PACP 6.0
Pipe Length (ft):		Owner:	City of Hobart	Pre Clean:	No Pre-Cleaning
P.O.#:	84	Surveyor:	M. Pielacha	PSR:	P-405-010-008
Customer:	City of Hobart	Clean Date:		Shape:	C

Street:	3rd Street	Flow Control:	Not Controlled
City:	Hobart, IN	Year Renewed:	
Location:	Light Highway	Tape/Media #:	DEP 84
Purpose:	Routine Assessment	Dia/Height:	15"
Use:	Sanitary	Material:	CP
Drain Area:		Lining:	
Category:	NA		
Comment:	YES501824 Submittal 2		
Location Details:		Direction of Survey:	Upstream
US MH:	M-405-010	DS MH:	M-405-008
		Total Length Surveyed (ft):	296.0

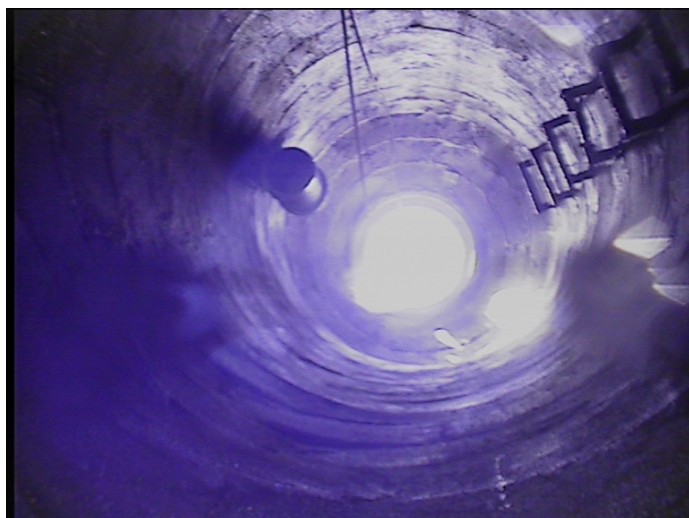
Code: **AMH**
 Description: **Manhole**

Distance (ft): **.0**
 Structural Grade: **0**
 O&M Grade: **0**
 Clock Start/From:
 Clock To:
 1st Value:
 2nd Value:
 Value Percent:
 Continuous Index:
 Within 8" of Joint: **NO**
 Remarks: **M-405-008**

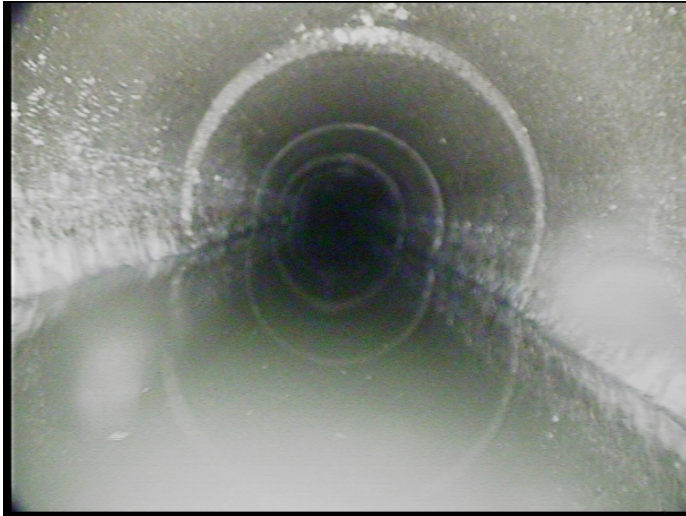
Code: **MWL**
Description: **Water Level**

Distance (ft): **.0**
Structural Grade: **0**
O&M Grade: **0**
Clock Start/From:
Clock To:
1st Value:
2nd Value:
Value Percent: **15.000**
Continuous Index:
Within 8" of Joint: **NO**
Remarks:

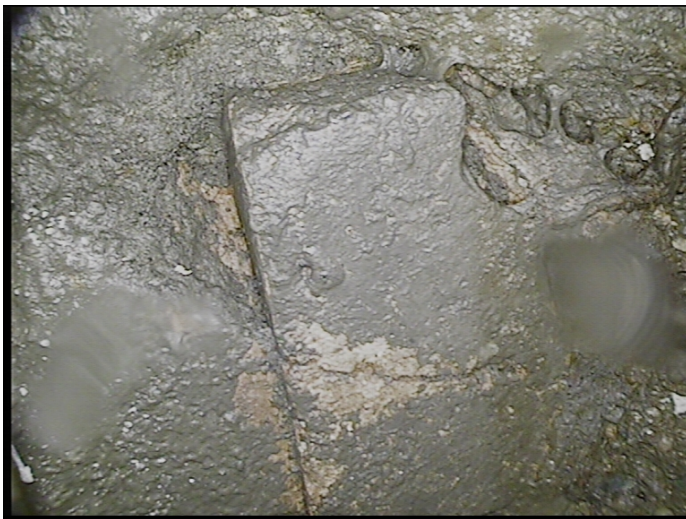
Code: **TBC**
Description: **Tap Break-in Capped**

Distance (ft): **57.1**
Structural Grade: **0**
O&M Grade: **2**
Clock Start/From: **9**
Clock To:
1st Value: **6.000**
2nd Value:
Value Percent:
Continuous Index:
Within 8" of Joint: **NO**
Remarks:

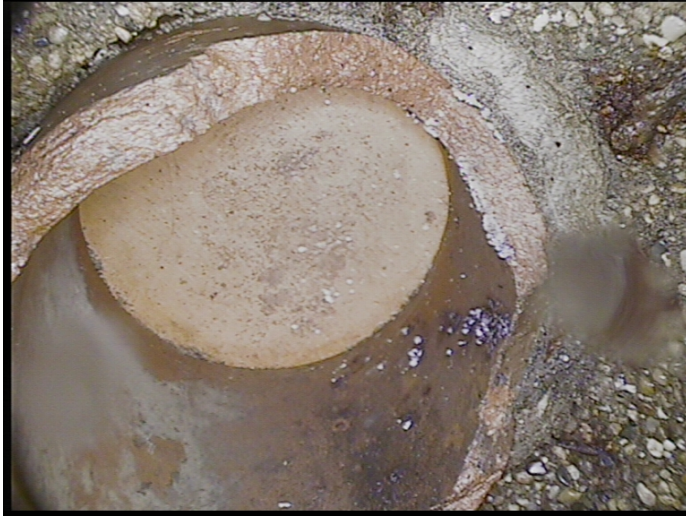
Code: **TBC**
Description: **Tap Break-in Capped**

Distance (ft): **124.1**
Structural Grade: **0**
O&M Grade: **2**
Clock Start/From: **9**
Clock To:
1st Value: **4.000**
2nd Value:
Value Percent:
Continuous Index:
Within 8" of Joint: **NO**
Remarks:

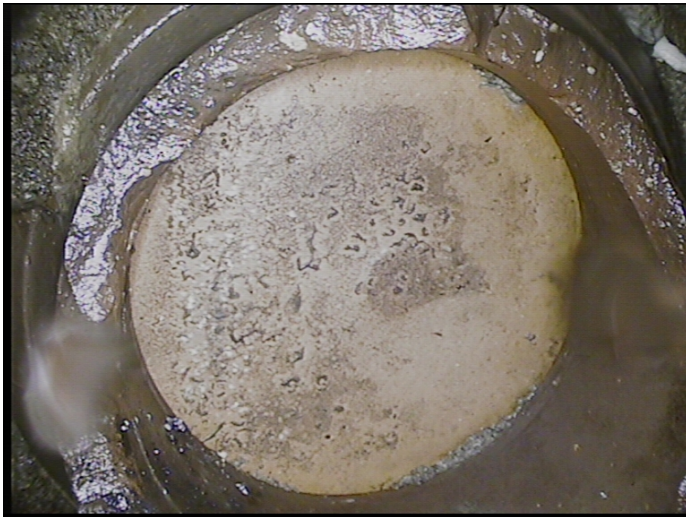
Code: **TBC**
Description: **Tap Break-in Capped**

Distance (ft): **130.5**
Structural Grade: **0**
O&M Grade: **2**
Clock Start/From: **3**
Clock To:
1st Value: **4.000**
2nd Value:
Value Percent:
Continuous Index:
Within 8" of Joint: **NO**
Remarks:

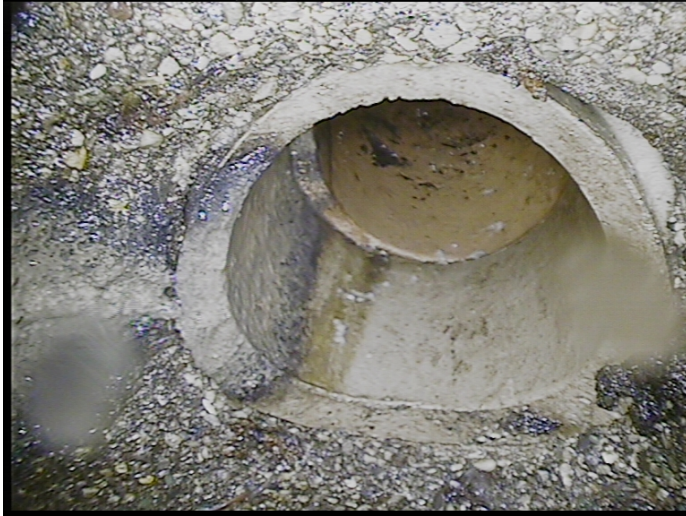
Code: **TBA**
Description: **Tap Break-in Active**

Distance (ft): **136.1**
Structural Grade: **0**
O&M Grade: **0**
Clock Start/From: **12**
Clock To:
1st Value: **4.000**
2nd Value:
Value Percent:
Continuous Index:
Within 8" of Joint: **NO**
Remarks:

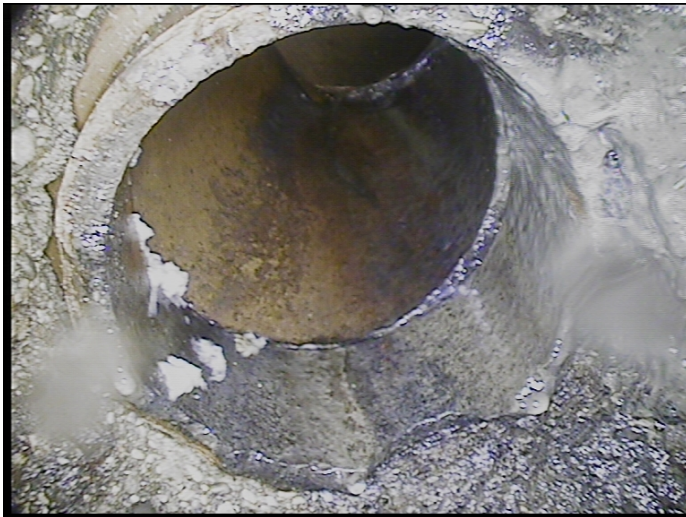
Code: **TBA**
Description: **Tap Break-in Active**

Distance (ft): **175.8**
Structural Grade: **0**
O&M Grade: **0**
Clock Start/From: **2**
Clock To:
1st Value: **4.000**
2nd Value:
Value Percent:
Continuous Index:
Within 8" of Joint: **NO**
Remarks:

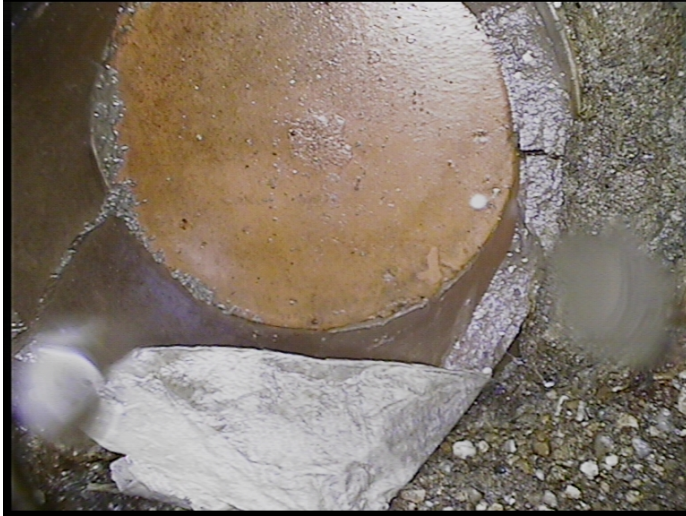
Code: **TBC**
Description: **Tap Break-in Capped**

Distance (ft): **191.4**
Structural Grade: **0**
O&M Grade: **2**
Clock Start/From: **9**
Clock To:
1st Value: **4.000**
2nd Value:
Value Percent:
Continuous Index:
Within 8" of Joint: **NO**
Remarks:

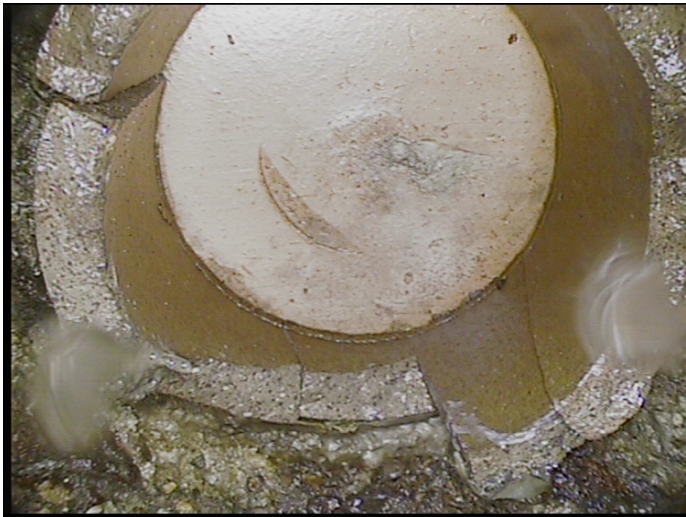
Code: **TBC**
Description: **Tap Break-in Capped**

Distance (ft): **194.2**
Structural Grade: **0**
O&M Grade: **2**
Clock Start/From: **3**
Clock To:
1st Value: **4.000**
2nd Value:
Value Percent:
Continuous Index:
Within 8" of Joint: **NO**
Remarks:

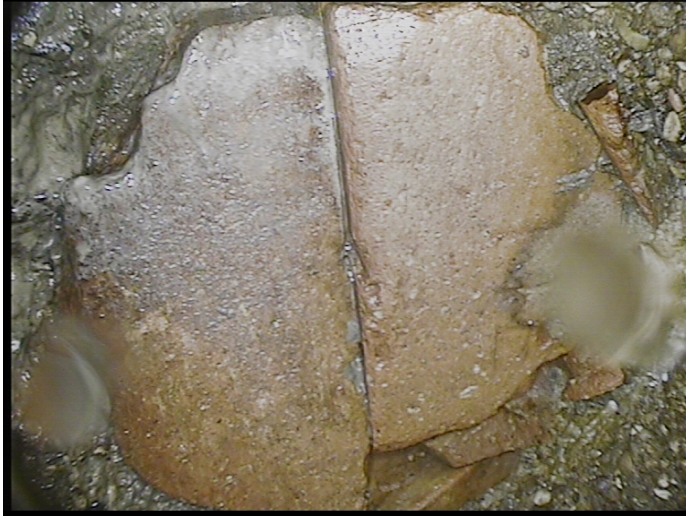
Code: **TBC**
Description: **Tap Break-in Capped**

Distance (ft): **200.2**
Structural Grade: **0**
O&M Grade: **2**
Clock Start/From: **9**
Clock To:
1st Value: **4.000**
2nd Value:
Value Percent:
Continuous Index:
Within 8" of Joint: **NO**
Remarks:

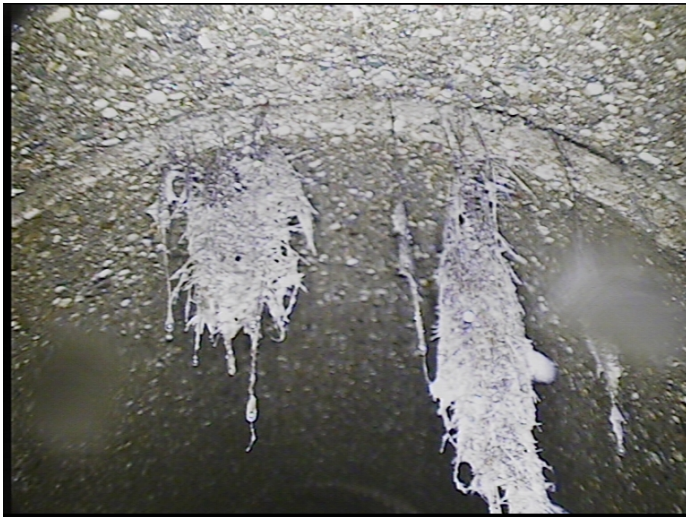
Code: **RFJ**
Description: **Roots Fine Joint**

Distance (ft): **213.3**
Structural Grade: **0**
O&M Grade: **1**
Clock Start/From: **11**
Clock To: **1**
1st Value:
2nd Value:
Value Percent:
Continuous Index:
Within 8" of Joint: **YES**
Remarks:

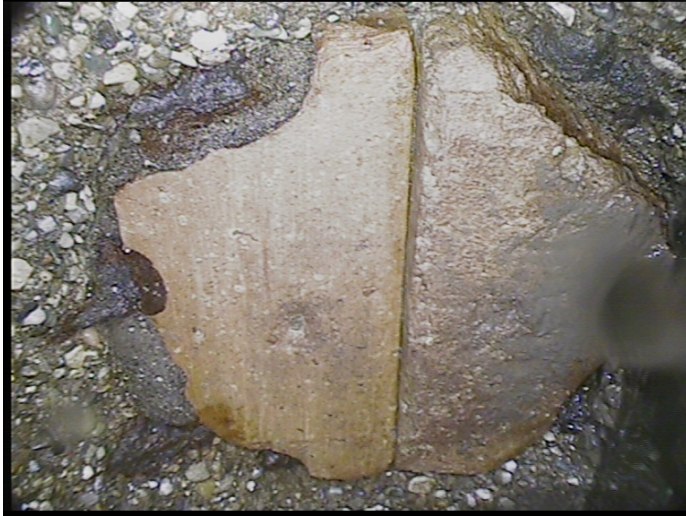
Code: **TBC**
Description: **Tap Break-in Capped**

Distance (ft): **276.7**
Structural Grade: **0**
O&M Grade: **2**
Clock Start/From: **3**
Clock To:
1st Value: **4.000**
2nd Value:
Value Percent:
Continuous Index:
Within 8" of Joint: **NO**
Remarks:

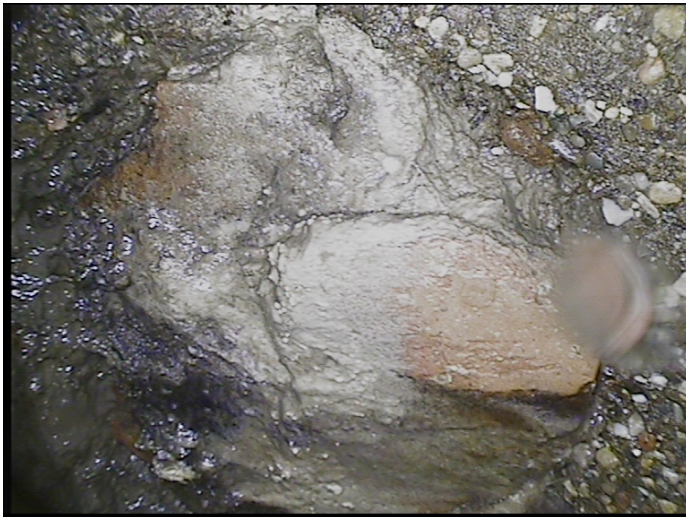
Code: **TBC**
Description: **Tap Break-in Capped**

Distance (ft): **280.0**
Structural Grade: **0**
O&M Grade: **2**
Clock Start/From: **9**
Clock To:
1st Value: **4.000**
2nd Value:
Value Percent:
Continuous Index:
Within 8" of Joint: **NO**
Remarks:

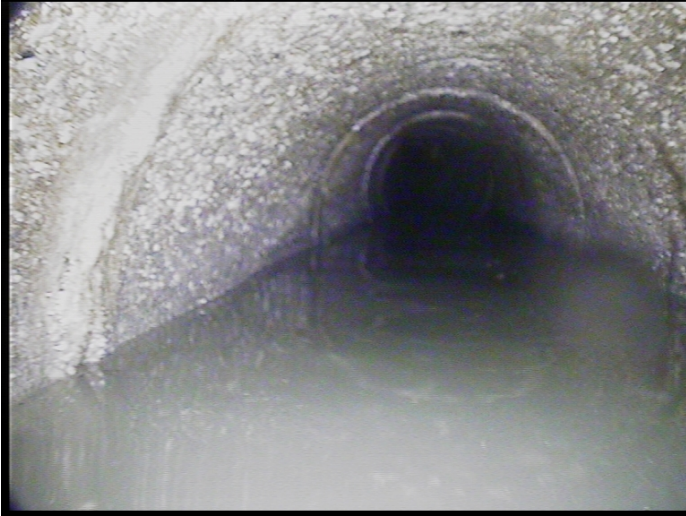
Code:	MSA
Description:	Abandoned Survey
Distance (ft):	296.0
Structural Grade:	0
O&M Grade:	0
Clock Start/From:	
Clock To:	
1st Value:	
2nd Value:	
Value Percent:	
Continuous Index:	
Within 8" of Joint:	NO
Remarks:	reverse complete
