## Profile/Photo Observation Report

Street:	<b>FOXCROFT STREET</b>	Flow Control:	<b>Not Controlled</b>
City:	<b>Hobart, IN</b>	Year Renewed:	
Location:	<b>Yard</b>	Tape/Media #:	
Purpose:	<b>Routine Assessment</b>	Dia/Height:	<b>8"</b>
Use:	<b>Sanitary</b>	Material:	<b>VCP</b>
Drain Area:	<b>NA</b>	Lining:	
Category:	<b>NA</b>		
Comment:	<b>Flow direction is marked wrong.</b>		
Location Details:		Direction of Survey:	<b>Upstream</b>
US MH:	<b>M-405-013</b>	DS MH:	<b>M-405-014</b>
		Total Length Surveyed (ft):	<b>153.2</b>

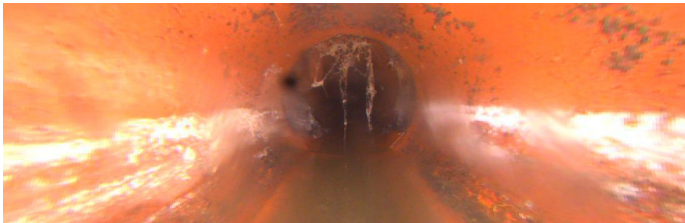
Code:	<b>RMJ</b>
Description:	<b>Roots Medium Joint</b>

Distance (ft):	<b>1.5</b>
Structural Grade:	<b>0</b>
O&M Grade:	<b>3</b>
Clock Start/From:	<b>7</b>
Clock To:	<b>5</b>
1st Value:	
2nd Value:	
Value Percent:	<b>20.000</b>
Continuous Index:	
Within 8" of Joint:	<b>YES</b>
Remarks:

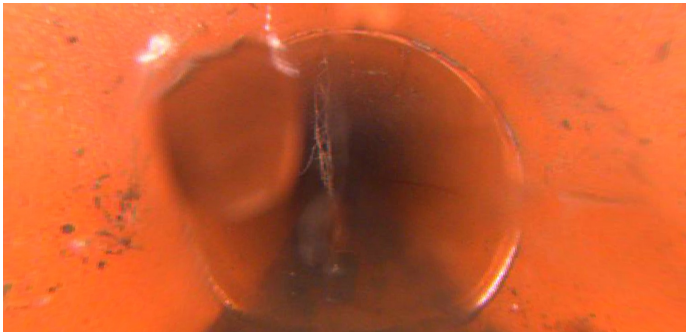
Code: **RFJ**  
Description: **Roots Fine Joint**

Distance (ft): **13.1**  
Structural Grade: **0**  
O&M Grade: **1**  
Clock Start/From: **12**  
Clock To:  
1st Value:  
2nd Value:  
Value Percent:  
Continuous Index:  
Within 8" of Joint: **YES**  
Remarks:

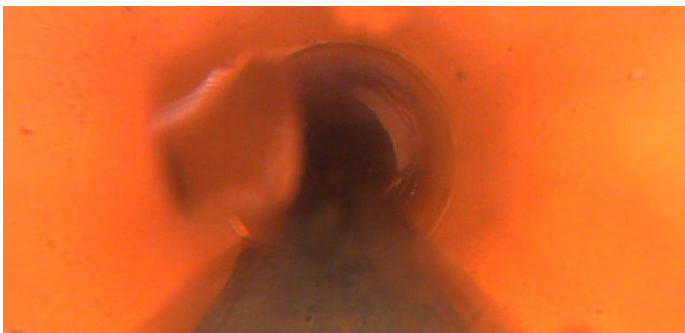
Code: **TF**  
Description: **Tap Factory**

Distance (ft): **95.0**  
Structural Grade: **0**  
O&M Grade: **0**  
Clock Start/From: **2**  
Clock To:  
1st Value: **4.000**  
2nd Value:  
Value Percent:  
Continuous Index:  
Within 8" of Joint:  
Remarks:
