Profile/Photo Observation Report

Street:	Off Lasalle Street	Flow Control:	Not Controlled
City:	Hobart, IN	Year Renewed:	
Location:	Light Highway	Tape/Media #:	DEP 121
Purpose:	Routine Assessment	Dia/Height:	15"
Use:	Sanitary	Material:	VCP
Drain Area:		Lining:	
Category:	NA		
Comment:	YES501824 Submittal 2		
Location Details:		Direction of Survey:	Upstream
US MH:	M-405-017	DS MH:	M-405-015
		Total Length Surveyed (ft):	169.4

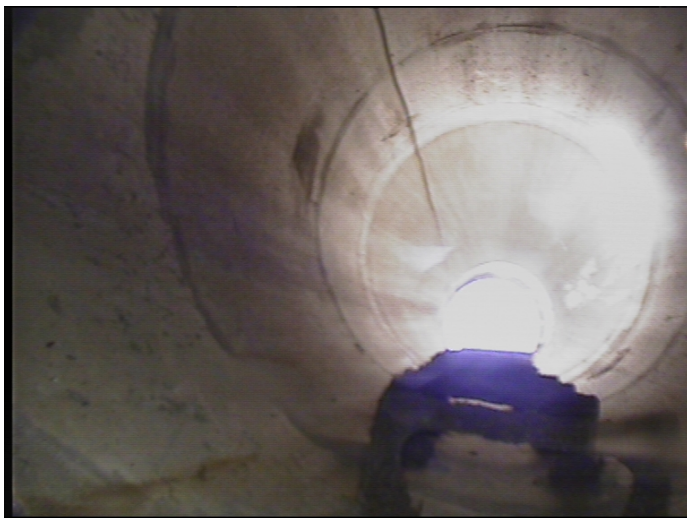
Code: **AMH**
 Description: **Manhole**

Distance (ft): **.0**
 Structural Grade: **0**
 O&M Grade: **0**
 Clock Start/From:
 Clock To:
 1st Value:
 2nd Value:
 Value Percent:
 Continuous Index:
 Within 8" of Joint: **NO**
 Remarks: **M-405-015**

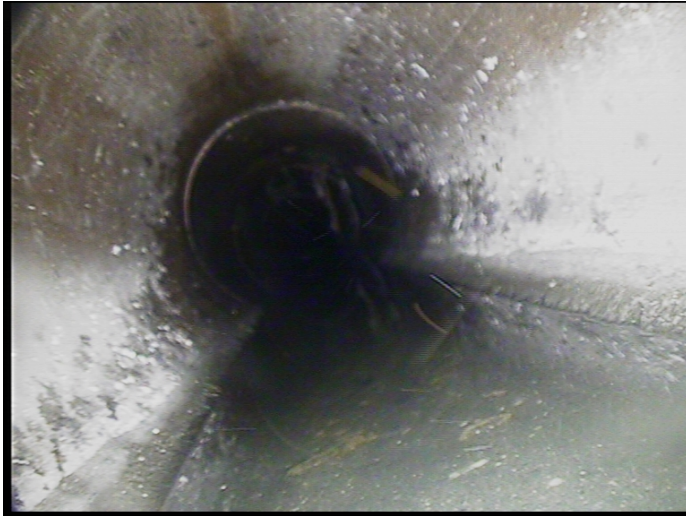
Code:	MWL
Description:	Water Level
Distance (ft):	.0
Structural Grade:	0
O&M Grade:	0
Clock Start/From:	
Clock To:	
1st Value:	
2nd Value:	
Value Percent:	10.000
Continuous Index:	
Within 8" of Joint:	NO
Remarks:

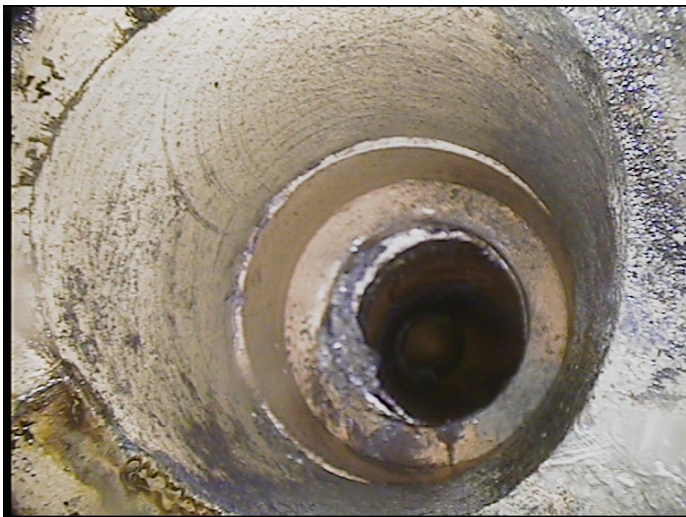
Code:	TF
Description:	Tap Factory
Distance (ft):	7.2
Structural Grade:	0
O&M Grade:	0
Clock Start/From:	2
Clock To:	
1st Value:	4.000
2nd Value:	
Value Percent:	
Continuous Index:	
Within 8" of Joint:	NO
Remarks:

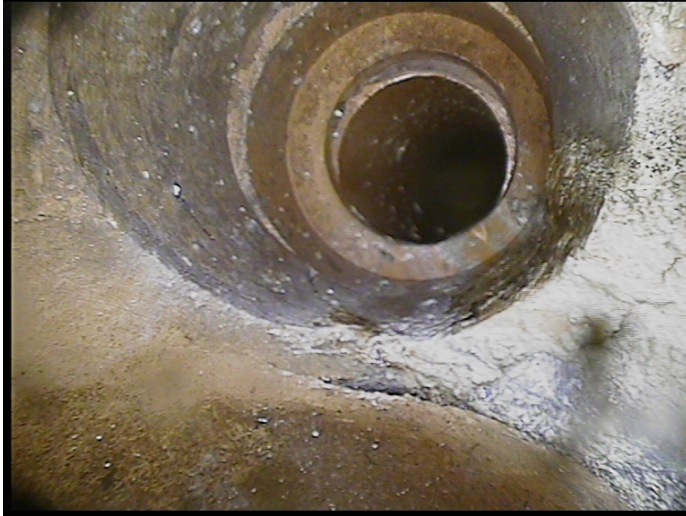
Code: **TFA**
Description: **Tap Factory Active**

Distance (ft): **84.9**
Structural Grade: **0**
O&M Grade: **0**
Clock Start/From: **2**
Clock To:
1st Value: **4.000**
2nd Value:
Value Percent:
Continuous Index:
Within 8" of Joint: **NO**
Remarks:
