Profile/Photo Observation Report

Date:	04/23/2018	Weather:		Coding:	PACP 6.0
Pipe Length (ft):	258.0	Owner:	NA	Pre Clean:	No Pre-Cleaning
P.O.#:		Surveyor:	Jen Costello	PSR:	P-405-024-023
Customer:		Clean Date:	01/01/1900	Shape:	C

Street:	OFF S LASALLE ST	Flow Control:	Not Controlled
City:	Hobart, IN	Year Renewed:	
Location:	Yard	Tape/Media #:	
Purpose:	Routine Assessment	Dia/Height:	12"
Use:	Sanitary	Material:	PVC
Drain Area:	NA	Lining:	
Category:	NA		
Comment:			
Location Details:		Direction of Survey:	Downstream
US MH:	M-405-024	DS MH:	M-405-023
		Total Length Surveyed (ft):	294.1

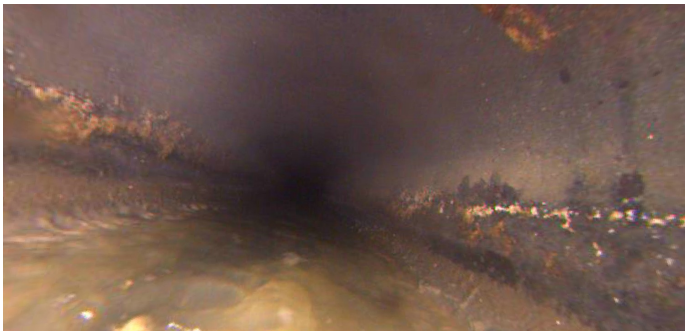
Code: **AMH**
Description: **Manhole**

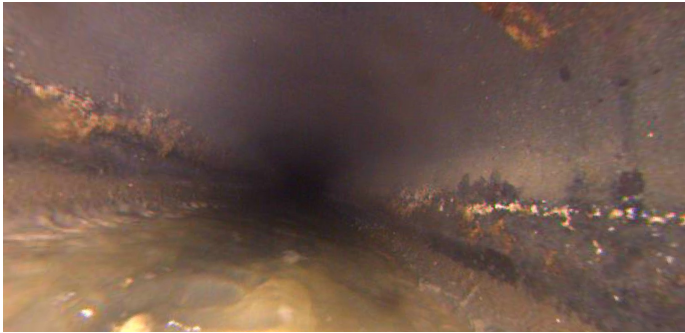
Code:	MWL
Description:	Water Level

Distance (ft):	.0
Structural Grade:	0
O&M Grade:	0
Clock Start/From:	
Clock To:	
1st Value:	
2nd Value:	
Value Percent:	30.000
Continuous Index:	
Within 8" of Joint:	NO
Remarks:

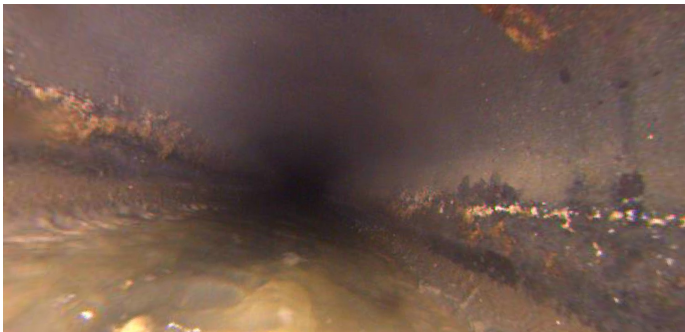
Code:	DAGS
Description:	Deposits Attached Grease

Distance (ft):	.0
Structural Grade:	0
O&M Grade:	2
Clock Start/From:	8
Clock To:	4
1st Value:	
2nd Value:	
Value Percent:	5.000
Continuous Index:	S01
Within 8" of Joint:	NO
Remarks:

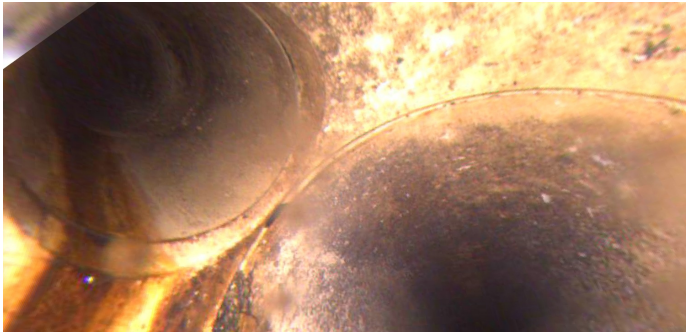
Code: **TFA**
Description: **Tap Factory Active**

Distance (ft): **15.1**
Structural Grade: **0**
O&M Grade: **0**
Clock Start/From: **10**
Clock To:
1st Value: **4.000**
2nd Value:
Value Percent:
Continuous Index:
Within 8" of Joint:
Remarks:

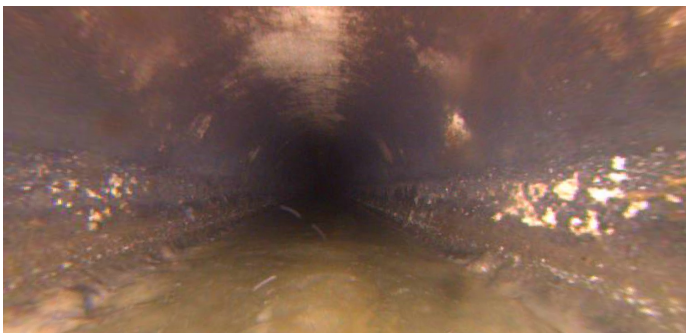
Code: **MWL**
Description: **Water Level**

Distance (ft): **63.0**
Structural Grade: **0**
O&M Grade: **0**
Clock Start/From:
Clock To:
1st Value:
2nd Value:
Value Percent: **20.000**
Continuous Index:
Within 8" of Joint: **NO**
Remarks:

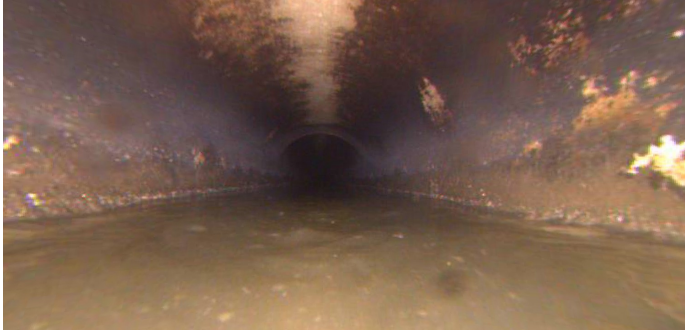
Code: **MWL**
Description: **Water Level**

Distance (ft): **83.3**
Structural Grade: **0**
O&M Grade: **0**
Clock Start/From:
Clock To:
1st Value:
2nd Value:
Value Percent: **40.000**
Continuous Index:
Within 8" of Joint: **NO**
Remarks:

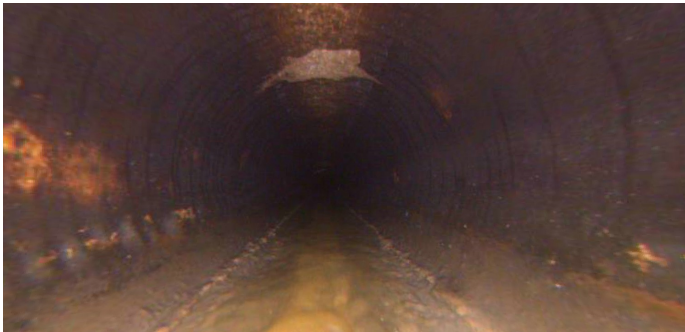
Code: **MWL**
Description: **Water Level**

Distance (ft): **102.8**
Structural Grade: **0**
O&M Grade: **0**
Clock Start/From:
Clock To:
1st Value:
2nd Value:
Value Percent: **5.000**
Continuous Index:
Within 8" of Joint: **NO**
Remarks:

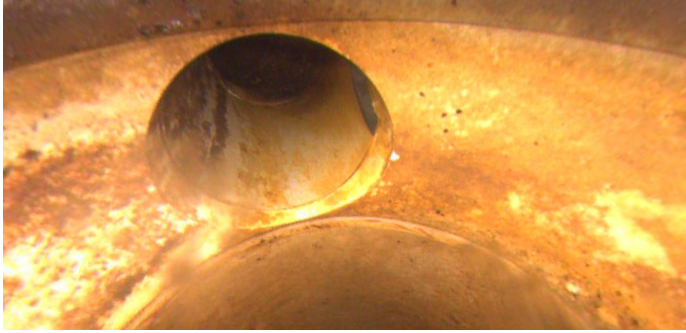
Code: **TF**
Description: **Tap Factory**

Distance (ft): **112.0**
Structural Grade: **0**
O&M Grade: **0**
Clock Start/From: **11**
Clock To:
1st Value: **4.000**
2nd Value:
Value Percent:
Continuous Index:
Within 8" of Joint:
Remarks:

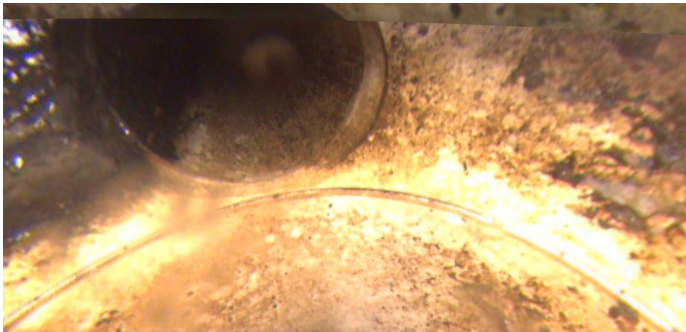
Code: **TF**
Description: **Tap Factory**

Distance (ft): **185.4**
Structural Grade: **0**
O&M Grade: **0**
Clock Start/From: **11**
Clock To:
1st Value: **4.000**
2nd Value:
Value Percent:
Continuous Index:
Within 8" of Joint:
Remarks:

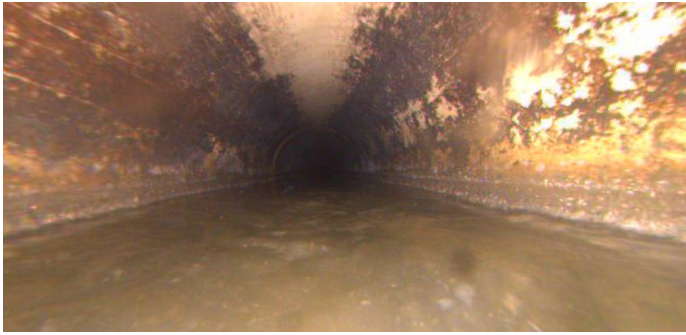
Code: **MWL**
Description: **Water Level**

Distance (ft): **238.0**
Structural Grade: **0**
O&M Grade: **0**
Clock Start/From:
Clock To:
1st Value:
2nd Value:
Value Percent: **40.000**
Continuous Index:
Within 8" of Joint: **NO**
Remarks:

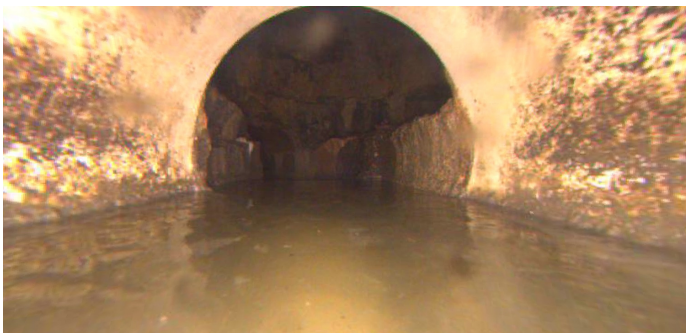
Code: **DAGS**
Description: **Deposits Attached Grease**

Distance (ft): **291.5**
Structural Grade: **0**
O&M Grade: **2**
Clock Start/From: **8**
Clock To: **4**
1st Value:
2nd Value:
Value Percent: **5.000**
Continuous Index: **F01**
Within 8" of Joint: **NO**
Remarks:

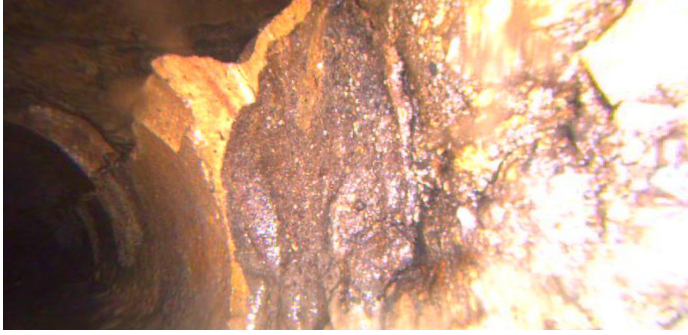
Code:	AMH
Description:	Manhole
Distance (ft):	294.1
Structural Grade:	0
O&M Grade:	0
Clock Start/From:	
Clock To:	
1st Value:	
2nd Value:	
Value Percent:	
Continuous Index:	
Within 8" of Joint:	NO
Remarks:	M-405-023
