## Profile/Photo Observation Report

Street:	<b>FOXCROFT STREET</b>	Flow Control:	<b>Not Controlled</b>
City:	<b>Hobart, IN</b>	Year Renewed:	
Location:	<b>Yard</b>	Tape/Media #:	
Purpose:	<b>Routine Assessment</b>	Dia/Height:	<b>12"</b>
Use:	<b>Sanitary</b>	Material:	<b>PVC</b>
Drain Area:	<b>NA</b>	Lining:	
Category:	<b>NA</b>		
Comment:

Location Details:		Direction of Survey:	<b>Downstream</b>
US MH:	<b>M-405-024</b>	DS MH:	<b>M-405-023</b>
		Total Length Surveyed (ft):	<b>294.1</b>

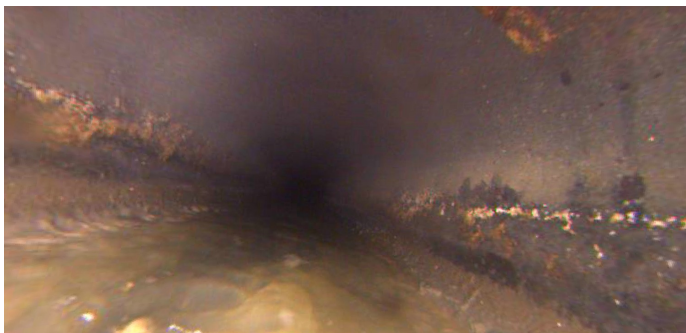
Code: **AMH**  
Description: **Manhole**

Distance (ft): **.0**  
Structural Grade: **0**  
O&M Grade: **0**  
Clock Start/From:  
Clock To:  
1st Value:  
2nd Value:  
Value Percent:  
Continuous Index:  
Within 8" of Joint: **NO**  
Remarks: **M-405-024**

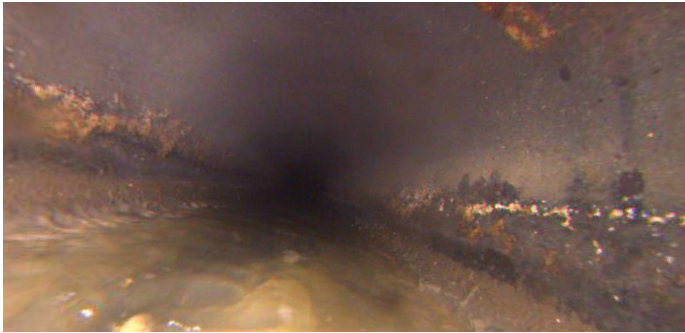
Code:	<b>MWL</b>
Description:	<b>Water Level</b>

Distance (ft):	<b>.0</b>
Structural Grade:	<b>0</b>
O&M Grade:	<b>0</b>
Clock Start/From:	
Clock To:	
1st Value:	
2nd Value:	
Value Percent:	<b>30.000</b>
Continuous Index:	
Within 8" of Joint:	<b>NO</b>
Remarks:

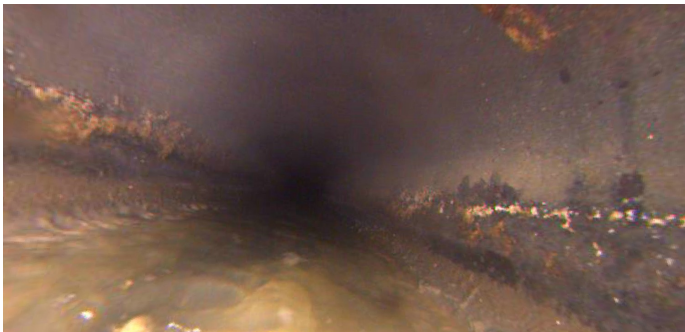
Code:	<b>DAGS</b>
Description:	<b>Deposits Attached Grease</b>

Distance (ft):	<b>.0</b>
Structural Grade:	<b>0</b>
O&M Grade:	<b>2</b>
Clock Start/From:	<b>8</b>
Clock To:	<b>4</b>
1st Value:	
2nd Value:	
Value Percent:	<b>5.000</b>
Continuous Index:	<b>S01</b>
Within 8" of Joint:	<b>NO</b>
Remarks:

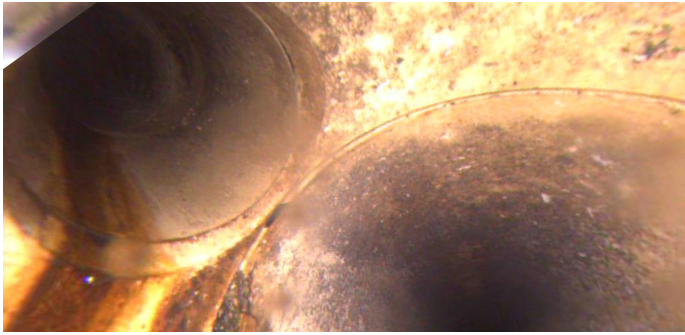
Code: **TFA**  
Description: **Tap Factory Active**

Distance (ft): **15.1**  
Structural Grade: **0**  
O&M Grade: **0**  
Clock Start/From: **10**  
Clock To:  
1st Value: **4.000**  
2nd Value:  
Value Percent:  
Continuous Index:  
Within 8" of Joint:  
Remarks:

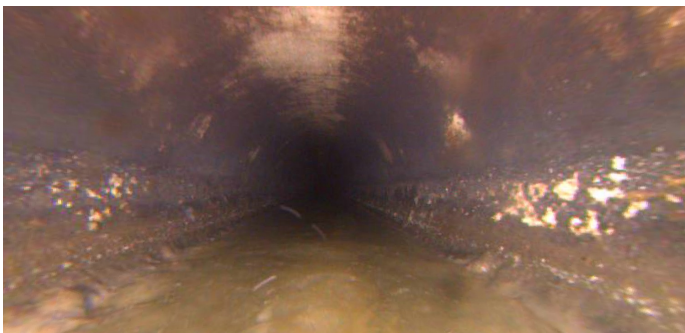
Code: **MWL**  
Description: **Water Level**

Distance (ft): **63.0**  
Structural Grade: **0**  
O&M Grade: **0**  
Clock Start/From:  
Clock To:  
1st Value:  
2nd Value:  
Value Percent: **20.000**  
Continuous Index:  
Within 8" of Joint: **NO**  
Remarks:

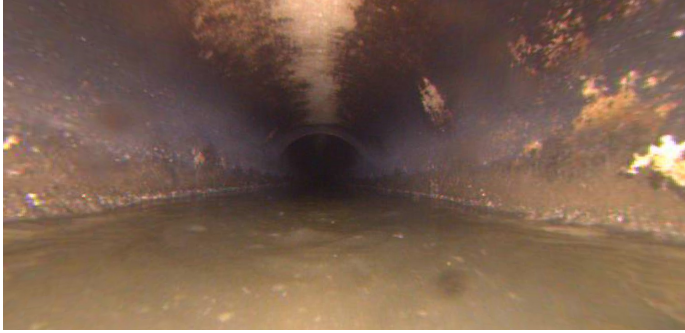
Code: **MWL**  
Description: **Water Level**

Distance (ft): **83.3**  
Structural Grade: **0**  
O&M Grade: **0**  
Clock Start/From:  
Clock To:  
1st Value:  
2nd Value:  
Value Percent: **40.000**  
Continuous Index:  
Within 8" of Joint: **NO**  
Remarks:

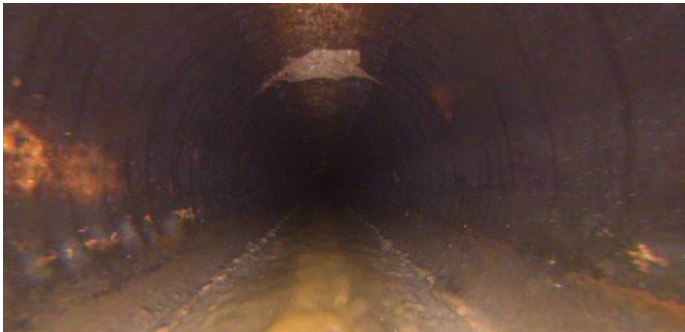
Code: **MWL**  
Description: **Water Level**

Distance (ft): **102.8**  
Structural Grade: **0**  
O&M Grade: **0**  
Clock Start/From:  
Clock To:  
1st Value:  
2nd Value:  
Value Percent: **5.000**  
Continuous Index:  
Within 8" of Joint: **NO**  
Remarks:

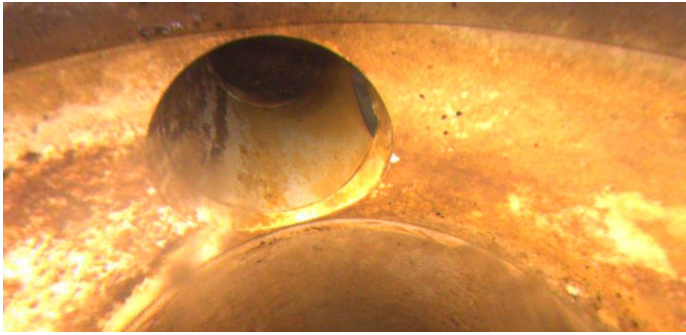
Code: **TF**  
Description: **Tap Factory**

Distance (ft): **112.0**  
Structural Grade: **0**  
O&M Grade: **0**  
Clock Start/From: **11**  
Clock To:  
1st Value: **4.000**  
2nd Value:  
Value Percent:  
Continuous Index:  
Within 8" of Joint:  
Remarks:

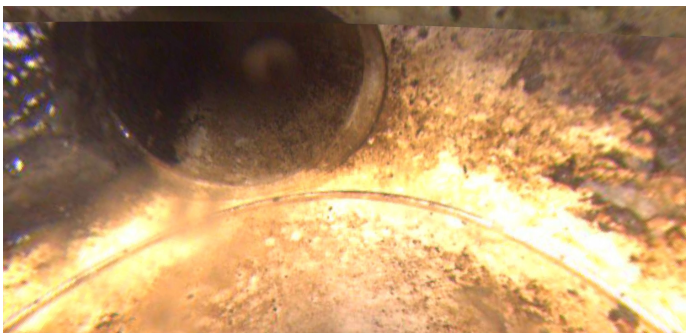
Code: **TF**  
Description: **Tap Factory**

Distance (ft): **185.4**  
Structural Grade: **0**  
O&M Grade: **0**  
Clock Start/From: **11**  
Clock To:  
1st Value: **4.000**  
2nd Value:  
Value Percent:  
Continuous Index:  
Within 8" of Joint:  
Remarks:

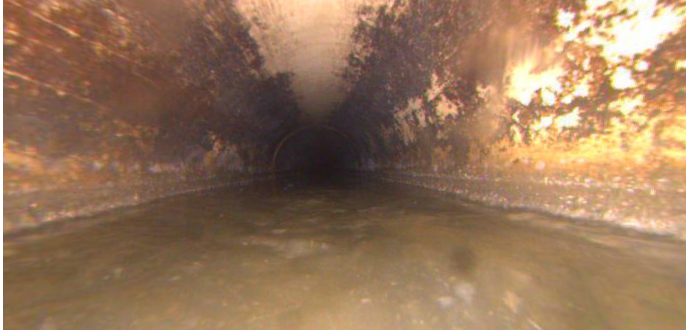
Code: **MWL**  
Description: **Water Level**

Distance (ft): **238.0**  
Structural Grade: **0**  
O&M Grade: **0**  
Clock Start/From:  
Clock To:  
1st Value:  
2nd Value:  
Value Percent: **40.000**  
Continuous Index:  
Within 8" of Joint: **NO**  
Remarks:

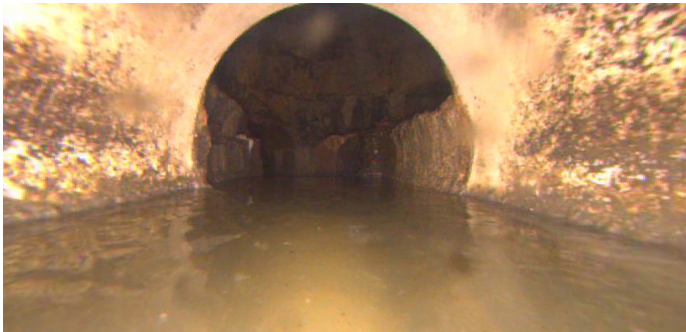
Code: **DAGS**  
Description: **Deposits Attached Grease**

Distance (ft): **291.5**  
Structural Grade: **0**  
O&M Grade: **2**  
Clock Start/From: **8**  
Clock To: **4**  
1st Value:  
2nd Value:  
Value Percent: **5.000**  
Continuous Index: **F01**  
Within 8" of Joint: **NO**  
Remarks:

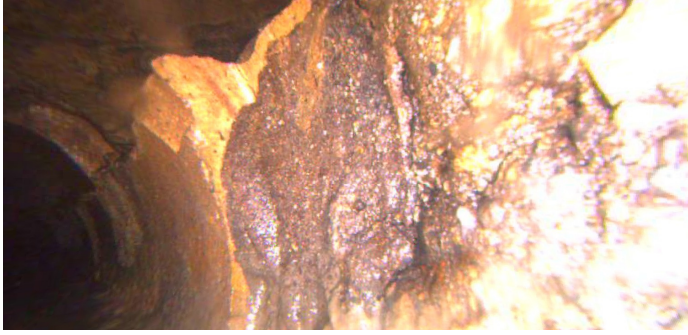
Code:	AMH
Description:	Manhole
Distance (ft):	294.1
Structural Grade:	0
O&M Grade:	0
Clock Start/From:	
Clock To:	
1st Value:	
2nd Value:	
Value Percent:	
Continuous Index:	
Within 8" of Joint:	NO
Remarks:	M-405-023
