Profile/Photo Observation Report

Date:	03/16/2024	Weather:		Coding:	PACP 7.0
Pipe Length (ft):	196.0	Owner:	City of Hobart	Pre Clean:	Heavy Cleaning
P.O.#:		Surveyor:	S. Bucklin	PSR:	P-405-027-026
Customer:	City of Hobart	Clean Date:	11/01/2023	Shape:	C

Street:	W 3RD PL	Flow Control:	Not Controlled
City:	Hobart, IN	Year Renewed:	
Location:	Easement/Right of Way	Tape/Media #:	
Purpose:	Sewer System Evaluation Survey (SS	Dia/Height:	10"
Use:	Sanitary Sewage Pipe	Material:	PVC
Drain Area:		Lining:	None
Category:	NA		
Comment:			
Location Details:		Direction of Survey:	Downstream
US MH:	M-405-026	DS MH:	M-405-027
		Total Length Surveyed (ft):	218.1

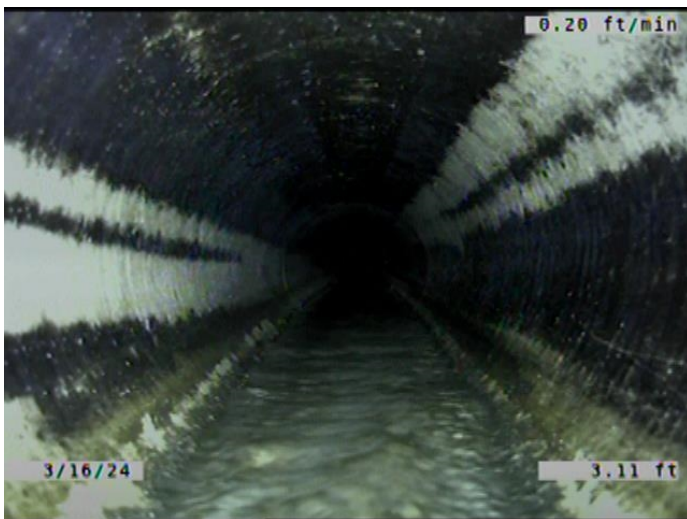
Code:	MWLS
Description:	Miscellaneous Water Level Sag
Distance (ft):	3.1
Structural Grade:	2
O&M Grade:	0
Clock Start/From:	
Clock To:	
1st Value:	
2nd Value:	
Value Percent:	15.000
Continuous Index:	S01
Within 8" of Joint:	NO
Remarks:

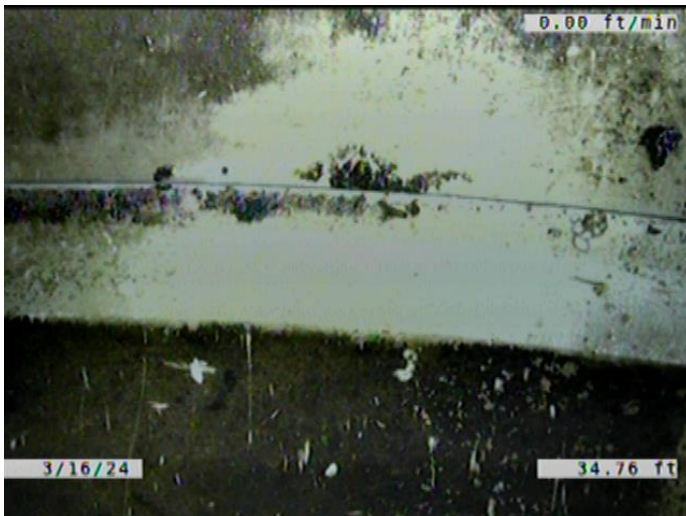
Code: **JAM**
Description: **Joint Angular Medium**

Distance (ft): **34.8**
Structural Grade: **3**
O&M Grade: **0**
Clock Start/From:
Clock To:
1st Value:
2nd Value:
Value Percent:
Continuous Index:
Within 8" of Joint: **NO**
Remarks:

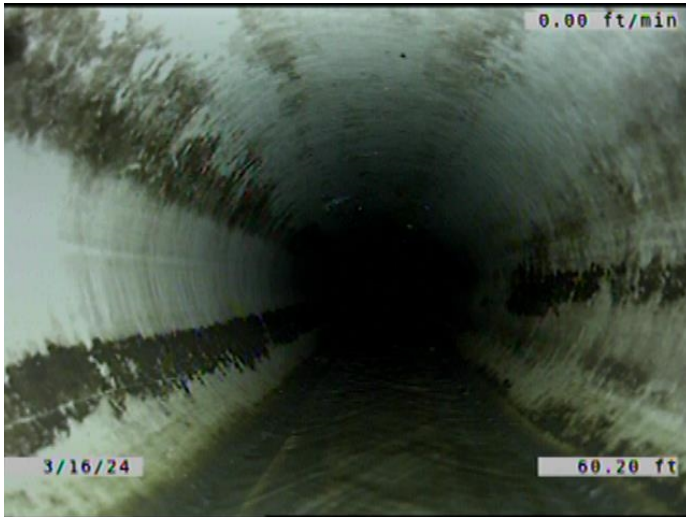
Code: **LR**
Description: **Line Right**

Distance (ft): **60.2**
Structural Grade: **0**
O&M Grade: **1**
Clock Start/From:
Clock To:
1st Value:
2nd Value:
Value Percent: **5.000**
Continuous Index:
Within 8" of Joint: **NO**
Remarks:

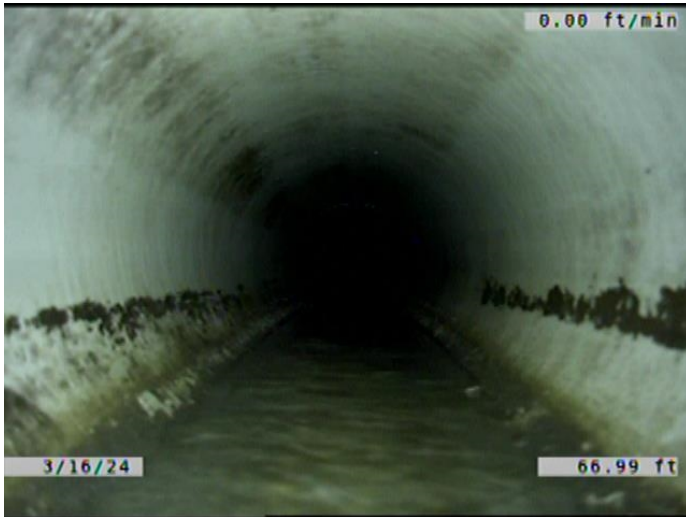
Code: **MWLS**
Description: **Miscellaneous Water Level Sag**

Distance (ft): **67.0**
Structural Grade: **2**
O&M Grade: **0**
Clock Start/From:
Clock To:
1st Value:
2nd Value:
Value Percent: **10.000**
Continuous Index: **S02**
Within 8" of Joint: **NO**
Remarks:

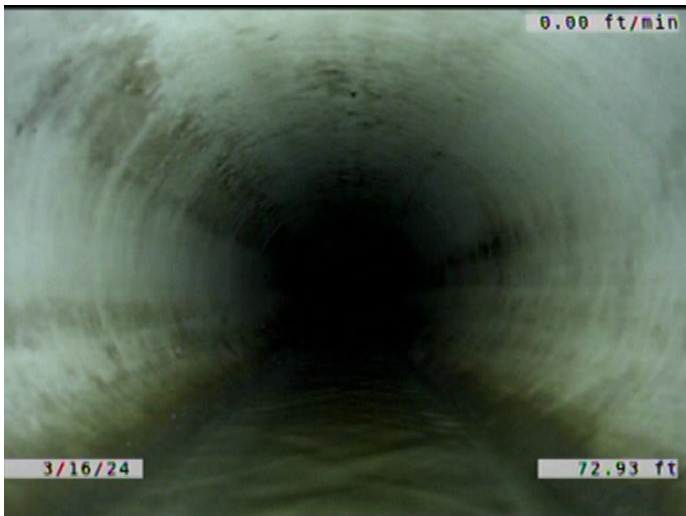
Code: **MWLS**
Description: **Miscellaneous Water Level Sag**

Distance (ft): **72.9**
Structural Grade: **2**
O&M Grade: **0**
Clock Start/From:
Clock To:
1st Value:
2nd Value:
Value Percent: **10.000**
Continuous Index: **F02**
Within 8" of Joint: **NO**
Remarks:

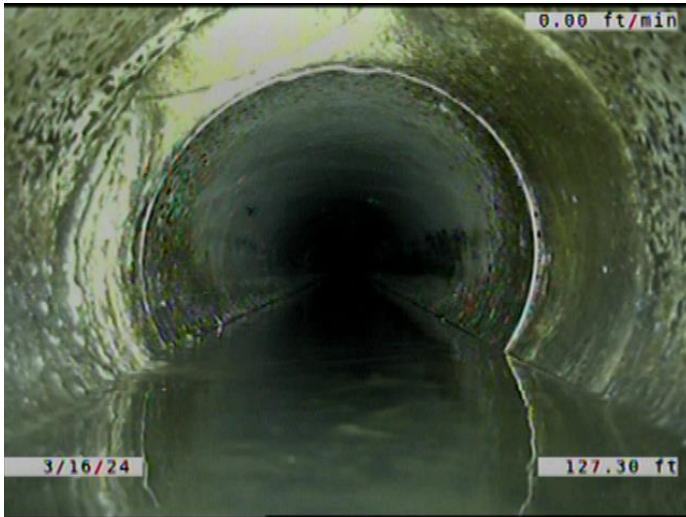
Code: **MWLS**
Description: **Miscellaneous Water Level Sag**

Distance (ft): **127.3**
Structural Grade: **2**
O&M Grade: **0**
Clock Start/From:
Clock To:
1st Value:
2nd Value:
Value Percent: **15.000**
Continuous Index: **S03**
Within 8" of Joint: **NO**
Remarks:

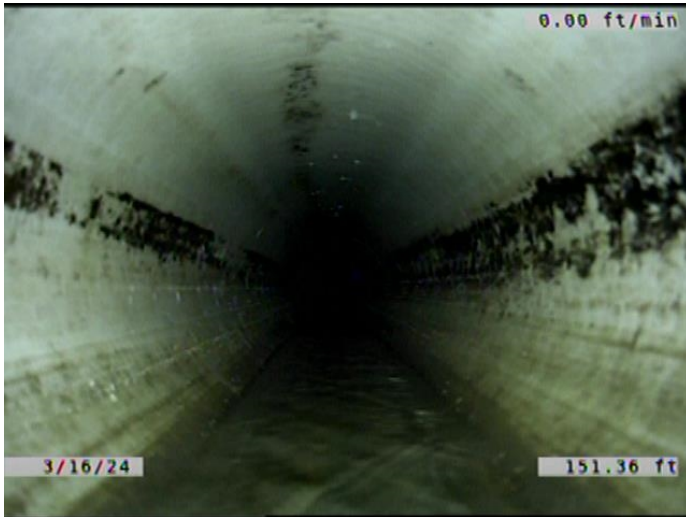
Code: **MWLS**
Description: **Miscellaneous Water Level Sag**

Distance (ft): **151.4**
Structural Grade: **2**
O&M Grade: **0**
Clock Start/From:
Clock To:
1st Value:
2nd Value:
Value Percent: **15.000**
Continuous Index: **F03**
Within 8" of Joint: **NO**
Remarks:
