## Profile/Photo Observation Report

Date:	<b>04/24/2018</b>	Weather:		Coding:	<b>PACP 6.0</b>
Pipe Length (ft):	<b>179.1</b>	Owner:	<b>NA</b>	Pre Clean:	<b>No Pre-Cleaning</b>
P.O.#:		Surveyor:	<b>Jen Costello</b>	PSR:	<b>P-405-029-028</b>
Customer:		Clean Date:	<b>01/01/1900</b>	Shape:	<b>C</b>

Street:	<b>ALLEY BETWEEN DRIFTWOOD DR &amp;</b>	Flow Control:	<b>Not Controlled</b>
City:	<b>Hobart, IN</b>	Year Renewed:	
Location:	<b>Yard</b>	Tape/Media #:	
Purpose:	<b>Routine Assessment</b>	Dia/Height:	<b>8"</b>
Use:	<b>Sanitary</b>	Material:	<b>VCP</b>
Drain Area:	<b>NA</b>	Lining:	
Category:	<b>NA</b>		
Comment:	<b>P_C at 52 ft root .Flow direction wrong</b>		
Location Details:		Direction of Survey:	<b>Upstream</b>
US MH:	<b>M-405-028</b>	DS MH:	<b>M-405-029</b>
		Total Length Surveyed (ft):	<b>53.5</b>

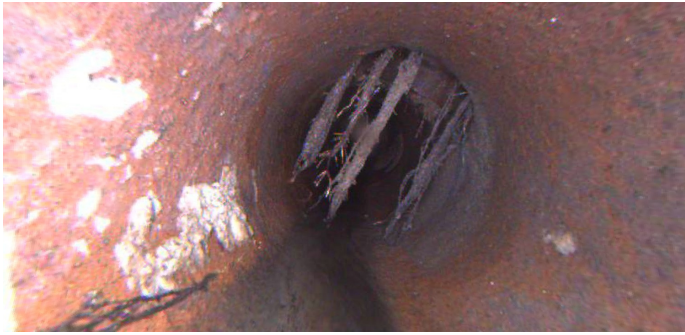
Code: **AMH**  
Description: **Manhole**

Distance (ft): **.0**  
Structural Grade: **0**  
O&M Grade: **0**  
Clock Start/From:  
Clock To:  
1st Value:  
2nd Value:  
Value Percent:  
Continuous Index:  
Within 8" of Joint: **NO**  
Remarks: **M-405-029**

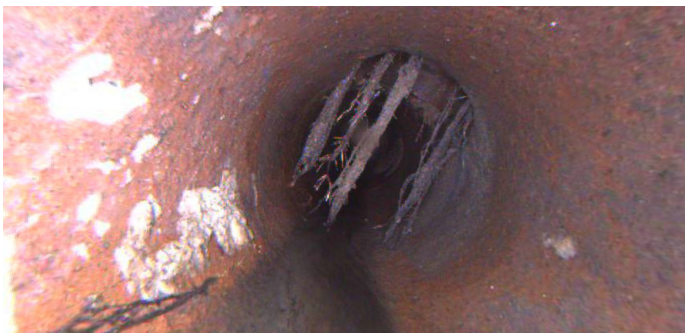
Code: **MWL**  
Description: **Water Level**

Distance (ft): **.0**  
Structural Grade: **0**  
O&M Grade: **0**  
Clock Start/From:  
Clock To:  
1st Value:  
2nd Value:  
Value Percent: **5.000**  
Continuous Index:  
Within 8" of Joint: **NO**  
Remarks:

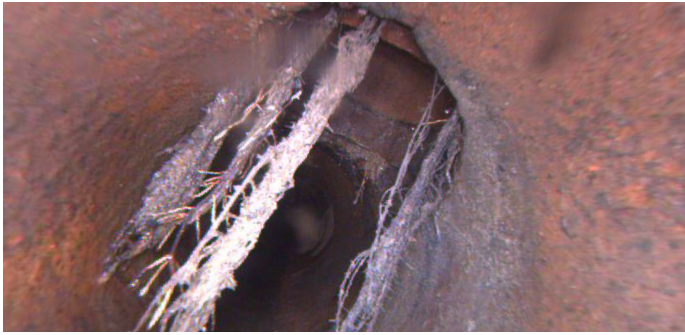
Code: **TBD**  
Description: **Tap Break-in Defective**

Distance (ft): **1.9**  
Structural Grade: **0**  
O&M Grade: **3**  
Clock Start/From: **12**  
Clock To:  
1st Value: **4.000**  
2nd Value:  
Value Percent:  
Continuous Index:  
Within 8" of Joint:  
Remarks: **roots**

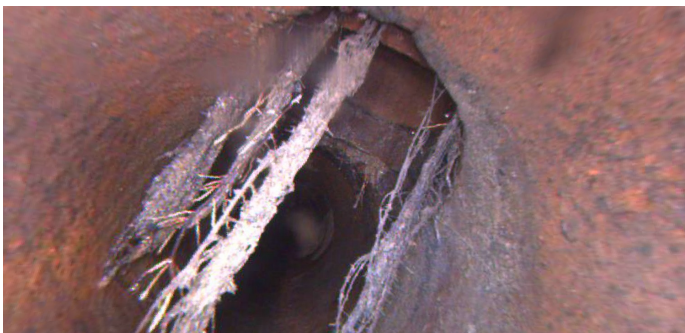
Code: **RMC**  
Description: **Roots Medium Connection**

Distance (ft): **1.9**  
Structural Grade: **0**  
O&M Grade: **3**  
Clock Start/From: **11**  
Clock To: **1**  
1st Value:  
2nd Value:  
Value Percent: **10.000**  
Continuous Index:  
Within 8" of Joint: **NO**  
Remarks:

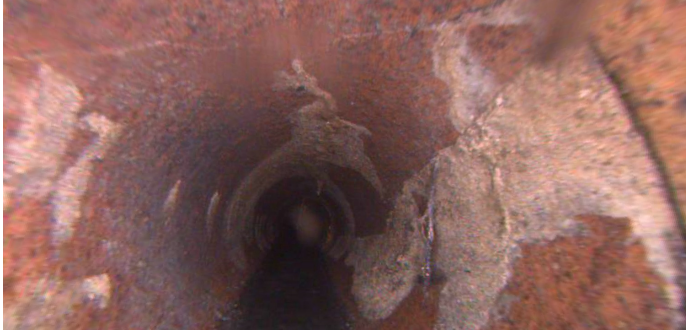
Code: **FM**  
Description: **Fracture Multiple**

Distance (ft): **3.6**  
Structural Grade: **4**  
O&M Grade: **0**  
Clock Start/From: **8**  
Clock To: **4**  
1st Value:  
2nd Value:  
Value Percent:  
Continuous Index:  
Within 8" of Joint: **YES**  
Remarks:

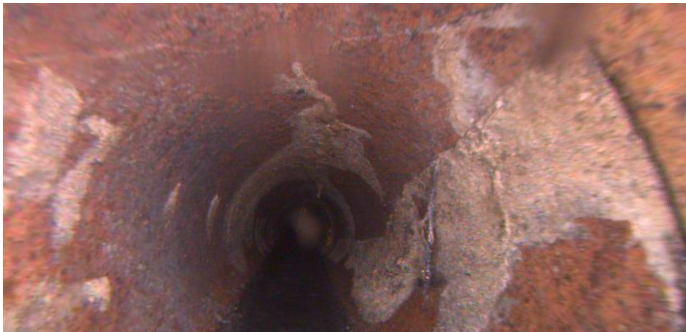
Code: **RFB**  
Description: **Roots Fine Barrel**

Distance (ft): **3.6**  
Structural Grade: **0**  
O&M Grade: **2**  
Clock Start/From: **3**  
Clock To:  
1st Value:  
2nd Value:  
Value Percent:  
Continuous Index:  
Within 8" of Joint: **NO**  
Remarks:

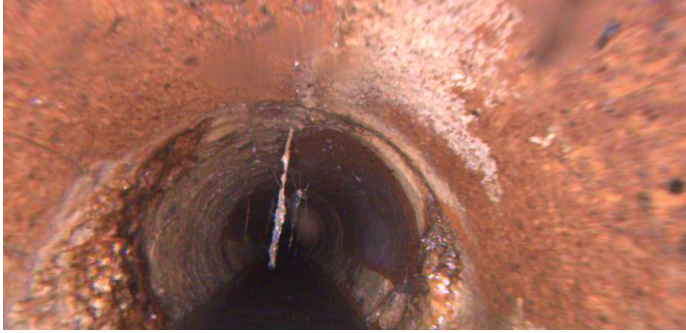
Code: **IW**  
Description: **Infil Weeper**

Distance (ft): **6.3**  
Structural Grade: **0**  
O&M Grade: **2**  
Clock Start/From: **8**  
Clock To: **4**  
1st Value:  
2nd Value:  
Value Percent:  
Continuous Index: **S01**  
Within 8" of Joint: **YES**  
Remarks:

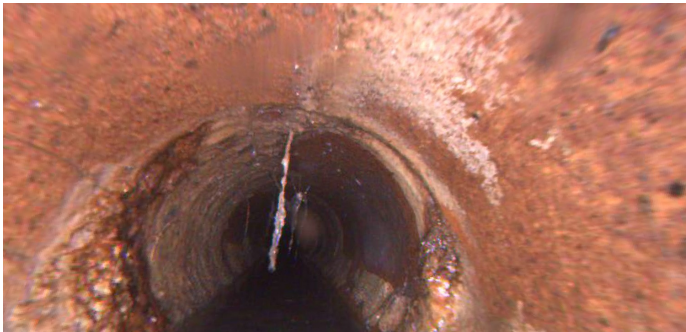
Code: **RFJ**  
Description: **Roots Fine Joint**

Distance (ft): **6.3**  
Structural Grade: **0**  
O&M Grade: **1**  
Clock Start/From: **10**  
Clock To: **12**  
1st Value:  
2nd Value:  
Value Percent:  
Continuous Index: **S03**  
Within 8" of Joint: **YES**  
Remarks:

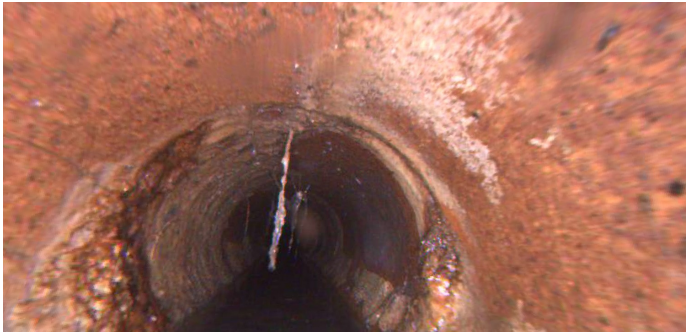
Code: **DAE**  
Description: **Deposits Attached Encrustation**

Distance (ft): **6.3**  
Structural Grade: **0**  
O&M Grade: **2**  
Clock Start/From: **8**  
Clock To: **4**  
1st Value:  
2nd Value:  
Value Percent: **5.000**  
Continuous Index: **S02**  
Within 8" of Joint: **YES**  
Remarks:

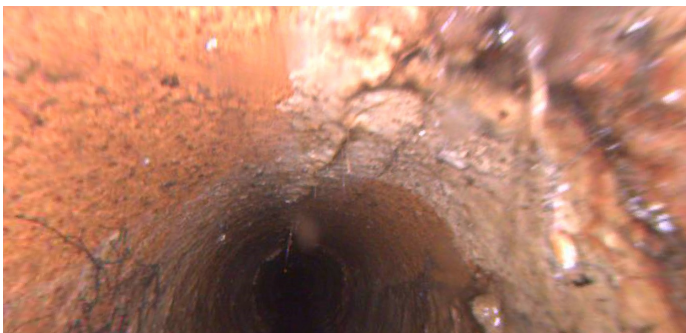
Code: **FL**  
Description: **Fracture Longitudinal**

Distance (ft): **10.7**  
Structural Grade: **3**  
O&M Grade: **0**  
Clock Start/From: **12**  
Clock To:  
1st Value:  
2nd Value:  
Value Percent:  
Continuous Index:  
Within 8" of Joint:  
Remarks:

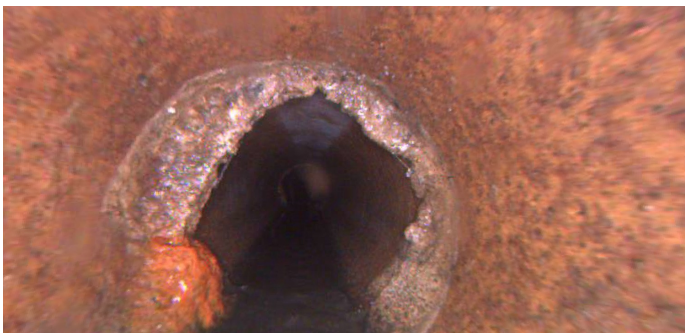
Code: **DAE**  
Description: **Deposits Attached Encrustation**

Distance (ft): **30.4**  
Structural Grade: **0**  
O&M Grade: **3**  
Clock Start/From: **8**  
Clock To: **4**  
1st Value:  
2nd Value:  
Value Percent: **15.000**  
Continuous Index:  
Within 8" of Joint: **YES**  
Remarks:

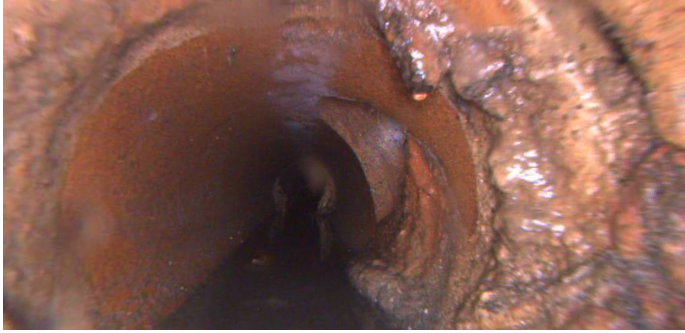
Code: ID  
Description: Infil Dripper

Distance (ft): 34.0  
Structural Grade: 0  
O&M Grade: 3  
Clock Start/From: 1  
Clock To:  
1st Value:  
2nd Value:  
Value Percent:  
Continuous Index:  
Within 8" of Joint: YES  
Remarks:

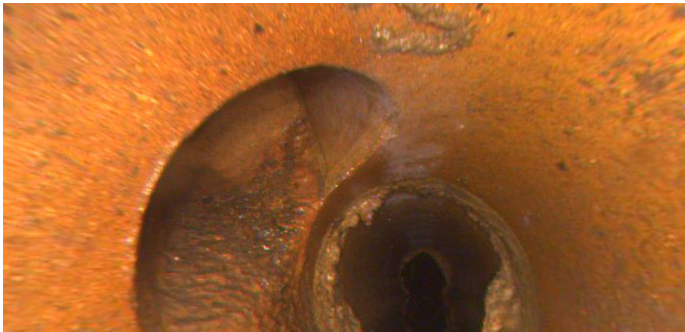
Code: TFC  
Description: Tap Factory Capped

Distance (ft): 35.5  
Structural Grade: 0  
O&M Grade: 0  
Clock Start/From: 2  
Clock To:  
1st Value: 4.000  
2nd Value:  
Value Percent:  
Continuous Index:  
Within 8" of Joint:  
Remarks:

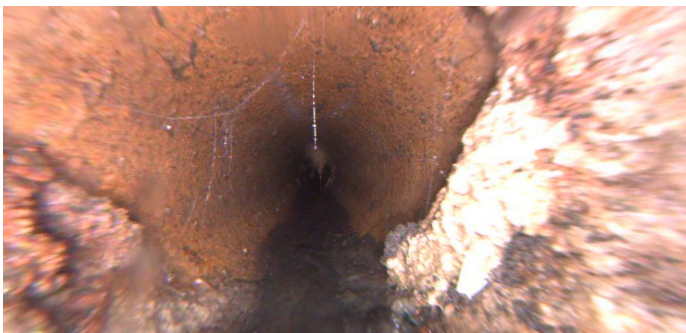
Code: **DAE**  
Description: **Deposits Attached Encrustation**

Distance (ft): **37.0**  
Structural Grade: **0**  
O&M Grade: **3**  
Clock Start/From: **8**  
Clock To: **4**  
1st Value:  
2nd Value:  
Value Percent: **20.000**  
Continuous Index:  
Within 8" of Joint: **YES**  
Remarks:

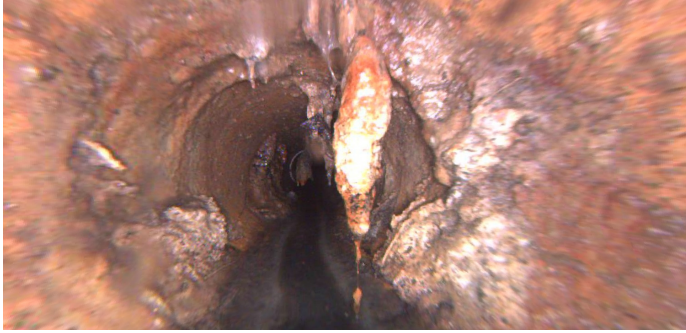
Code: ID  
Description: Infil Dripper

Distance (ft): 39.9  
Structural Grade: 0  
O&M Grade: 3  
Clock Start/From: 12  
Clock To:  
1st Value:  
2nd Value:  
Value Percent:  
Continuous Index:  
Within 8" of Joint: YES  
Remarks:

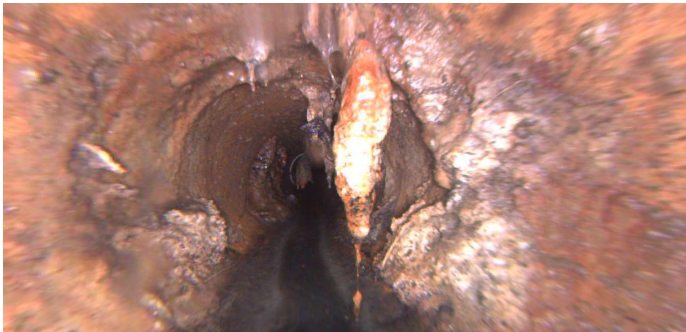
Code: DAE  
Description: Deposits Attached Encrustation

Distance (ft): 39.9  
Structural Grade: 0  
O&M Grade: 3  
Clock Start/From: 8  
Clock To: 4  
1st Value:  
2nd Value:  
Value Percent: 20.000  
Continuous Index:  
Within 8" of Joint: YES  
Remarks:

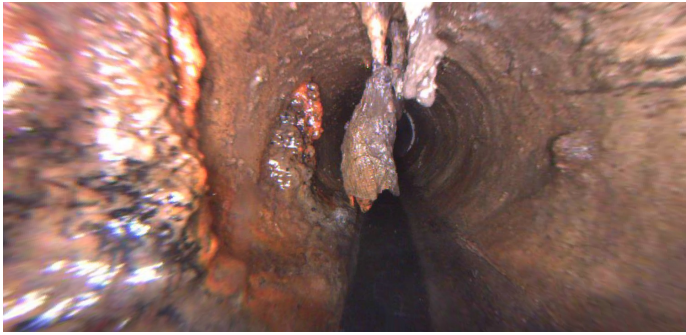
Code: **DAE**  
Description: **Deposits Attached Encrustation**

Distance (ft): **41.2**  
Structural Grade: **0**  
O&M Grade: **2**  
Clock Start/From: **7**  
Clock To: **10**  
1st Value:  
2nd Value:  
Value Percent: **10.000**  
Continuous Index:  
Within 8" of Joint: **NO**  
Remarks:

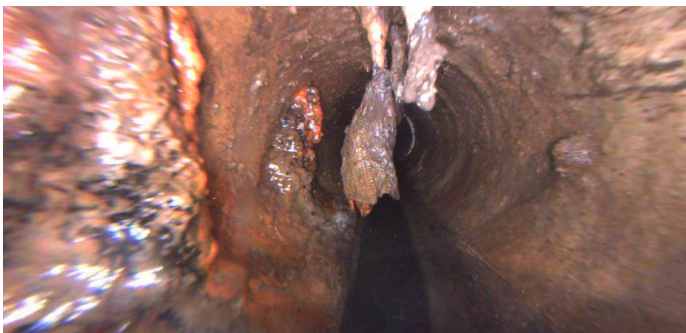
Code: **IW**  
Description: **Infil Weeper**

Distance (ft): **41.2**  
Structural Grade: **0**  
O&M Grade: **2**  
Clock Start/From: **8**  
Clock To: **10**  
1st Value:  
2nd Value:  
Value Percent:  
Continuous Index:  
Within 8" of Joint:  
Remarks:

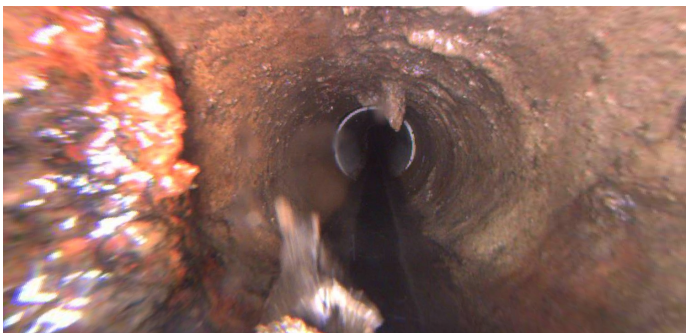
Code: **DAE**  
Description: **Deposits Attached Encrustation**

Distance (ft): **41.6**  
Structural Grade: **0**  
O&M Grade: **2**  
Clock Start/From: **7**  
Clock To: **10**  
1st Value:  
2nd Value:  
Value Percent: **10.000**  
Continuous Index:  
Within 8" of Joint: **NO**  
Remarks:

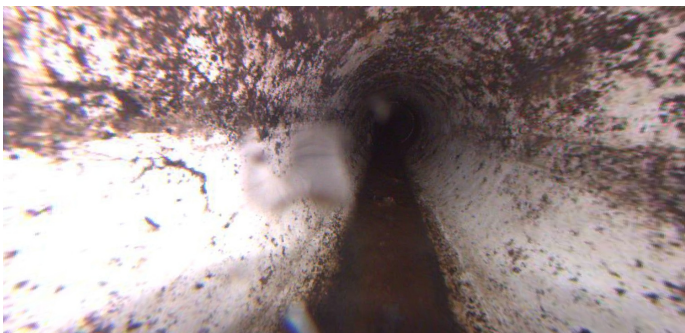
Code: **DAE**  
Description: **Deposits Attached Encrustation**

Distance (ft): **43.4**  
Structural Grade: **0**  
O&M Grade: **2**  
Clock Start/From: **8**  
Clock To: **4**  
1st Value:  
2nd Value:  
Value Percent: **5.000**  
Continuous Index: **F02**  
Within 8" of Joint: **YES**  
Remarks:

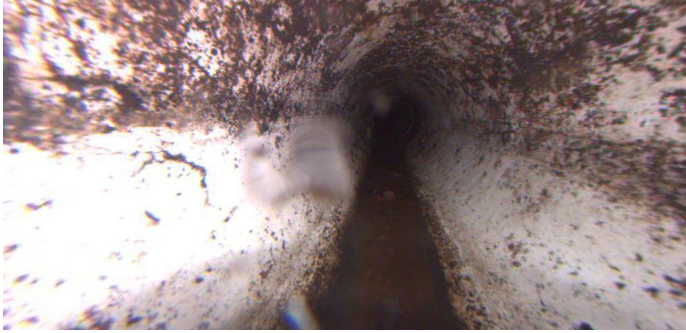
Code: **RFJ**  
Description: **Roots Fine Joint**

Distance (ft): **43.4**  
Structural Grade: **0**  
O&M Grade: **1**  
Clock Start/From: **10**  
Clock To: **12**  
1st Value:  
2nd Value:  
Value Percent:  
Continuous Index: **F03**  
Within 8" of Joint: **YES**  
Remarks:

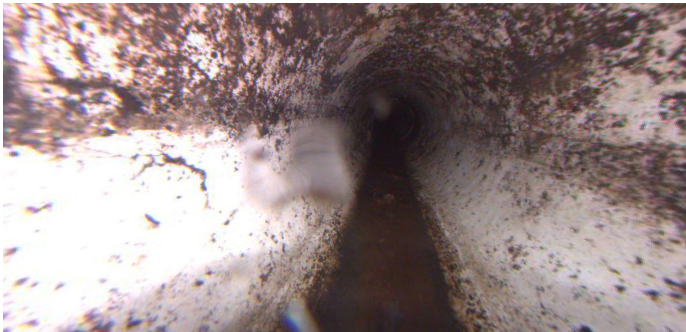
Code: **IW**  
Description: **Infil Weeper**

Distance (ft): **43.4**  
Structural Grade: **0**  
O&M Grade: **2**  
Clock Start/From: **8**  
Clock To: **4**  
1st Value:  
2nd Value:  
Value Percent:  
Continuous Index: **F01**  
Within 8" of Joint: **YES**  
Remarks:

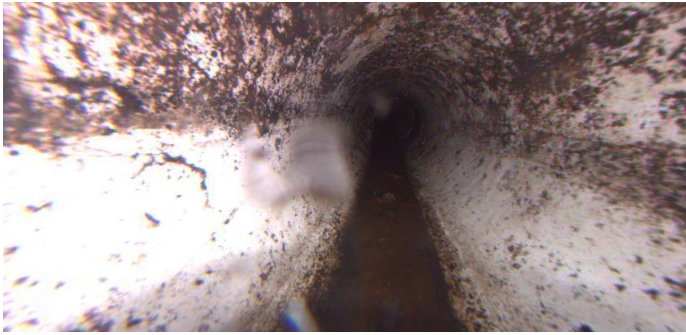
Code: **MMC**  
Description: **Material Change**

Distance (ft): **43.4**  
Structural Grade: **0**  
O&M Grade: **0**  
Clock Start/From:  
Clock To:  
1st Value:  
2nd Value:  
Value Percent:  
Continuous Index:  
Within 8" of Joint: **NO**  
Remarks: **PVC**

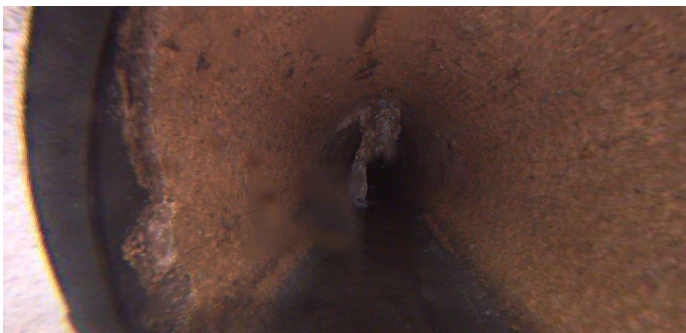
Code: **MMC**  
Description: **Material Change**

Distance (ft): **52.4**  
Structural Grade: **0**  
O&M Grade: **0**  
Clock Start/From:  
Clock To:  
1st Value:  
2nd Value:  
Value Percent:  
Continuous Index:  
Within 8" of Joint: **NO**  
Remarks: **vc**

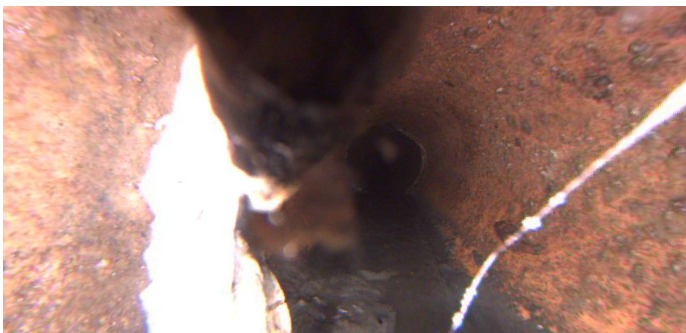
Code: **MSA**  
Description: **Abandoned Survey**

Distance (ft): **53.5**  
Structural Grade: **0**  
O&M Grade: **0**  
Clock Start/From:  
Clock To:  
1st Value:  
2nd Value:  
Value Percent:  
Continuous Index:  
Within 8" of Joint: **NO**  
Remarks: **dae**
