Profile/Photo Observation Report

Date:	04/20/2018	Weather:		Coding:	PACP 6.0
Pipe Length (ft):	138.1	Owner:	NA	Pre Clean:	No Pre-Cleaning
P.O.#:		Surveyor:	Byrd Fitzgerald	PSR:	P-405-038-028
Customer:		Clean Date:	01/01/1900	Shape:	C

Street:	3RD PL	Flow Control:	Not Controlled
City:	Hobart, IN	Year Renewed:	
Location:	Yard	Tape/Media #:	
Purpose:	Routine Assessment	Dia/Height:	8"
Use:	Sanitary	Material:	VCP
Drain Area:	NA	Lining:	Cured in Place
Category:	NA		
Comment:	Flow direction wrong		
Location Details:		Direction of Survey:	Upstream
US MH:	M-405-028	DS MH:	M-405-038
		Total Length Surveyed (ft):	129.1

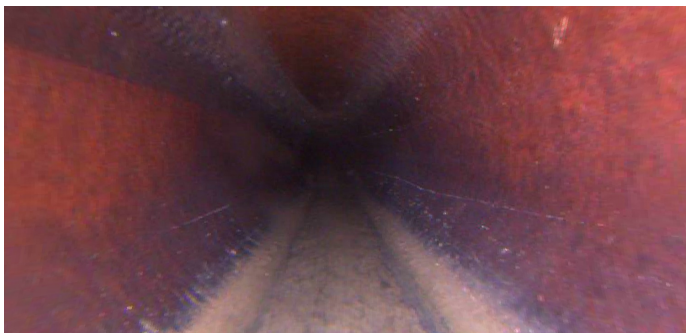
Code: **AMH**
Description: **Manhole**

Distance (ft): **.0**
Structural Grade: **0**
O&M Grade: **0**
Clock Start/From:
Clock To:
1st Value:
2nd Value:
Value Percent:
Continuous Index:
Within 8" of Joint: **NO**
Remarks: **M-405-038**

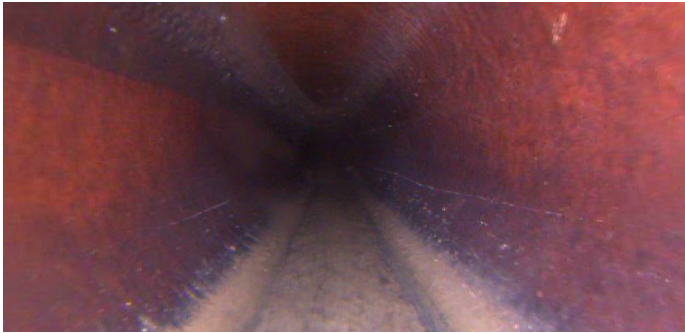
Code:	MWL
Description:	Water Level

Distance (ft):	.0
Structural Grade:	0
O&M Grade:	0
Clock Start/From:	
Clock To:	
1st Value:	
2nd Value:	
Value Percent:	5.000
Continuous Index:	
Within 8" of Joint:	NO
Remarks:

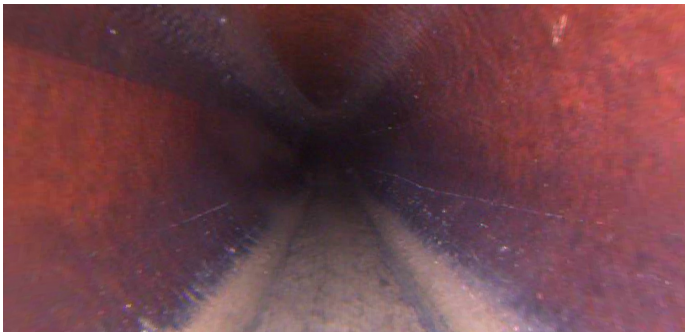
Code:	SZ
Description:	Surface Other

Distance (ft):	.0
Structural Grade:	0
O&M Grade:	0
Clock Start/From:	8
Clock To:	4
1st Value:	
2nd Value:	
Value Percent:	
Continuous Index:	S01
Within 8" of Joint:	
Remarks:	scratches

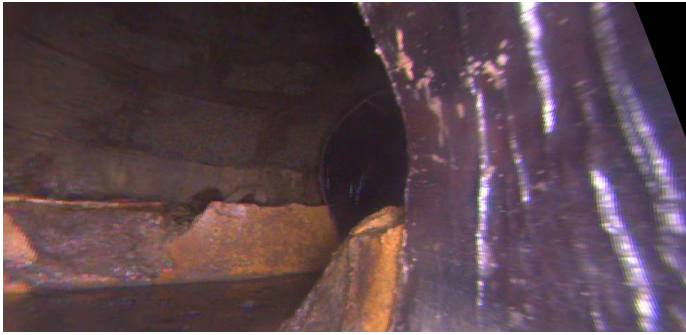
Code: **SZ**
Description: **Surface Other**

Distance (ft): **128.1**
Structural Grade: **0**
O&M Grade: **0**
Clock Start/From: **8**
Clock To: **4**
1st Value:
2nd Value:
Value Percent:
Continuous Index: **F01**
Within 8" of Joint:
Remarks: **scratches**

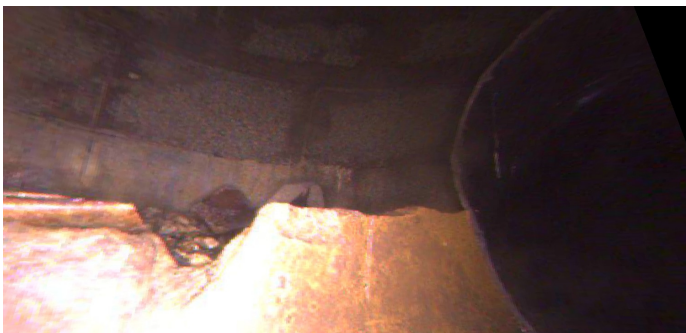
Code: **AMH**
Description: **Manhole**

Distance (ft): **129.1**
Structural Grade: **0**
O&M Grade: **0**
Clock Start/From:
Clock To:
1st Value:
2nd Value:
Value Percent:
Continuous Index:
Within 8" of Joint: **NO**
Remarks: **M-405-028**
