Profile/Photo Observation Report

Street:	FOXCROFT STREET	Flow Control:	Not Controlled
City:	Hobart, IN	Year Renewed:	
Location:	Yard	Tape/Media #:	
Purpose:	Routine Assessment	Dia/Height:	8"
Use:	Sanitary	Material:	VCP
Drain Area:	NA	Lining:	Cured in Place
Category:	NA		
Comment:	Flow direction wrong		
Location Details:		Direction of Survey:	Upstream
US MH:	M-405-028	DS MH:	M-405-038
		Total Length Surveyed (ft):	129.1

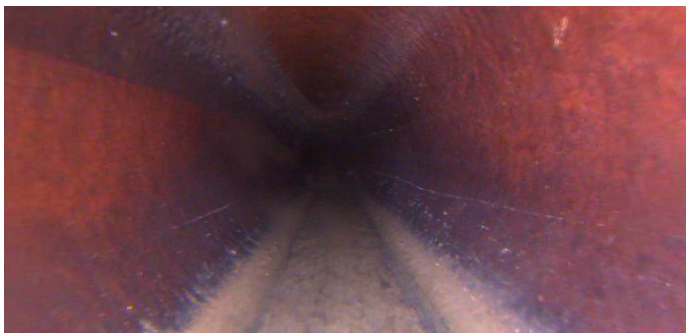
Code: **AMH**
Description: **Manhole**

Distance (ft): **.0**
Structural Grade: **0**
O&M Grade: **0**
Clock Start/From:
Clock To:
1st Value:
2nd Value:
Value Percent:
Continuous Index:
Within 8" of Joint: **NO**
Remarks: **M-405-038**

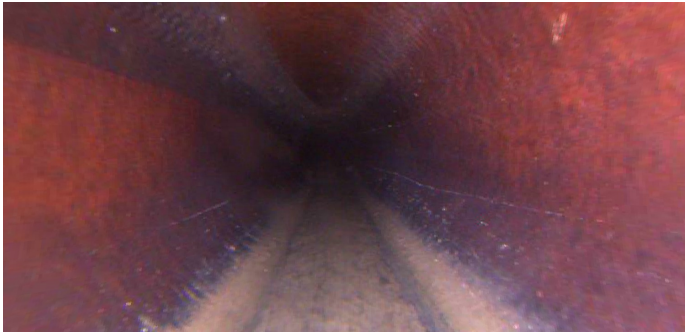
Code:	MWL
Description:	Water Level

Distance (ft):	.0
Structural Grade:	0
O&M Grade:	0
Clock Start/From:	
Clock To:	
1st Value:	
2nd Value:	
Value Percent:	5.000
Continuous Index:	
Within 8" of Joint:	NO
Remarks:

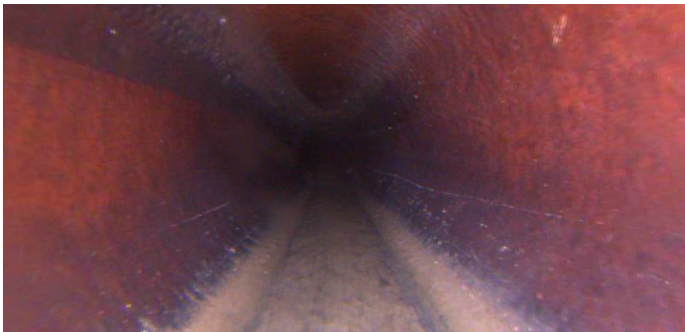
Code:	SZ
Description:	Surface Other

Distance (ft):	.0
Structural Grade:	0
O&M Grade:	0
Clock Start/From:	8
Clock To:	4
1st Value:	
2nd Value:	
Value Percent:	
Continuous Index:	S01
Within 8" of Joint:	
Remarks:	scratches

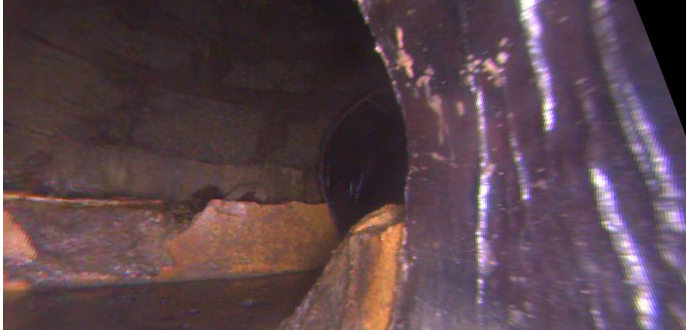
Code: **SZ**
Description: **Surface Other**

Distance (ft): **128.1**
Structural Grade: **0**
O&M Grade: **0**
Clock Start/From: **8**
Clock To: **4**
1st Value:
2nd Value:
Value Percent:
Continuous Index: **F01**
Within 8" of Joint:
Remarks: **scratches**

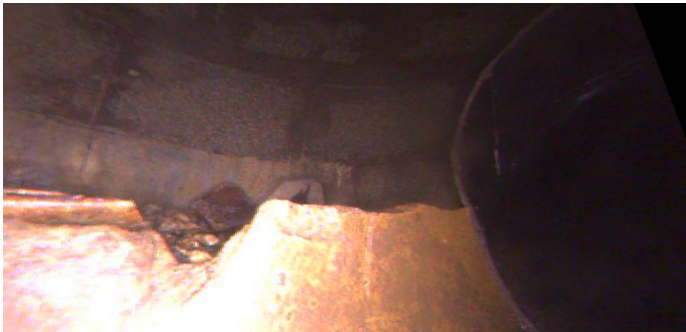
Code: **AMH**
Description: **Manhole**

Distance (ft): **129.1**
Structural Grade: **0**
O&M Grade: **0**
Clock Start/From:
Clock To:
1st Value:
2nd Value:
Value Percent:
Continuous Index:
Within 8" of Joint: **NO**
Remarks: **M-405-028**
