Profile/Photo Observation Report

Date:	04/19/2018	Weather:		Coding:	PACP 6.0
Pipe Length (ft):	310.5	Owner:	NA	Pre Clean:	No Pre-Cleaning
P.O.#:		Surveyor:	Justin Gonzales	PSR:	P-405-031-026
Customer:		Clean Date:	01/01/1900	Shape:	C

Street:	OFF W 49TH AVE	Flow Control:	Not Controlled
City:	Hobart, IN	Year Renewed:	
Location:	Yard	Tape/Media #:	
Purpose:	Routine Assessment	Dia/Height:	10"
Use:	Sanitary	Material:	PVC
Drain Area:	NA	Lining:	
Category:	NA		
Comment:

Location Details:		Direction of Survey:	Downstream
US MH:	M-405-031	DS MH:	M-405-026
		Total Length Surveyed (ft):	302.6

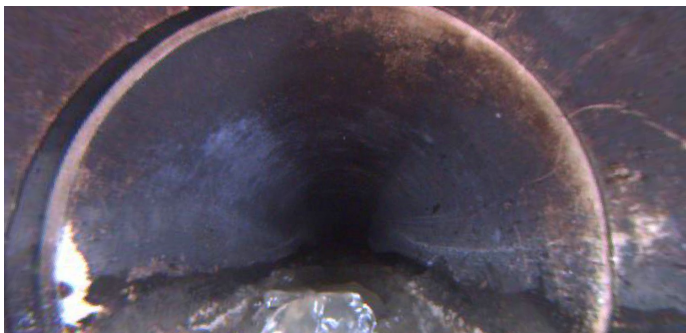
Code: **JOM**
Description: **Joint Offset Medium**

Distance (ft): **.0**
Structural Grade: **1**
O&M Grade: **0**
Clock Start/From:
Clock To:
1st Value:
2nd Value:
Value Percent:
Continuous Index:
Within 8" of Joint: **NO**
Remarks:

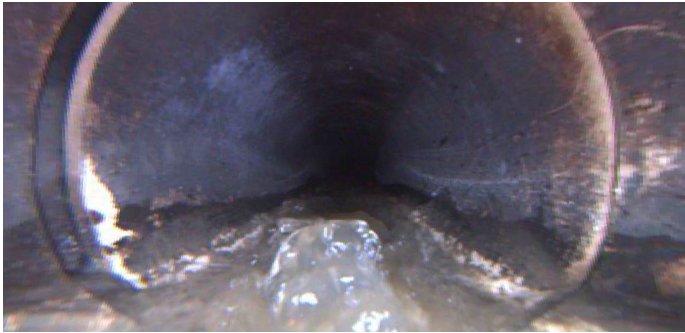
Code:	AMH
Description:	Manhole

Distance (ft):	.0
Structural Grade:	0
O&M Grade:	0
Clock Start/From:	
Clock To:	
1st Value:	
2nd Value:	
Value Percent:	
Continuous Index:	
Within 8" of Joint:	NO
Remarks:	M-405-031

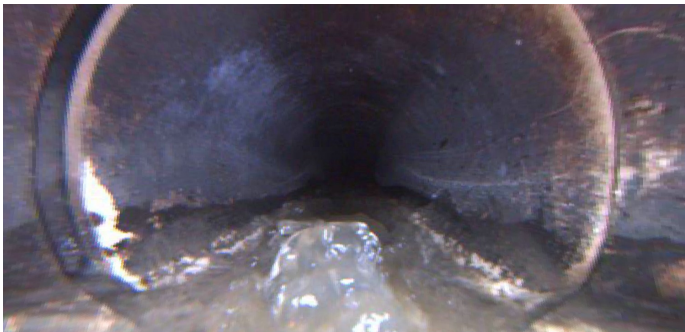
Code:	MWL
Description:	Water Level

Distance (ft):	.0
Structural Grade:	0
O&M Grade:	0
Clock Start/From:	
Clock To:	
1st Value:	
2nd Value:	
Value Percent:	10.000
Continuous Index:	
Within 8" of Joint:	NO
Remarks:

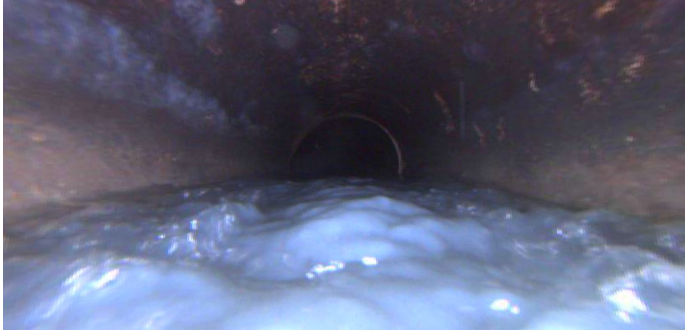
Code: **MWL**
Description: **Water Level**

Distance (ft): **25.1**
Structural Grade: **0**
O&M Grade: **0**
Clock Start/From:
Clock To:
1st Value:
2nd Value:
Value Percent: **20.000**
Continuous Index:
Within 8" of Joint: **NO**
Remarks:

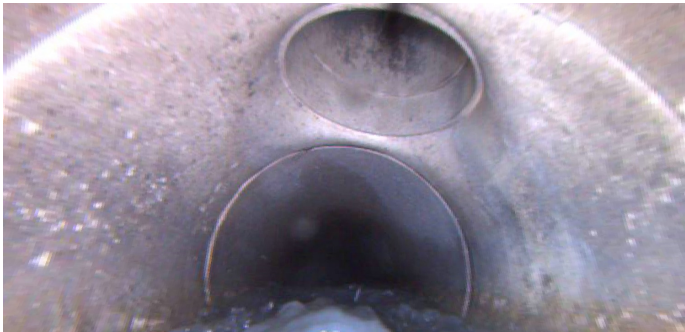
Code: **TF**
Description: **Tap Factory**

Distance (ft): **38.1**
Structural Grade: **0**
O&M Grade: **0**
Clock Start/From: **1**
Clock To:
1st Value: **4.000**
2nd Value:
Value Percent:
Continuous Index:
Within 8" of Joint:
Remarks:

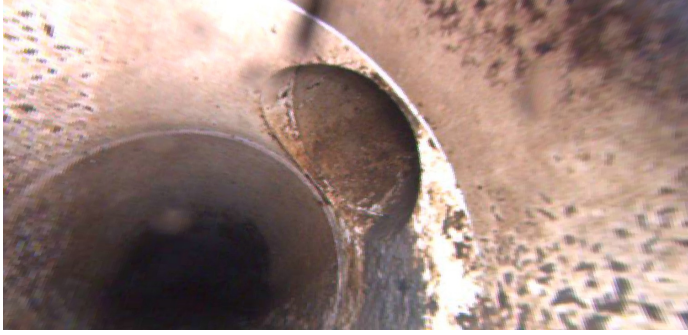
Code: **TF**
Description: **Tap Factory**

Distance (ft): **86.4**
Structural Grade: **0**
O&M Grade: **0**
Clock Start/From: **1**
Clock To:
1st Value: **4.000**
2nd Value:
Value Percent:
Continuous Index:
Within 8" of Joint:
Remarks:

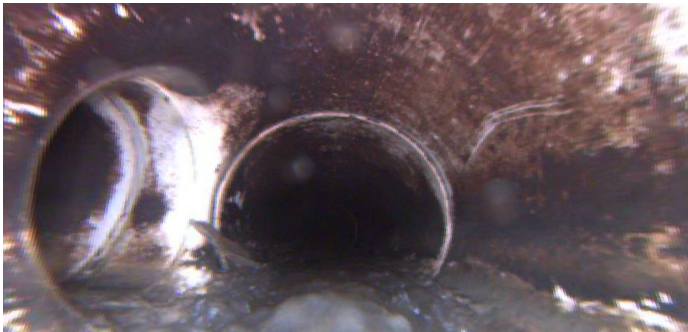
Code: **TF**
Description: **Tap Factory**

Distance (ft): **149.4**
Structural Grade: **0**
O&M Grade: **0**
Clock Start/From: **9**
Clock To:
1st Value: **4.000**
2nd Value:
Value Percent:
Continuous Index:
Within 8" of Joint:
Remarks:

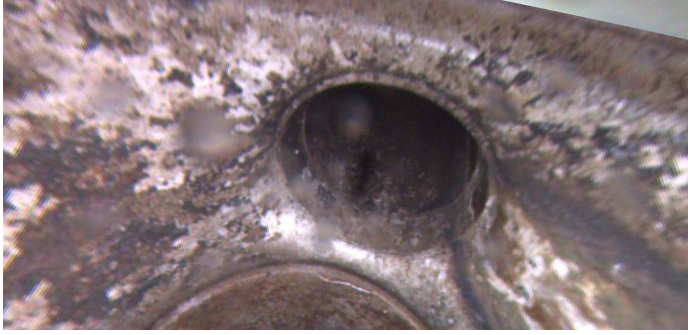
Code: **TF**
Description: **Tap Factory**

Distance (ft): **201.1**
Structural Grade: **0**
O&M Grade: **0**
Clock Start/From: **1**
Clock To:
1st Value: **4.000**
2nd Value:
Value Percent:
Continuous Index:
Within 8" of Joint:
Remarks:

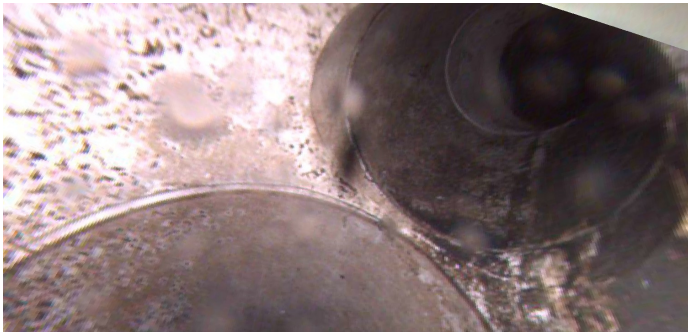
Code: **TF**
Description: **Tap Factory**

Distance (ft): **261.1**
Structural Grade: **0**
O&M Grade: **0**
Clock Start/From: **1**
Clock To:
1st Value: **4.000**
2nd Value:
Value Percent:
Continuous Index:
Within 8" of Joint:
Remarks:

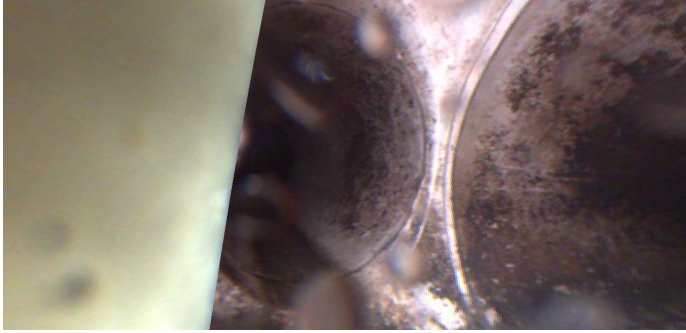
Code: **TF**
Description: **Tap Factory**

Distance (ft): **262.7**
Structural Grade: **0**
O&M Grade: **0**
Clock Start/From: **9**
Clock To:
1st Value: **4.000**
2nd Value:
Value Percent:
Continuous Index:
Within 8" of Joint:
Remarks:

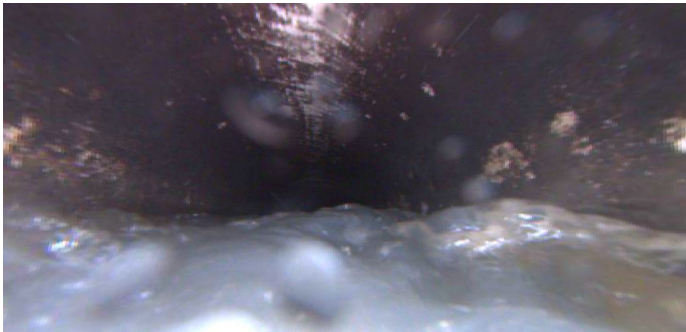
Code: **MWL**
Description: **Water Level**

Distance (ft): **293.9**
Structural Grade: **0**
O&M Grade: **0**
Clock Start/From:
Clock To:
1st Value:
2nd Value:
Value Percent: **20.000**
Continuous Index:
Within 8" of Joint: **NO**
Remarks:

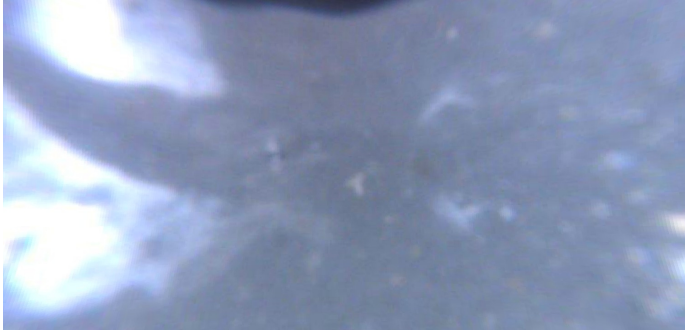
Code: **MCU**
Description: **Camera Underwater**

Distance (ft): **297.9**
Structural Grade: **0**
O&M Grade: **4**
Clock Start/From:
Clock To:
1st Value:
2nd Value:
Value Percent:
Continuous Index:
Within 8" of Joint: **NO**
Remarks:

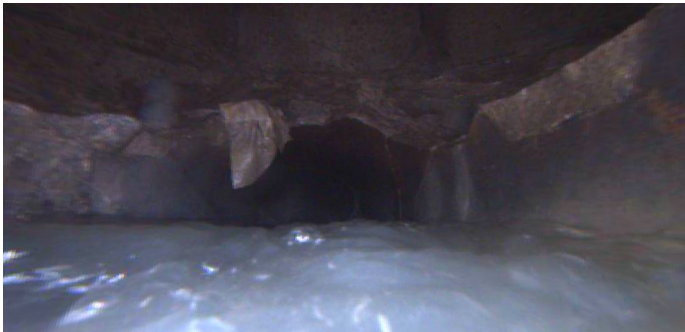
Code: **AMH**
Description: **Manhole**

Distance (ft): **302.6**
Structural Grade: **0**
O&M Grade: **0**
Clock Start/From:
Clock To:
1st Value:
2nd Value:
Value Percent:
Continuous Index:
Within 8" of Joint: **NO**
Remarks: **M-405-026**
