Profile/Photo Observation Report

Street:	FOXCROFT STREET	Flow Control:	Not Controlled
City:	Hobart, IN	Year Renewed:	
Location:	Yard	Tape/Media #:	
Purpose:	Routine Assessment	Dia/Height:	10"
Use:	Sanitary	Material:	PVC
Drain Area:	NA	Lining:	
Category:	NA		
Comment:

Location Details:		Direction of Survey:	Downstream
US MH:	M-405-031	DS MH:	M-405-026
		Total Length Surveyed (ft):	302.6

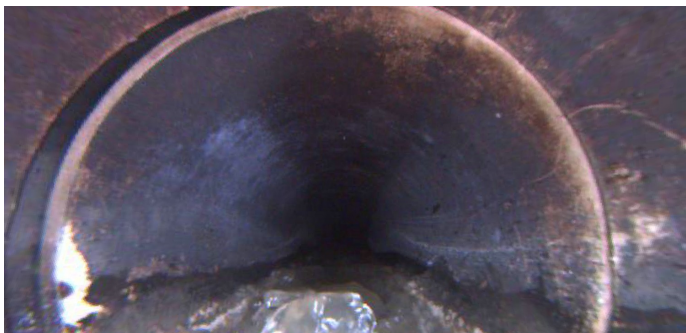
Code: **JOM**
Description: **Joint Offset Medium**

Distance (ft): **.0**
Structural Grade: **1**
O&M Grade: **0**
Clock Start/From:
Clock To:
1st Value:
2nd Value:
Value Percent:
Continuous Index:
Within 8" of Joint: **NO**
Remarks:

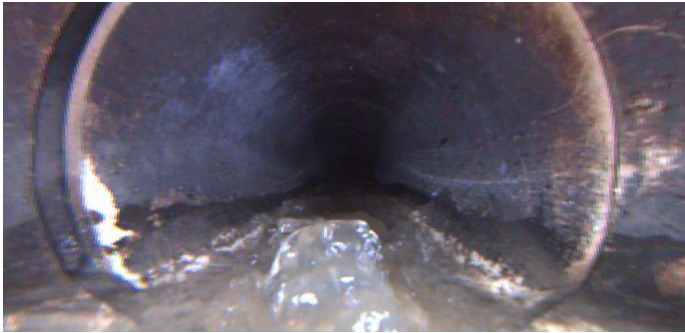
Code:	AMH
Description:	Manhole

Distance (ft):	.0
Structural Grade:	0
O&M Grade:	0
Clock Start/From:	
Clock To:	
1st Value:	
2nd Value:	
Value Percent:	
Continuous Index:	
Within 8" of Joint:	NO
Remarks:	M-405-031

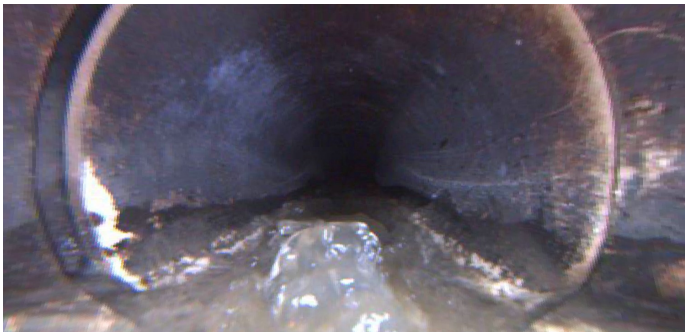
Code:	MWL
Description:	Water Level

Distance (ft):	.0
Structural Grade:	0
O&M Grade:	0
Clock Start/From:	
Clock To:	
1st Value:	
2nd Value:	
Value Percent:	10.000
Continuous Index:	
Within 8" of Joint:	NO
Remarks:

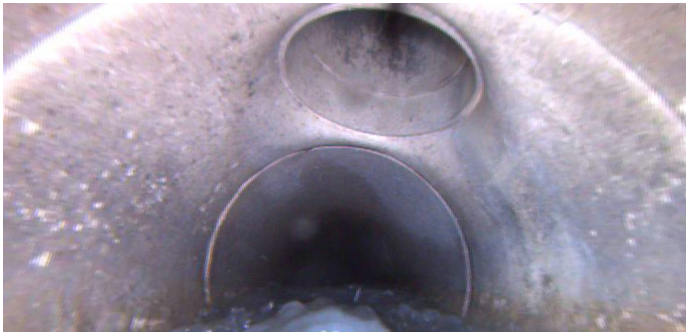
Code: **TF**
Description: **Tap Factory**

Distance (ft): **38.1**
Structural Grade: **0**
O&M Grade: **0**
Clock Start/From: **1**
Clock To:
1st Value: **4.000**
2nd Value:
Value Percent:
Continuous Index:
Within 8" of Joint:
Remarks:

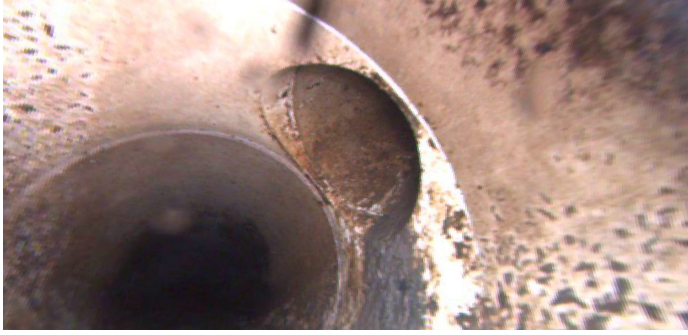
Code: **TF**
Description: **Tap Factory**

Distance (ft): **86.4**
Structural Grade: **0**
O&M Grade: **0**
Clock Start/From: **1**
Clock To:
1st Value: **4.000**
2nd Value:
Value Percent:
Continuous Index:
Within 8" of Joint:
Remarks:

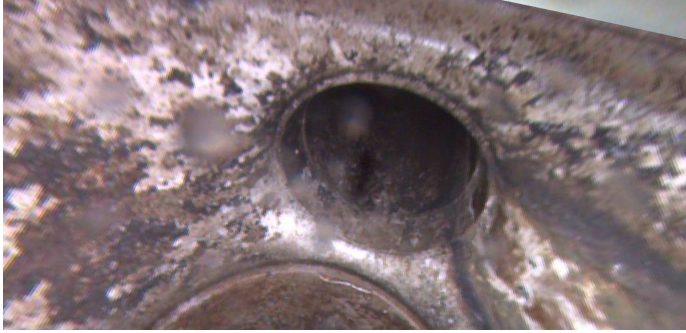
Code: **TF**
Description: **Tap Factory**

Distance (ft): **201.1**
Structural Grade: **0**
O&M Grade: **0**
Clock Start/From: **1**
Clock To:
1st Value: **4.000**
2nd Value:
Value Percent:
Continuous Index:
Within 8" of Joint:
Remarks:

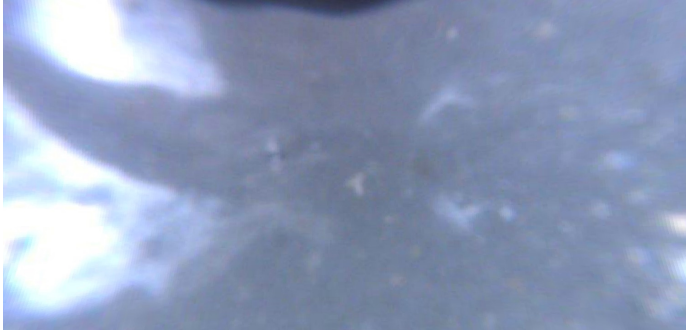
Code: **MCU**
Description: **Camera Underwater**

Distance (ft): **297.9**
Structural Grade: **0**
O&M Grade: **4**
Clock Start/From:
Clock To:
1st Value:
2nd Value:
Value Percent:
Continuous Index:
Within 8" of Joint: **NO**
Remarks:

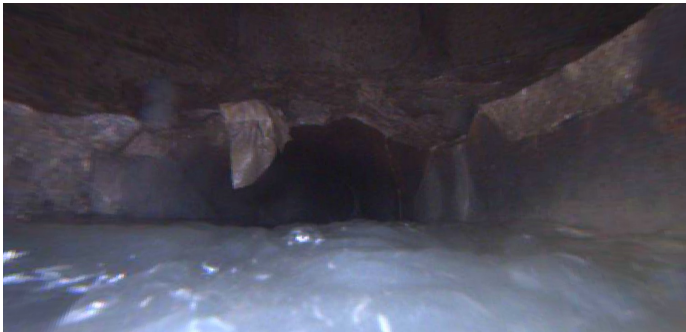
Code: **AMH**
Description: **Manhole**

Distance (ft): **302.6**
Structural Grade: **0**
O&M Grade: **0**
Clock Start/From:
Clock To:
1st Value:
2nd Value:
Value Percent:
Continuous Index:
Within 8" of Joint: **NO**
Remarks: **M-405-026**
