Profile/Photo Observation Report

Date:	04/19/2018	Weather:		Coding:	PACP 6.0
Pipe Length (ft):	332.8	Owner:	NA	Pre Clean:	No Pre-Cleaning
P.O.#:		Surveyor:	Curtis Montgomery	PSR:	P-405-035-031
Customer:		Clean Date:	01/01/1900	Shape:	C

Street:	FOXCROFT STREET	Flow Control:	Not Controlled
City:	Hobart, IN	Year Renewed:	
Location:	Yard	Tape/Media #:	
Purpose:	Routine Assessment	Dia/Height:	8"
Use:	Sanitary	Material:	VCP
Drain Area:	NA	Lining:	
Category:	NA		
Comment:	P_C at 147 roots		
Location Details:		Direction of Survey:	Upstream
US MH:	M-405-031	DS MH:	M-405-035
		Total Length Surveyed (ft):	148.5

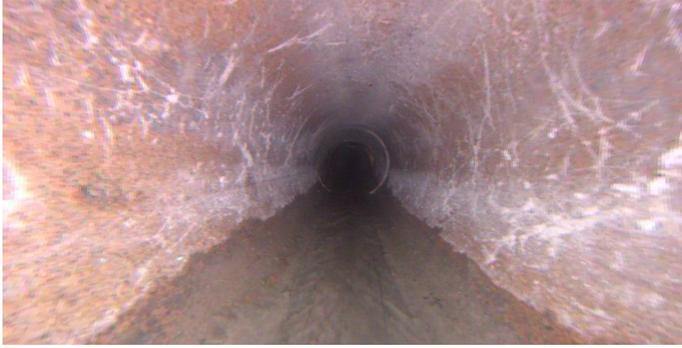
Code: **AMH**
Description: **Manhole**

Distance (ft): **.0**
Structural Grade: **0**
O&M Grade: **0**
Clock Start/From:
Clock To:
1st Value:
2nd Value:
Value Percent:
Continuous Index:
Within 8" of Joint: **NO**
Remarks: **M-405-035**

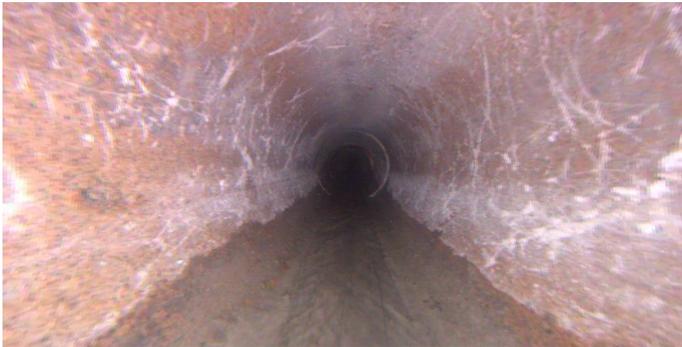
Code: **MWL**
Description: **Water Level**

Distance (ft): **.0**
Structural Grade: **0**
O&M Grade: **0**
Clock Start/From:
Clock To:
1st Value:
2nd Value:
Value Percent: **5.000**
Continuous Index:
Within 8" of Joint: **NO**
Remarks: **M-405-031**

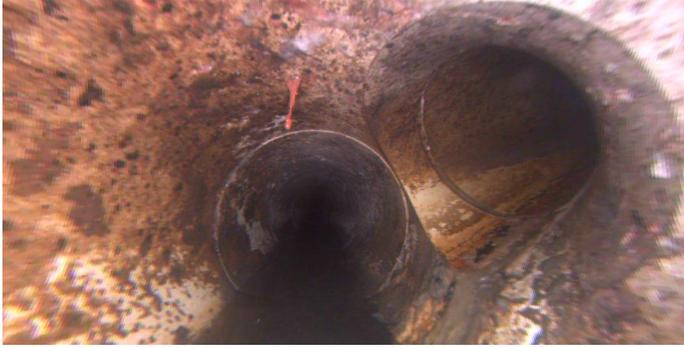
Code: **TF**
Description: **Tap Factory**

Distance (ft): **3.8**
Structural Grade: **0**
O&M Grade: **0**
Clock Start/From: **2**
Clock To:
1st Value: **6.000**
2nd Value:
Value Percent:
Continuous Index:
Within 8" of Joint:
Remarks:

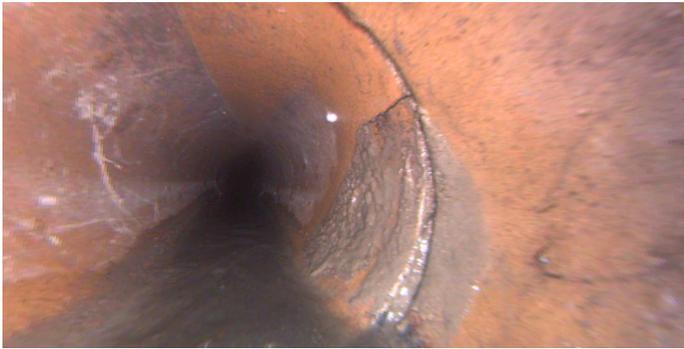
Code: **FL**
Description: **Fracture Longitudinal**

Distance (ft): **9.5**
Structural Grade: **3**
O&M Grade: **0**
Clock Start/From: **2**
Clock To:
1st Value:
2nd Value:
Value Percent:
Continuous Index:
Within 8" of Joint: **YES**
Remarks:

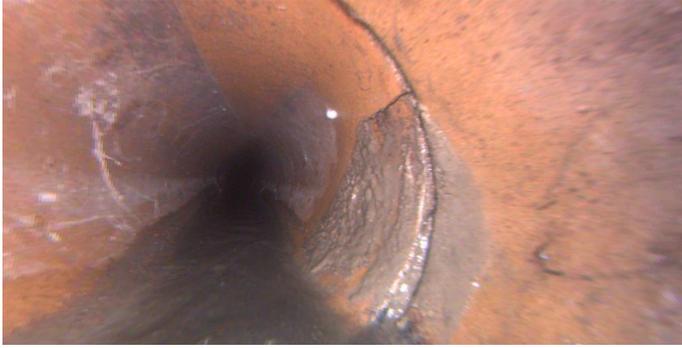
Code: **IS**
Description: **Infil Stain**

Distance (ft): **9.5**
Structural Grade: **0**
O&M Grade: **0**
Clock Start/From: **2**
Clock To: **5**
1st Value:
2nd Value:
Value Percent:
Continuous Index:
Within 8" of Joint: **YES**
Remarks:

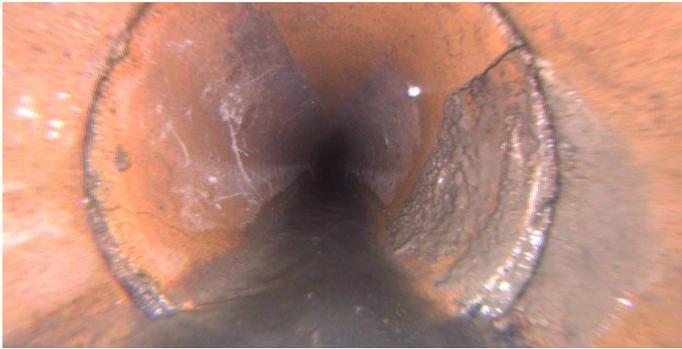
Code: **CS**
Description: **Crack Spiral**

Distance (ft): **9.5**
Structural Grade: **2**
O&M Grade: **0**
Clock Start/From: **8**
Clock To: **9**
1st Value:
2nd Value:
Value Percent:
Continuous Index:
Within 8" of Joint: **YES**
Remarks:

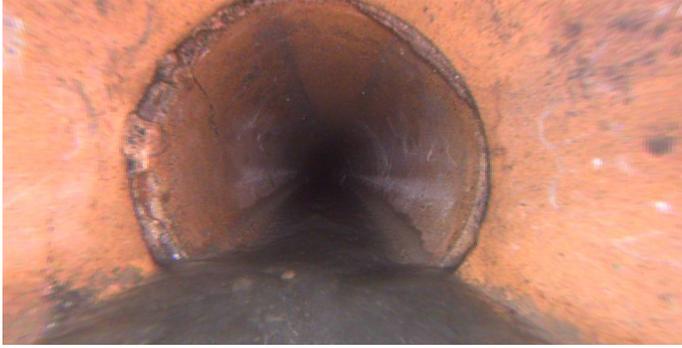
Code: **CS**
Description: **Crack Spiral**

Distance (ft): **12.4**
Structural Grade: **2**
O&M Grade: **0**
Clock Start/From: **9**
Clock To: **10**
1st Value:
2nd Value:
Value Percent:
Continuous Index:
Within 8" of Joint: **YES**
Remarks:

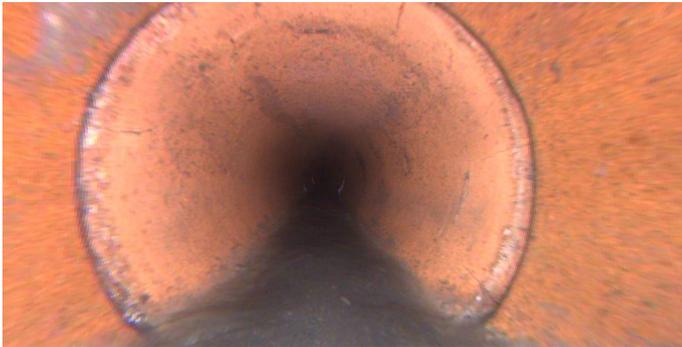
Code: **CM**
Description: **Crack Multiple**

Distance (ft): **18.4**
Structural Grade: **3**
O&M Grade: **0**
Clock Start/From: **9**
Clock To: **4**
1st Value:
2nd Value:
Value Percent:
Continuous Index:
Within 8" of Joint: **YES**
Remarks:

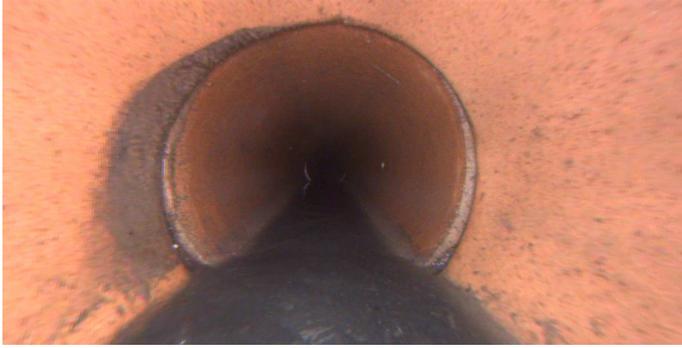
Code: **IS**
Description: **Infil Stain**

Distance (ft): **21.3**
Structural Grade: **0**
O&M Grade: **0**
Clock Start/From: **8**
Clock To: **12**
1st Value:
2nd Value:
Value Percent:
Continuous Index:
Within 8" of Joint: **YES**
Remarks:

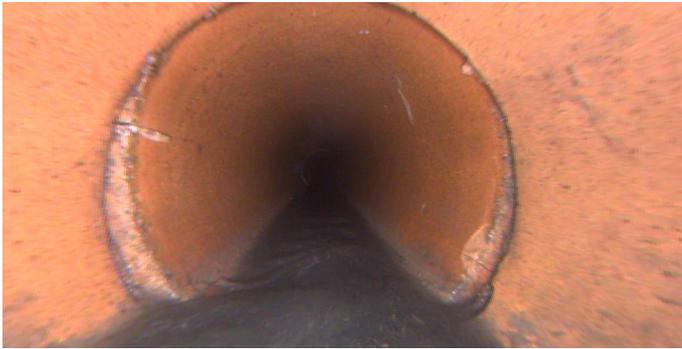
Code: **CM**
Description: **Crack Multiple**

Distance (ft): **24.4**
Structural Grade: **3**
O&M Grade: **0**
Clock Start/From: **10**
Clock To: **4**
1st Value:
2nd Value:
Value Percent:
Continuous Index:
Within 8" of Joint: **YES**
Remarks:

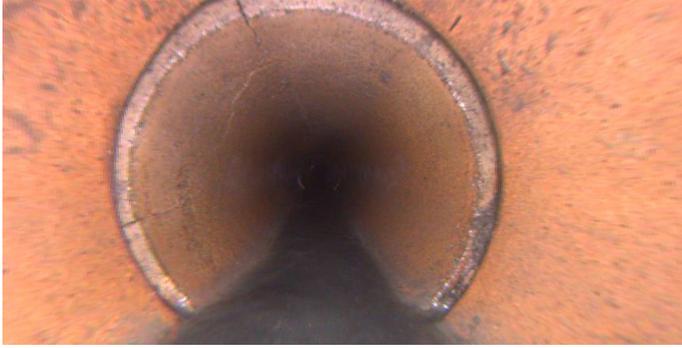
Code: **CS**
Description: **Crack Spiral**

Distance (ft): **27.4**
Structural Grade: **2**
O&M Grade: **0**
Clock Start/From: **8**
Clock To: **11**
1st Value:
2nd Value:
Value Percent:
Continuous Index:
Within 8" of Joint: **YES**
Remarks:

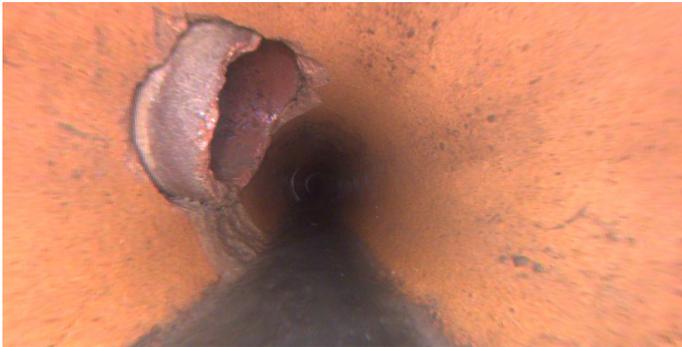
Code: **TBI**
Description: **Tap Break-in Intruding**

Distance (ft): **33.7**
Structural Grade: **0**
O&M Grade: **2**
Clock Start/From: **10**
Clock To:
1st Value: **6.000**
2nd Value: **2.000**
Value Percent:
Continuous Index:
Within 8" of Joint:
Remarks:

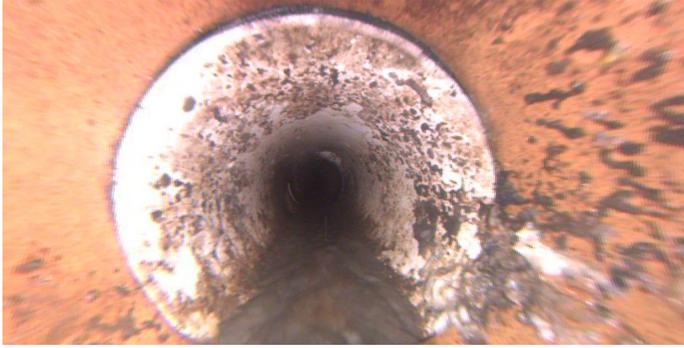
Code: **MMC**
Description: **Material Change**

Distance (ft): **39.5**
Structural Grade: **0**
O&M Grade: **0**
Clock Start/From:
Clock To:
1st Value:
2nd Value:
Value Percent:
Continuous Index:
Within 8" of Joint: **NO**
Remarks: **vcp to pvc**

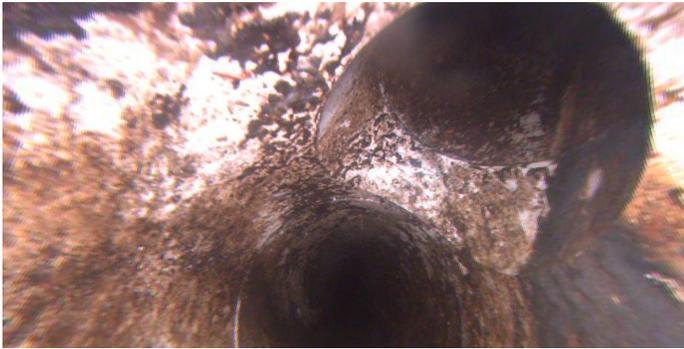
Code: **TF**
Description: **Tap Factory**

Distance (ft): **41.3**
Structural Grade: **0**
O&M Grade: **0**
Clock Start/From: **1**
Clock To:
1st Value: **6.000**
2nd Value:
Value Percent:
Continuous Index:
Within 8" of Joint:
Remarks:

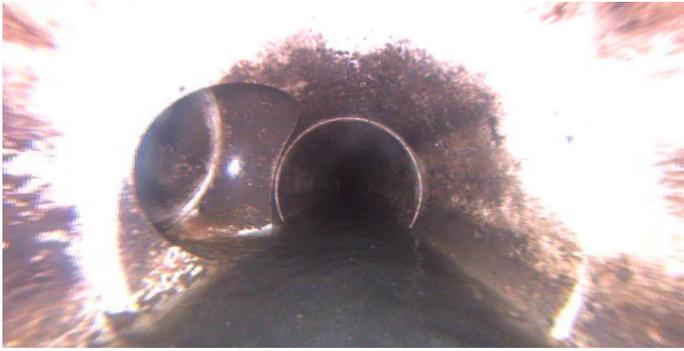
Code: **TF**
Description: **Tap Factory**

Distance (ft): **48.8**
Structural Grade: **0**
O&M Grade: **0**
Clock Start/From: **9**
Clock To:
1st Value: **6.000**
2nd Value:
Value Percent:
Continuous Index:
Within 8" of Joint:
Remarks:

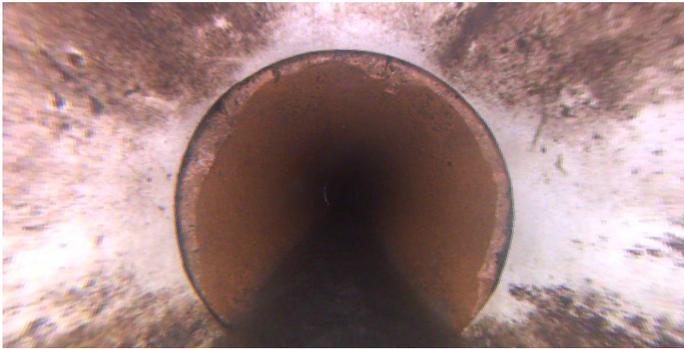
Code: **MMC**
Description: **Material Change**

Distance (ft): **51.6**
Structural Grade: **0**
O&M Grade: **0**
Clock Start/From:
Clock To:
1st Value:
2nd Value:
Value Percent:
Continuous Index:
Within 8" of Joint: **NO**
Remarks: **pvc to vcp**

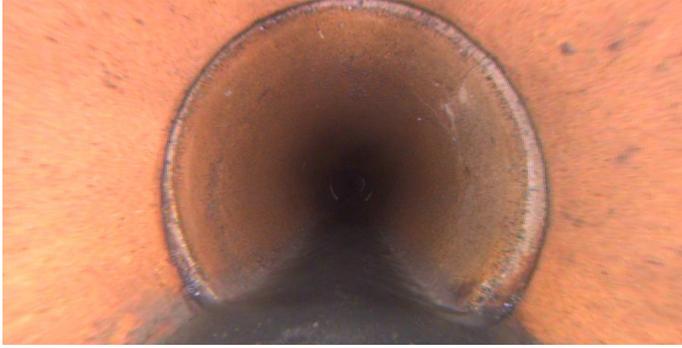
Code: **CS**
Description: **Crack Spiral**

Distance (ft): **57.5**
Structural Grade: **2**
O&M Grade: **0**
Clock Start/From: **2**
Clock To: **5**
1st Value:
2nd Value:
Value Percent:
Continuous Index:
Within 8" of Joint: **YES**
Remarks:

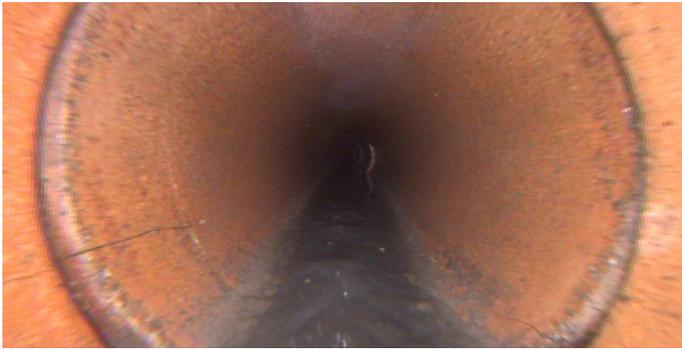
Code: **CM**
Description: **Crack Multiple**

Distance (ft): **60.6**
Structural Grade: **3**
O&M Grade: **0**
Clock Start/From: **5**
Clock To: **8**
1st Value:
2nd Value:
Value Percent:
Continuous Index:
Within 8" of Joint: **YES**
Remarks:

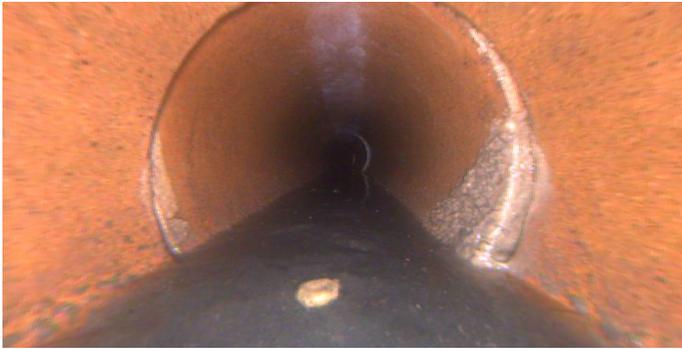
Code: **DAE**
Description: **Deposits Attached Encrustation**

Distance (ft): **63.5**
Structural Grade: **0**
O&M Grade: **2**
Clock Start/From: **3**
Clock To: **5**
1st Value:
2nd Value:
Value Percent: **5.000**
Continuous Index:
Within 8" of Joint: **YES**
Remarks:

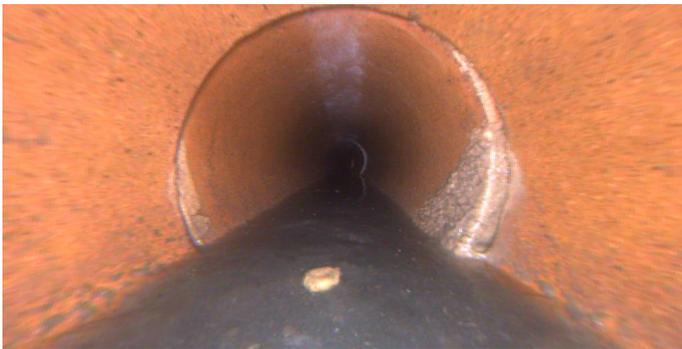
Code: **IW**
Description: **Infil Weeper**

Distance (ft): **63.5**
Structural Grade: **0**
O&M Grade: **2**
Clock Start/From: **3**
Clock To: **5**
1st Value:
2nd Value:
Value Percent:
Continuous Index:
Within 8" of Joint: **YES**
Remarks:

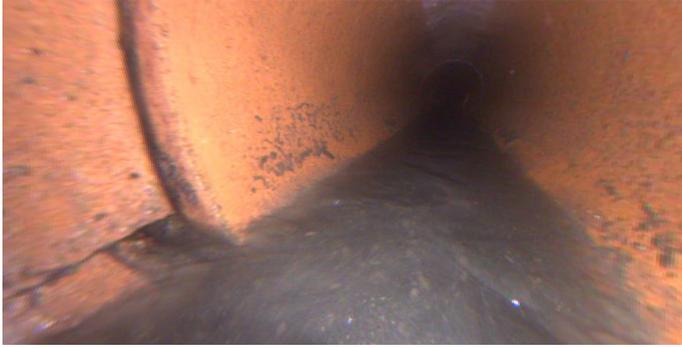
Code: **H**
Description: **Hole**

Distance (ft): **69.7**
Structural Grade: **3**
O&M Grade: **0**
Clock Start/From: **7**
Clock To:
1st Value:
2nd Value:
Value Percent:
Continuous Index:
Within 8" of Joint: **YES**
Remarks:

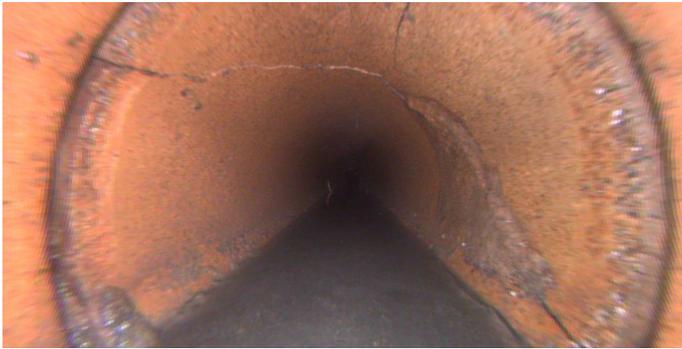
Code: **FM**
Description: **Fracture Multiple**

Distance (ft): **78.7**
Structural Grade: **4**
O&M Grade: **0**
Clock Start/From: **10**
Clock To: **5**
1st Value:
2nd Value:
Value Percent:
Continuous Index:
Within 8" of Joint: **YES**
Remarks:

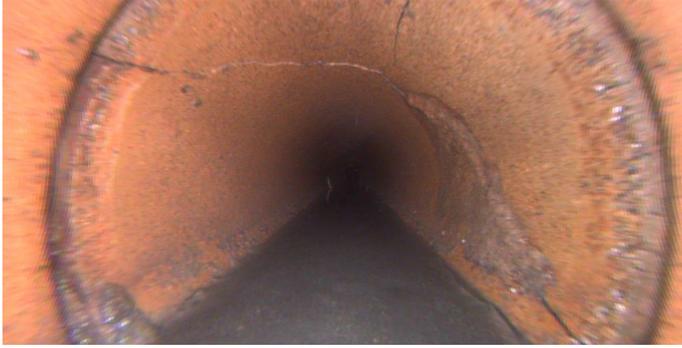
Code: **DAE**
Description: **Deposits Attached Encrustation**

Distance (ft): **78.7**
Structural Grade: **0**
O&M Grade: **2**
Clock Start/From: **2**
Clock To: **4**
1st Value:
2nd Value:
Value Percent: **5.000**
Continuous Index:
Within 8" of Joint: **YES**
Remarks:

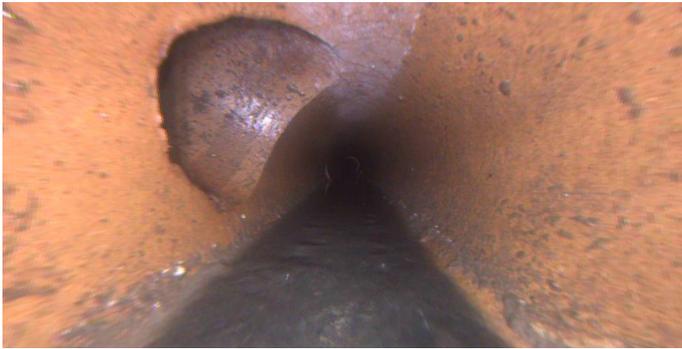
Code: **TF**
Description: **Tap Factory**

Distance (ft): **85.0**
Structural Grade: **0**
O&M Grade: **0**
Clock Start/From: **10**
Clock To:
1st Value: **6.000**
2nd Value:
Value Percent:
Continuous Index:
Within 8" of Joint:
Remarks:

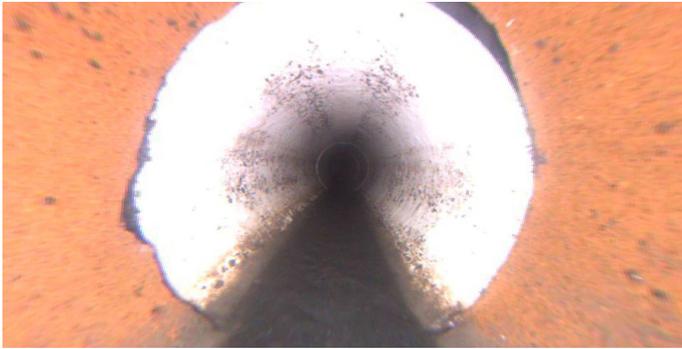
Code: **MMC**
Description: **Material Change**

Distance (ft): **93.0**
Structural Grade: **0**
O&M Grade: **0**
Clock Start/From:
Clock To:
1st Value:
2nd Value:
Value Percent:
Continuous Index:
Within 8" of Joint: **NO**
Remarks: **vcp to pvc**

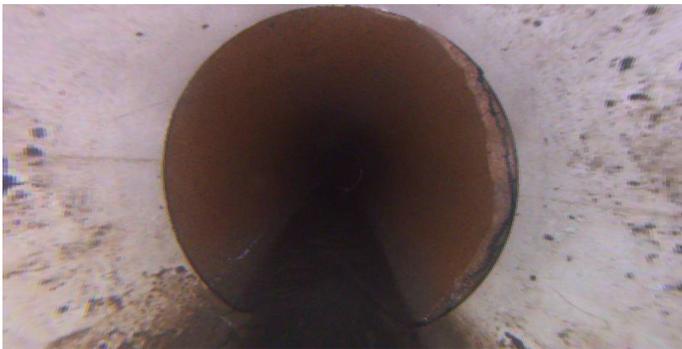
Code: **MMC**
Description: **Material Change**

Distance (ft): **97.0**
Structural Grade: **0**
O&M Grade: **0**
Clock Start/From:
Clock To:
1st Value:
2nd Value:
Value Percent:
Continuous Index:
Within 8" of Joint: **NO**
Remarks: **pvc to vcp**

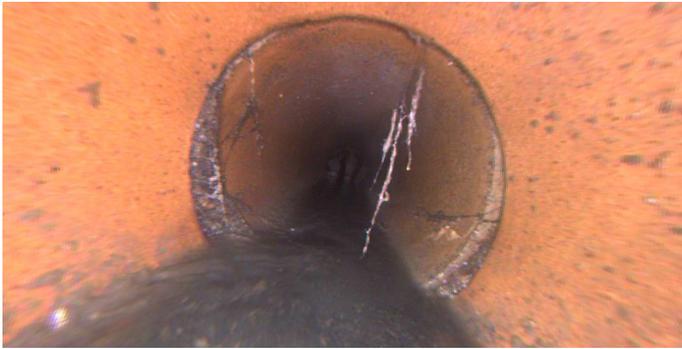
Code: **RFJ**
Description: **Roots Fine Joint**

Distance (ft): **102.5**
Structural Grade: **0**
O&M Grade: **1**
Clock Start/From: **7**
Clock To: **4**
1st Value:
2nd Value:
Value Percent:
Continuous Index:
Within 8" of Joint: **YES**
Remarks:

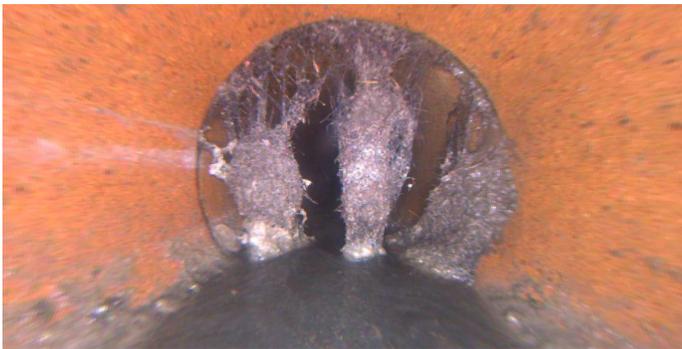
Code: **RMJ**
Description: **Roots Medium Joint**

Distance (ft): **105.5**
Structural Grade: **0**
O&M Grade: **3**
Clock Start/From: **8**
Clock To: **4**
1st Value:
2nd Value:
Value Percent: **50.000**
Continuous Index:
Within 8" of Joint: **YES**
Remarks:

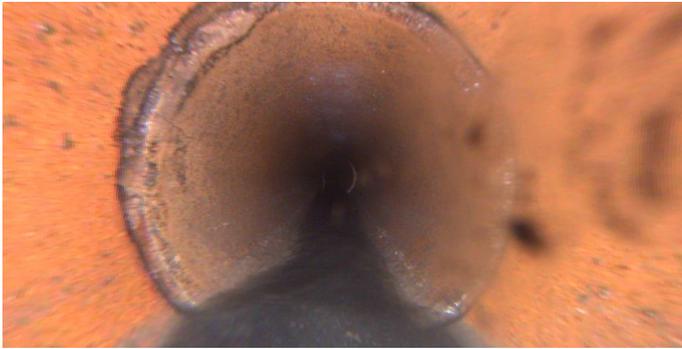
Code: **CL**
Description: **Crack Longitudinal**

Distance (ft): **108.6**
Structural Grade: **2**
O&M Grade: **0**
Clock Start/From: **9**
Clock To:
1st Value:
2nd Value:
Value Percent:
Continuous Index:
Within 8" of Joint: **YES**
Remarks:

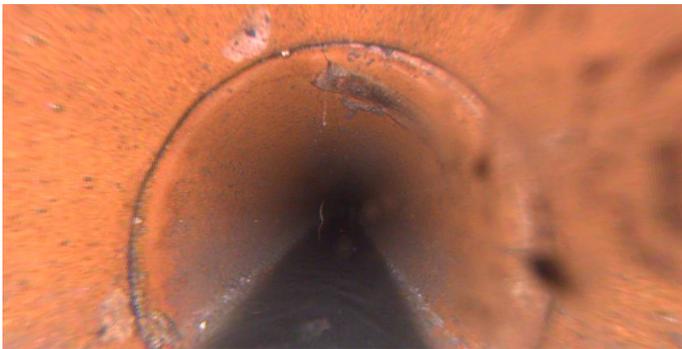
Code: **CL**
Description: **Crack Longitudinal**

Distance (ft): **111.6**
Structural Grade: **2**
O&M Grade: **0**
Clock Start/From: **12**
Clock To:
1st Value:
2nd Value:
Value Percent:
Continuous Index:
Within 8" of Joint: **YES**
Remarks:

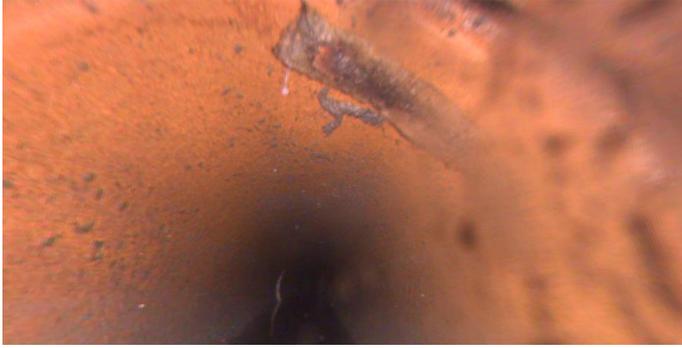
Code: **IS**
Description: **Infil Stain**

Distance (ft): **111.8**
Structural Grade: **0**
O&M Grade: **0**
Clock Start/From: **12**
Clock To:
1st Value:
2nd Value:
Value Percent:
Continuous Index:
Within 8" of Joint: **YES**
Remarks:

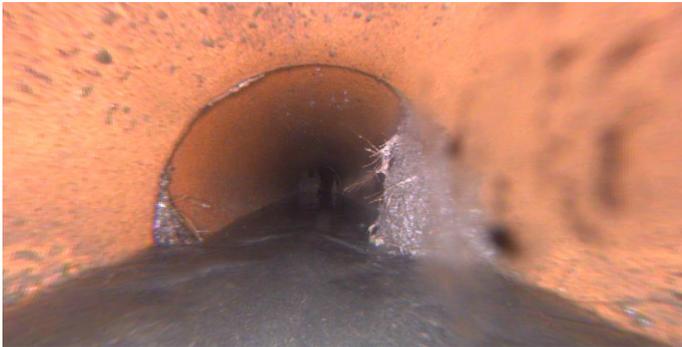
Code: **MWL**
Description: **Water Level**

Distance (ft): **117.5**
Structural Grade: **0**
O&M Grade: **0**
Clock Start/From:
Clock To:
1st Value:
2nd Value:
Value Percent: **25.000**
Continuous Index:
Within 8" of Joint: **NO**
Remarks:

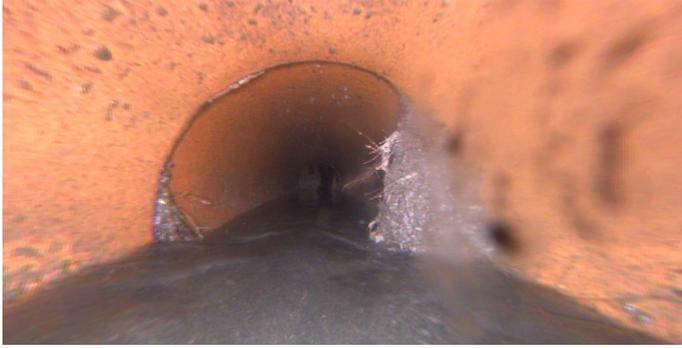
Code: **RMJ**
Description: **Roots Medium Joint**

Distance (ft): **117.5**
Structural Grade: **0**
O&M Grade: **3**
Clock Start/From: **8**
Clock To: **4**
1st Value:
2nd Value:
Value Percent: **20.000**
Continuous Index:
Within 8" of Joint: **YES**
Remarks:

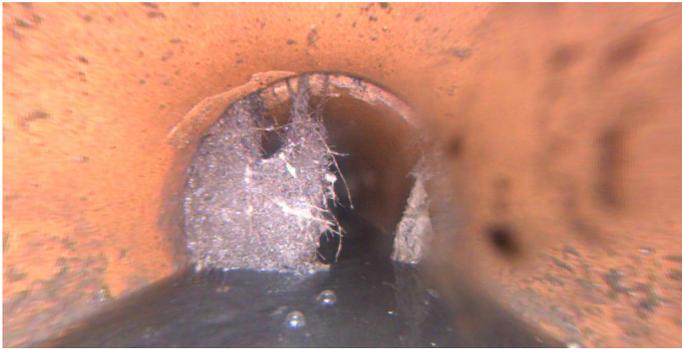
Code: **RMJ**
Description: **Roots Medium Joint**

Distance (ft): **120.5**
Structural Grade: **0**
O&M Grade: **3**
Clock Start/From: **8**
Clock To: **4**
1st Value:
2nd Value:
Value Percent: **50.000**
Continuous Index:
Within 8" of Joint: **YES**
Remarks:

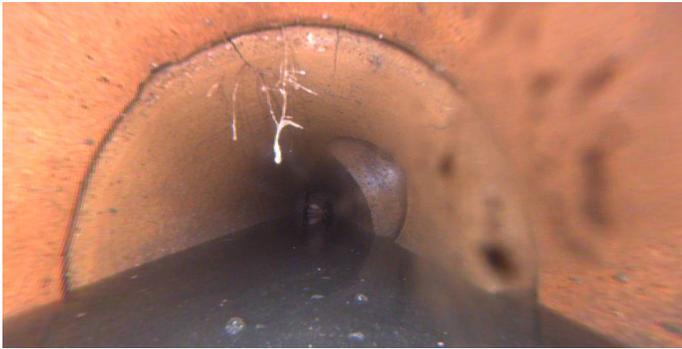
Code: **RFJ**
Description: **Roots Fine Joint**

Distance (ft): **126.7**
Structural Grade: **0**
O&M Grade: **1**
Clock Start/From: **12**
Clock To:
1st Value:
2nd Value:
Value Percent:
Continuous Index:
Within 8" of Joint: **YES**
Remarks:

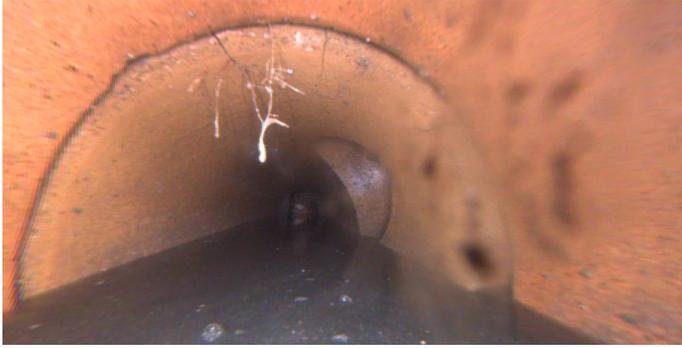
Code: **CM**
Description: **Crack Multiple**

Distance (ft): **126.7**
Structural Grade: **3**
O&M Grade: **0**
Clock Start/From: **11**
Clock To: **2**
1st Value:
2nd Value:
Value Percent:
Continuous Index:
Within 8" of Joint: **YES**
Remarks:

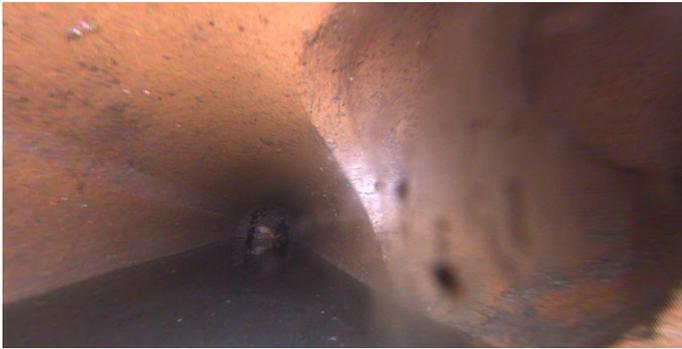
Code: **TFC**
Description: **Tap Factory Capped**

Distance (ft): **127.4**
Structural Grade: **0**
O&M Grade: **0**
Clock Start/From: **2**
Clock To:
1st Value: **6.000**
2nd Value:
Value Percent:
Continuous Index:
Within 8" of Joint:
Remarks:

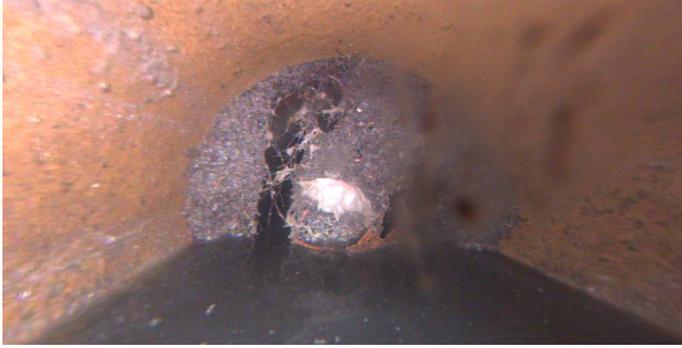
Code: **RBJ**
Description: **Roots Ball Joint**

Distance (ft): **129.6**
Structural Grade: **0**
O&M Grade: **4**
Clock Start/From: **8**
Clock To: **4**
1st Value:
2nd Value:
Value Percent: **55.000**
Continuous Index:
Within 8" of Joint: **YES**
Remarks:

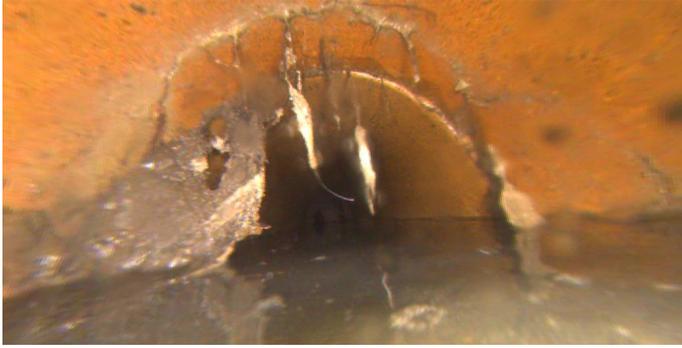
Code: **CS**
Description: **Crack Spiral**

Distance (ft): **133.4**
Structural Grade: **2**
O&M Grade: **0**
Clock Start/From: **9**
Clock To: **2**
1st Value:
2nd Value:
Value Percent:
Continuous Index:
Within 8" of Joint: **YES**
Remarks:

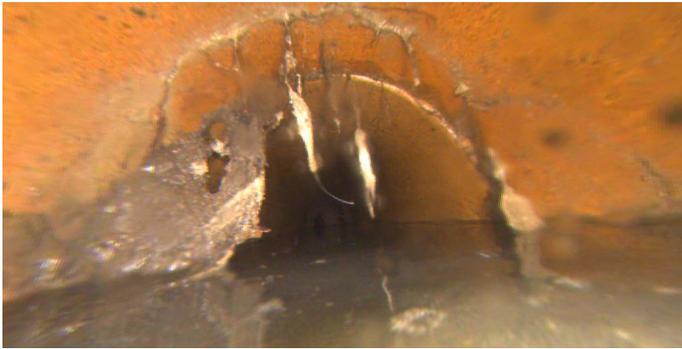
Code: **RMJ**
Description: **Roots Medium Joint**

Distance (ft): **133.4**
Structural Grade: **0**
O&M Grade: **3**
Clock Start/From: **9**
Clock To: **3**
1st Value:
2nd Value:
Value Percent: **20.000**
Continuous Index:
Within 8" of Joint: **YES**
Remarks:

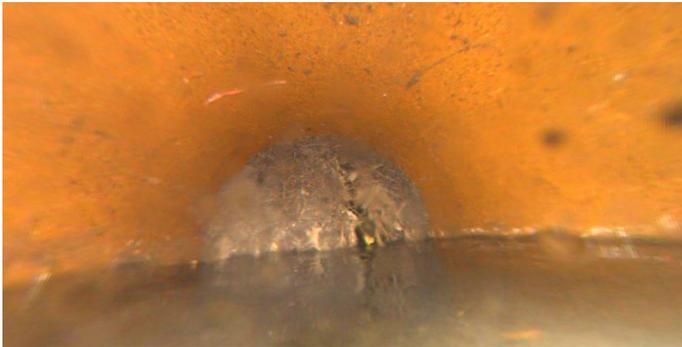
Code: **RBJ**
Description: **Roots Ball Joint**

Distance (ft): **136.7**
Structural Grade: **0**
O&M Grade: **4**
Clock Start/From: **8**
Clock To: **4**
1st Value:
2nd Value:
Value Percent: **55.000**
Continuous Index:
Within 8" of Joint: **YES**
Remarks:

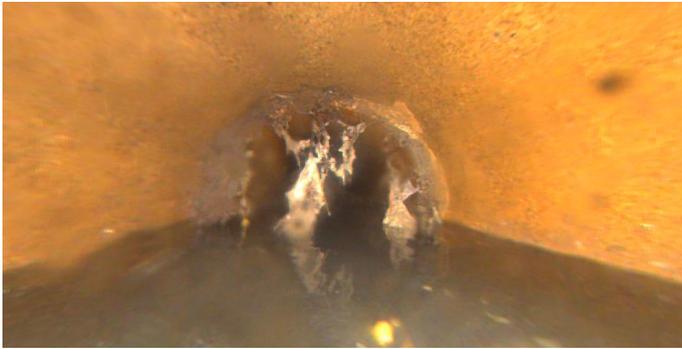
Code: **RMJ**
Description: **Roots Medium Joint**

Distance (ft): **139.6**
Structural Grade: **0**
O&M Grade: **3**
Clock Start/From: **8**
Clock To: **4**
1st Value:
2nd Value:
Value Percent: **20.000**
Continuous Index:
Within 8" of Joint: **YES**
Remarks:

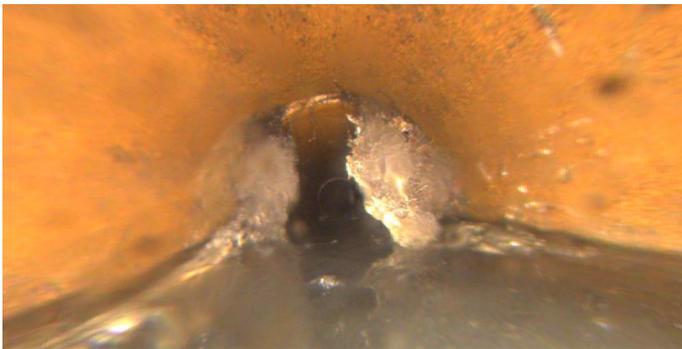
Code: **RMJ**
Description: **Roots Medium Joint**

Distance (ft): **145.7**
Structural Grade: **0**
O&M Grade: **3**
Clock Start/From: **8**
Clock To: **4**
1st Value:
2nd Value:
Value Percent: **30.000**
Continuous Index:
Within 8" of Joint: **YES**
Remarks:

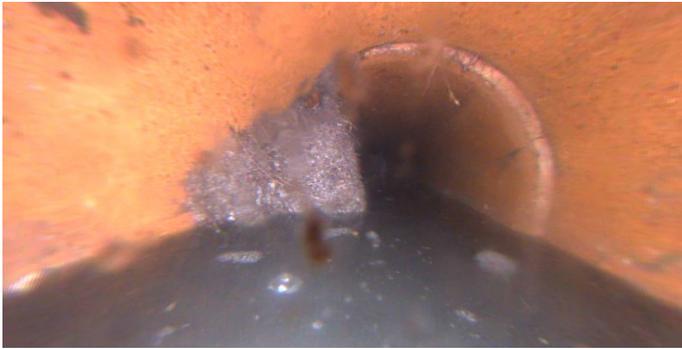
Code: **RMJ**
Description: **Roots Medium Joint**

Distance (ft): **147.5**
Structural Grade: **0**
O&M Grade: **3**
Clock Start/From: **8**
Clock To: **11**
1st Value:
2nd Value:
Value Percent: **25.000**
Continuous Index:
Within 8" of Joint: **YES**
Remarks:

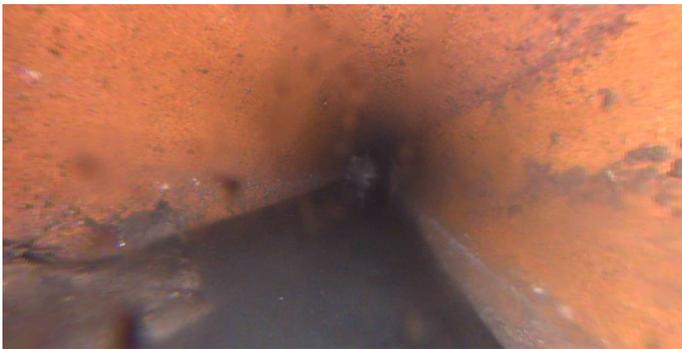
Code: **MSA**
Description: **Abandoned Survey**

Distance (ft): **148.5**
Structural Grade: **0**
O&M Grade: **0**
Clock Start/From:
Clock To:
1st Value:
2nd Value:
Value Percent:
Continuous Index:
Within 8" of Joint: **NO**
Remarks: **cannot pass RMJ**
