Profile/Photo Observation Report

Street:	FOXCROFT STREET	Flow Control:	Not Controlled
City:	Hobart, IN	Year Renewed:	
Location:	Yard	Tape/Media #:	
Purpose:	Routine Assessment	Dia/Height:	8"
Use:	Sanitary	Material:	PVC
Drain Area:	NA	Lining:	
Category:	NA		
Comment:	P_C At 173 ft roots

Location Details:		Direction of Survey:	Downstream
US MH:	M-405-035	DS MH:	M-405-036
		Total Length Surveyed (ft):	175.0

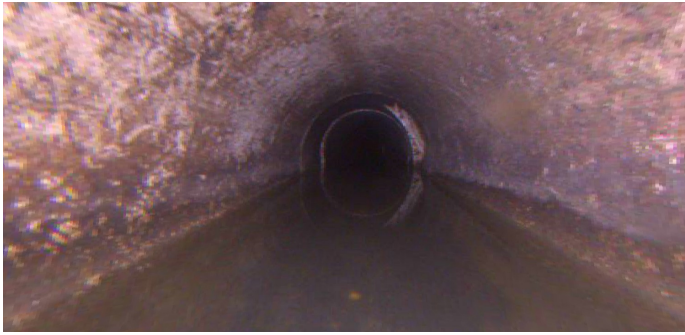
Code: **AMH**
Description: **Manhole**

Distance (ft): **.0**
Structural Grade: **0**
O&M Grade: **0**
Clock Start/From:
Clock To:
1st Value:
2nd Value:
Value Percent:
Continuous Index:
Within 8" of Joint: **NO**
Remarks: **M-405-035**

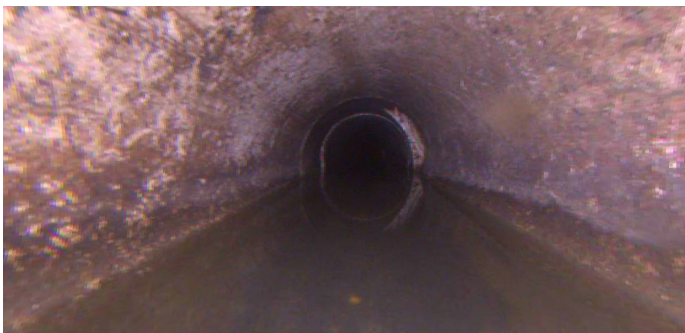
Code: **MWL**
Description: **Water Level**

Distance (ft): **.0**
Structural Grade: **0**
O&M Grade: **0**
Clock Start/From:
Clock To:
1st Value:
2nd Value:
Value Percent: **10.000**
Continuous Index:
Within 8" of Joint: **NO**
Remarks:

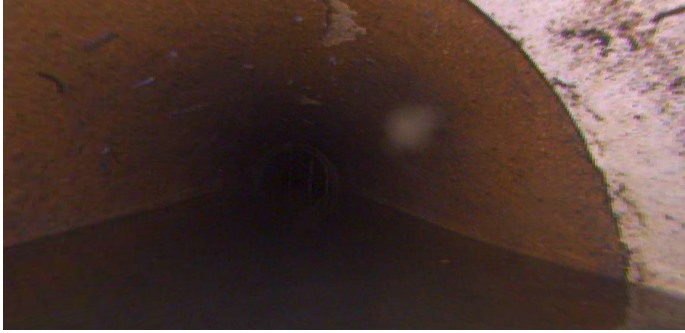
Code: **MWL**
Description: **Water Level**

Distance (ft): **27.9**
Structural Grade: **0**
O&M Grade: **0**
Clock Start/From:
Clock To:
1st Value:
2nd Value:
Value Percent: **50.000**
Continuous Index:
Within 8" of Joint: **NO**
Remarks:

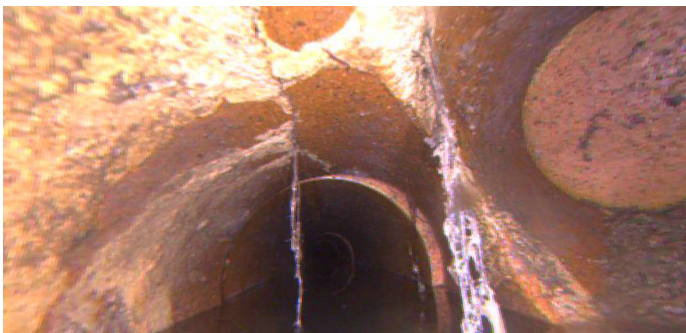
Code: **RFC**
Description: **Roots Fine Connection**

Distance (ft): **30.1**
Structural Grade: **0**
O&M Grade: **1**
Clock Start/From: **1**
Clock To:
1st Value:
2nd Value:
Value Percent:
Continuous Index:
Within 8" of Joint: **NO**
Remarks:

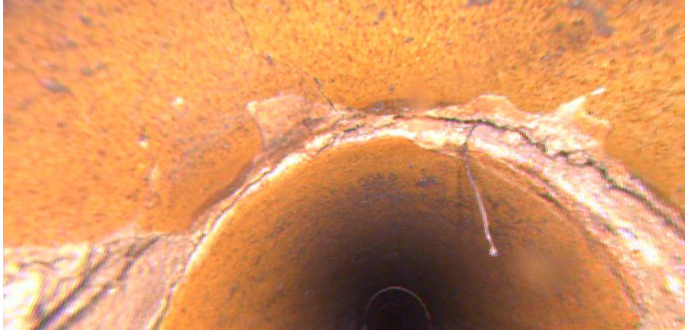
Code: **CM**
Description: **Crack Multiple**

Distance (ft): **33.7**
Structural Grade: **3**
O&M Grade: **0**
Clock Start/From: **10**
Clock To: **11**
1st Value:
2nd Value:
Value Percent:
Continuous Index: **S02**
Within 8" of Joint: **YES**
Remarks: **wnadering**

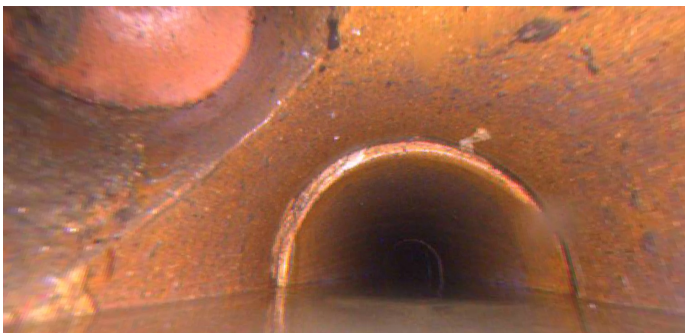
Code: **TFC**
Description: **Tap Factory Capped**

Distance (ft): **39.3**
Structural Grade: **0**
O&M Grade: **0**
Clock Start/From: **11**
Clock To:
1st Value: **4.000**
2nd Value:
Value Percent:
Continuous Index:
Within 8" of Joint: **YES**
Remarks:

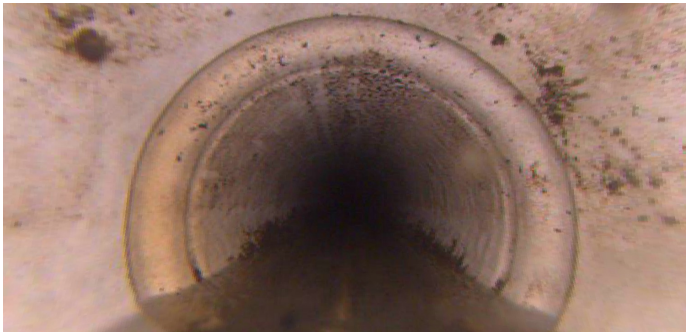
Code:	MWL
Description:	Water Level
Distance (ft):	62.8
Structural Grade:	0
O&M Grade:	0
Clock Start/From:	
Clock To:	
1st Value:	
2nd Value:	
Value Percent:	5.000
Continuous Index:	
Within 8" of Joint:	NO
Remarks:

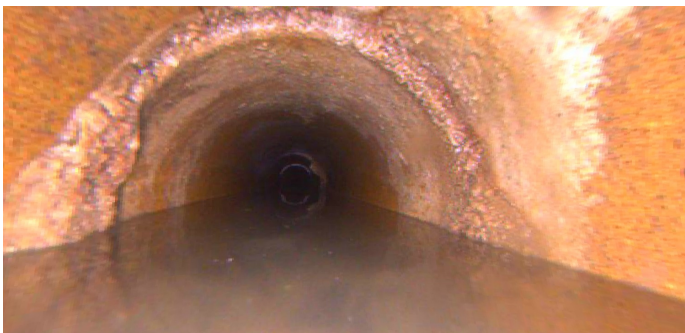
Code: **DAZ**
Description: **Deposits Attached Other**

Distance (ft): **78.7**
Structural Grade: **0**
O&M Grade: **2**
Clock Start/From: **8**
Clock To: **4**
1st Value:
2nd Value:
Value Percent: **5.000**
Continuous Index: **S03**
Within 8" of Joint: **YES**
Remarks: **wandering**

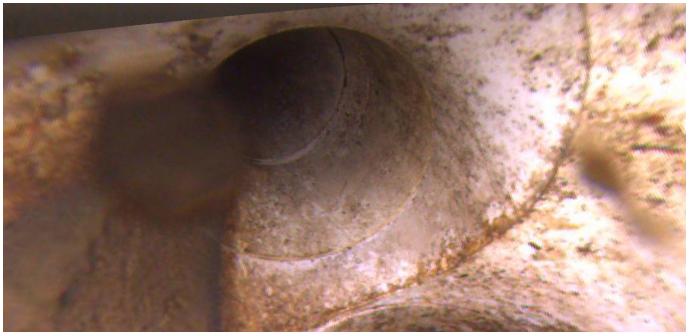
Code:	TF
Description:	Tap Factory
Distance (ft):	104.1
Structural Grade:	0
O&M Grade:	0
Clock Start/From:	11
Clock To:	
1st Value:	4.000
2nd Value:	
Value Percent:	
Continuous Index:	
Within 8" of Joint:	YES
Remarks:

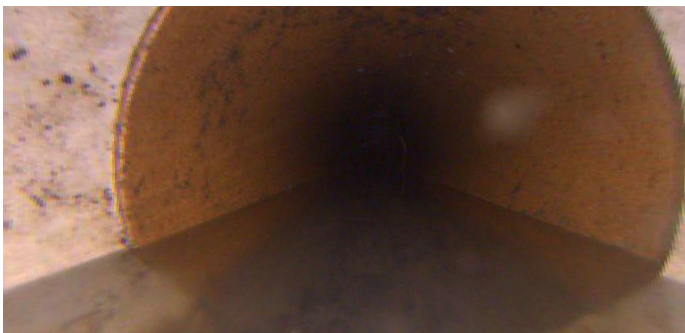
Code: **MMC**
Description: **Material Change**

Distance (ft): **120.9**
Structural Grade: **0**
O&M Grade: **0**
Clock Start/From:
Clock To:
1st Value:
2nd Value:
Value Percent:
Continuous Index:
Within 8" of Joint: **NO**
Remarks: **vcp**
