Profile/Photo Observation Report

Date:	04/20/2018	Weather:		Coding:	PACP 6.0
Pipe Length (ft):	80.2	Owner:	NA	Pre Clean:	No Pre-Cleaning
P.O.#:		Surveyor:	Byrd Fitzgerald	PSR:	P-405-039-038
Customer:		Clean Date:	01/01/1900	Shape:	C

Street:	FOXCROFT STREET	Flow Control:	Not Controlled
City:	Hobart, IN	Year Renewed:	
Location:	Yard	Tape/Media #:	
Purpose:	Routine Assessment	Dia/Height:	8"
Use:	Sanitary	Material:	PVC
Drain Area:	NA	Lining:	
Category:	NA		
Comment:	Flow direction wrong		
Location Details:		Direction of Survey:	Upstream
US MH:	M-405-038	DS MH:	M-405-039
		Total Length Surveyed (ft):	83.8

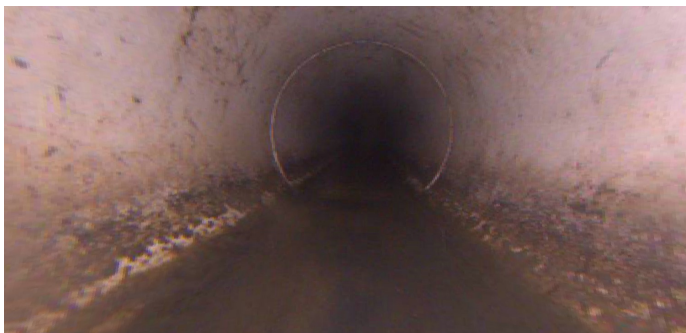
Code: **AMH**
Description: **Manhole**

Distance (ft): **.0**
Structural Grade: **0**
O&M Grade: **0**
Clock Start/From:
Clock To:
1st Value:
2nd Value:
Value Percent:
Continuous Index:
Within 8" of Joint: **NO**
Remarks: **M-405-039**

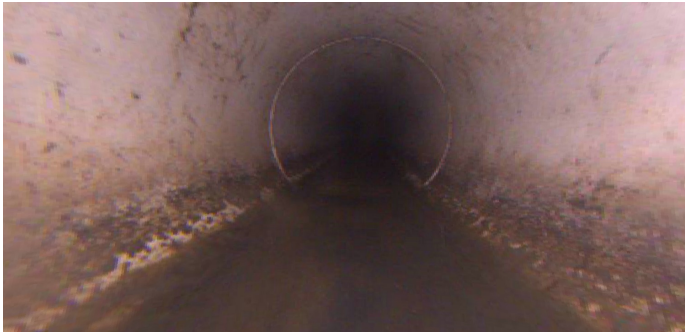
Code:	MWL
Description:	Water Level

Distance (ft):	.0
Structural Grade:	0
O&M Grade:	0
Clock Start/From:	
Clock To:	
1st Value:	
2nd Value:	
Value Percent:	5.000
Continuous Index:	
Within 8" of Joint:	NO
Remarks:

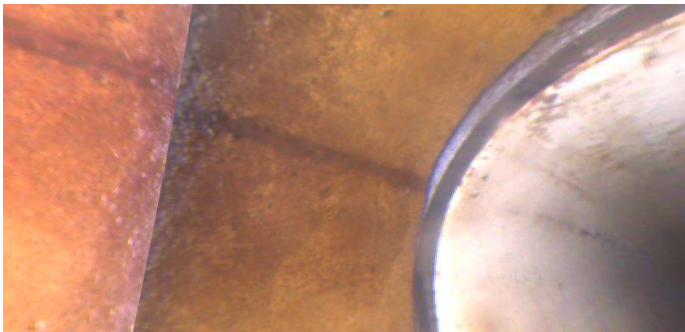
Code:	MMC
Description:	Material Change

Distance (ft):	31.9
Structural Grade:	0
O&M Grade:	0
Clock Start/From:	
Clock To:	
1st Value:	
2nd Value:	
Value Percent:	
Continuous Index:	
Within 8" of Joint:	NO
Remarks:	vcp

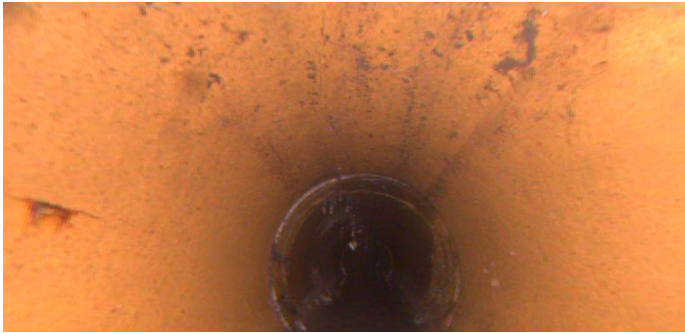
Code: **CM**
Description: **Crack Multiple**

Distance (ft): **38.2**
Structural Grade: **3**
O&M Grade: **0**
Clock Start/From: **9**
Clock To: **5**
1st Value:
2nd Value:
Value Percent:
Continuous Index: **S01**
Within 8" of Joint: **YES**
Remarks: **wandering**

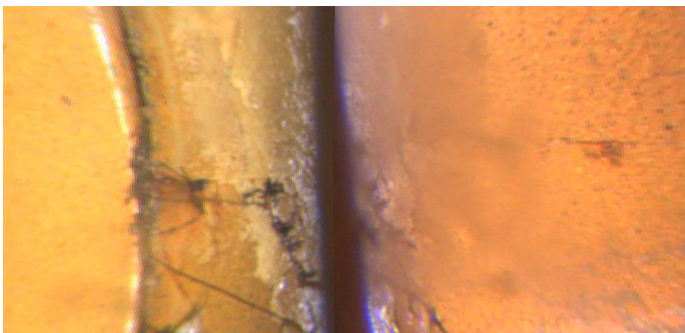
Code: **RFJ**
Description: **Roots Fine Joint**

Distance (ft): **39.4**
Structural Grade: **0**
O&M Grade: **1**
Clock Start/From: **7**
Clock To: **5**
1st Value:
2nd Value:
Value Percent:
Continuous Index: **S02**
Within 8" of Joint: **YES**
Remarks:

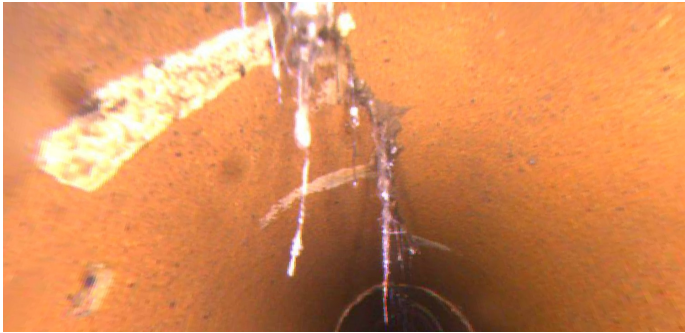
Code: **RFB**
Description: **Roots Fine Barrel**

Distance (ft): **40.6**
Structural Grade: **0**
O&M Grade: **2**
Clock Start/From: **12**
Clock To:
1st Value:
2nd Value:
Value Percent:
Continuous Index: **S03**
Within 8" of Joint: **NO**
Remarks:

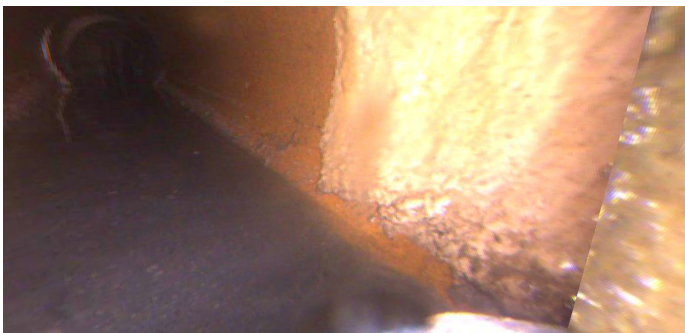
Code: **DAZ**
Description: **Deposits Attached Other**

Distance (ft): **45.4**
Structural Grade: **0**
O&M Grade: **2**
Clock Start/From: **7**
Clock To: **5**
1st Value:
2nd Value:
Value Percent: **5.000**
Continuous Index: **S04**
Within 8" of Joint: **NO**
Remarks: **wandering at joints and barrel**

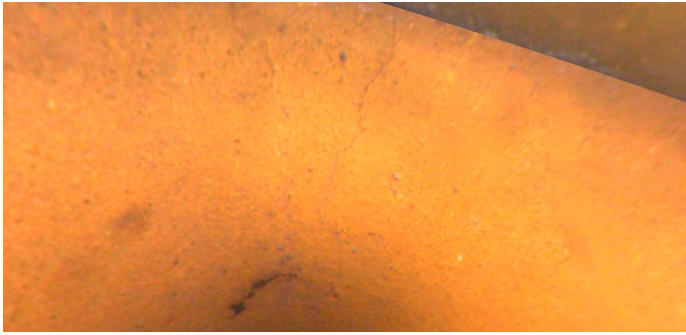
Code: **RFB**
Description: **Roots Fine Barrel**

Distance (ft): **47.2**
Structural Grade: **0**
O&M Grade: **2**
Clock Start/From: **12**
Clock To:
1st Value:
2nd Value:
Value Percent:
Continuous Index: **F03**
Within 8" of Joint: **NO**
Remarks:

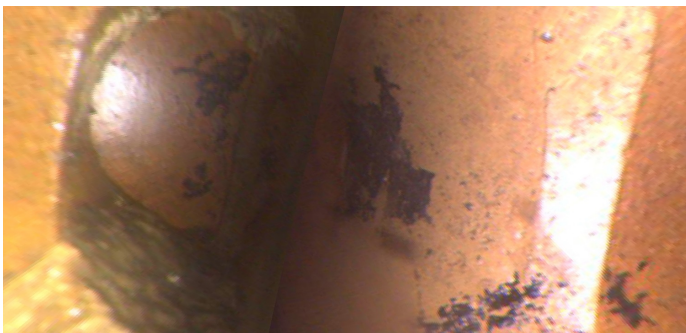
Code: **TFC**
Description: **Tap Factory Capped**

Distance (ft): **48.7**
Structural Grade: **0**
O&M Grade: **0**
Clock Start/From: **10**
Clock To:
1st Value: **4.000**
2nd Value:
Value Percent:
Continuous Index:
Within 8" of Joint: **YES**
Remarks:

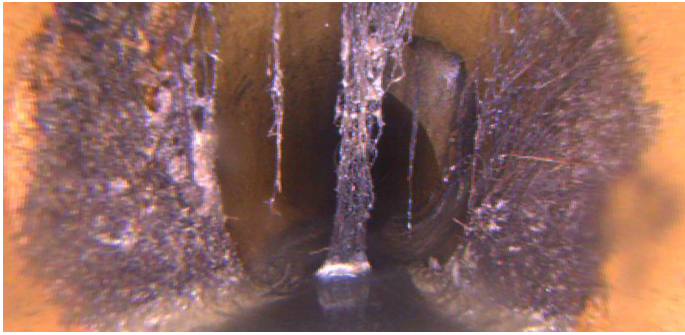
Code: **RMJ**
Description: **Roots Medium Joint**

Distance (ft): **50.7**
Structural Grade: **0**
O&M Grade: **3**
Clock Start/From: **7**
Clock To: **5**
1st Value:
2nd Value:
Value Percent: **5.000**
Continuous Index:
Within 8" of Joint: **YES**
Remarks:

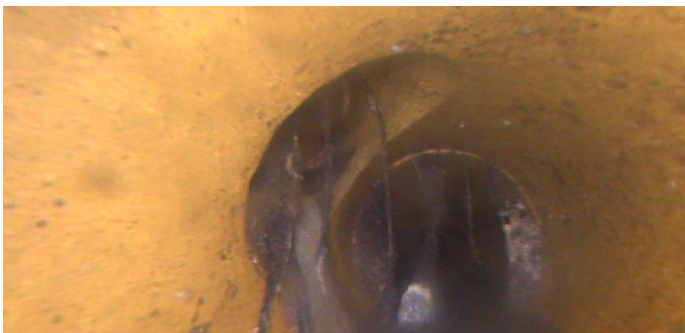
Code: **TF**
Description: **Tap Factory**

Distance (ft): **52.3**
Structural Grade: **0**
O&M Grade: **0**
Clock Start/From: **2**
Clock To:
1st Value: **4.000**
2nd Value:
Value Percent:
Continuous Index:
Within 8" of Joint: **YES**
Remarks:

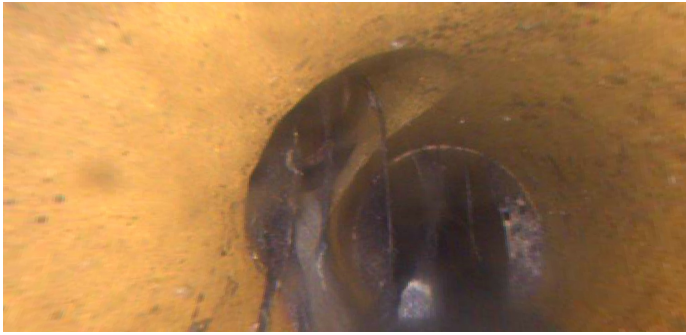
Code: **RML**
Description: **Roots Medium Lateral**

Distance (ft): **52.3**
Structural Grade: **0**
O&M Grade: **3**
Clock Start/From: **12**
Clock To: **12**
1st Value:
2nd Value:
Value Percent: **5.000**
Continuous Index:
Within 8" of Joint: **NO**
Remarks:

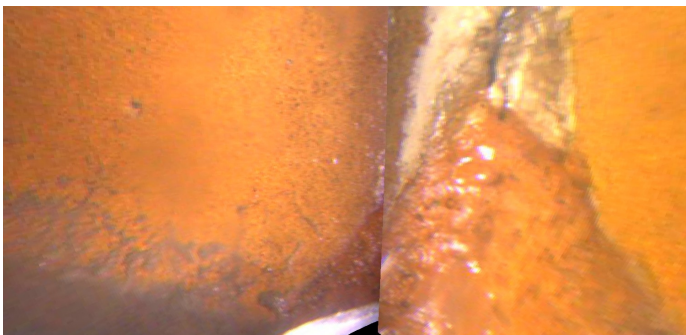
Code: **DAE**
Description: **Deposits Attached Encrustation**

Distance (ft): **63.0**
Structural Grade: **0**
O&M Grade: **2**
Clock Start/From: **5**
Clock To:
1st Value:
2nd Value:
Value Percent: **5.000**
Continuous Index:
Within 8" of Joint: **YES**
Remarks:

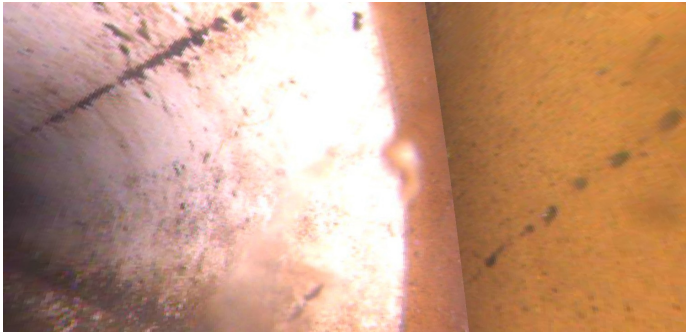
Code: **MMC**
Description: **Material Change**

Distance (ft): **71.6**
Structural Grade: **0**
O&M Grade: **0**
Clock Start/From:
Clock To:
1st Value:
2nd Value:
Value Percent:
Continuous Index:
Within 8" of Joint: **NO**
Remarks: **pvc**

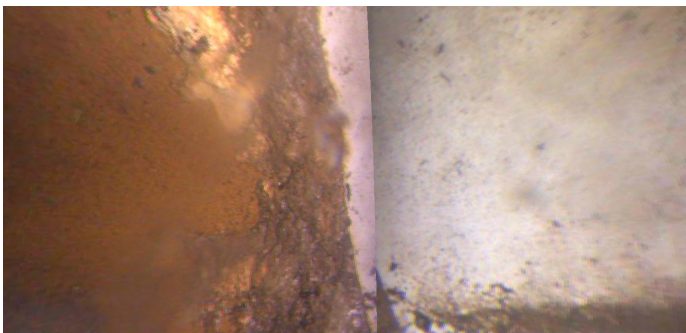
Code: **MMC**
Description: **Material Change**

Distance (ft): **81.0**
Structural Grade: **0**
O&M Grade: **0**
Clock Start/From:
Clock To:
1st Value:
2nd Value:
Value Percent:
Continuous Index:
Within 8" of Joint: **NO**
Remarks: **vcp**

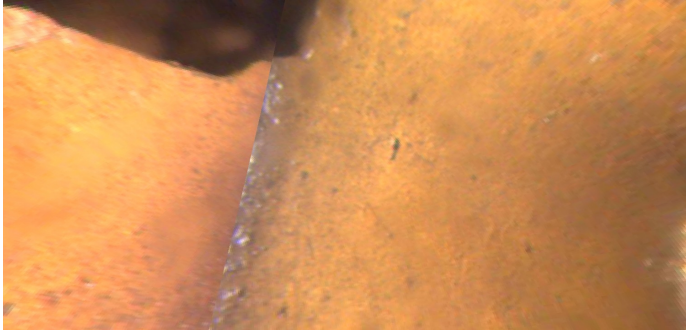
Code: **DAZ**
Description: **Deposits Attached Other**

Distance (ft): **82.1**
Structural Grade: **0**
O&M Grade: **2**
Clock Start/From: **7**
Clock To: **5**
1st Value:
2nd Value:
Value Percent: **5.000**
Continuous Index: **F04**
Within 8" of Joint: **NO**
Remarks: **wandering at joints and barrel**

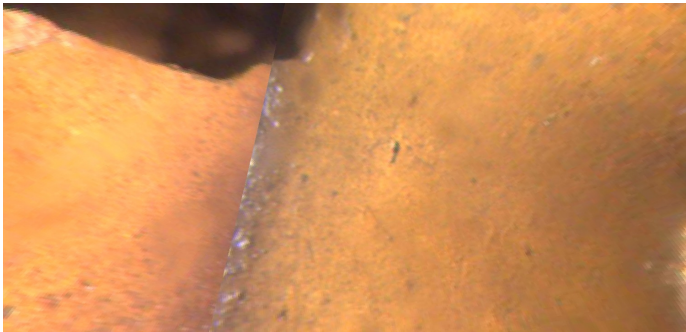
Code: **RFJ**
Description: **Roots Fine Joint**

Distance (ft): **82.1**
Structural Grade: **0**
O&M Grade: **1**
Clock Start/From: **7**
Clock To: **5**
1st Value:
2nd Value:
Value Percent:
Continuous Index: **F02**
Within 8" of Joint: **YES**
Remarks:

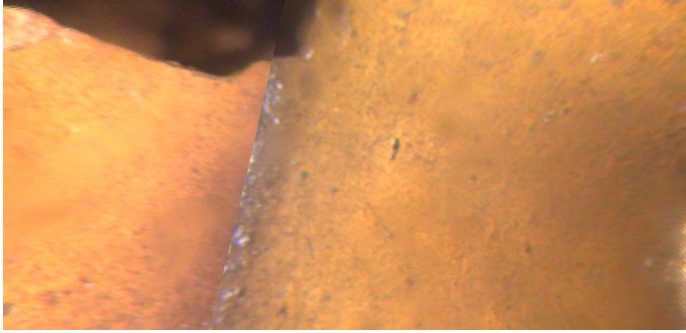
Code: **CM**
Description: **Crack Multiple**

Distance (ft): **82.1**
Structural Grade: **3**
O&M Grade: **0**
Clock Start/From: **9**
Clock To: **5**
1st Value:
2nd Value:
Value Percent:
Continuous Index: **F01**
Within 8" of Joint: **YES**
Remarks: **wandering**

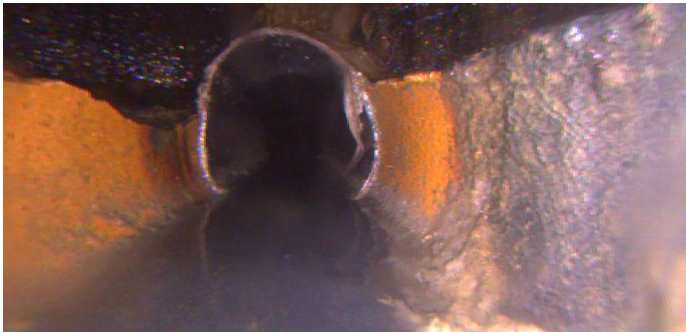
Code: **AMH**
Description: **Manhole**

Distance (ft): **83.8**
Structural Grade: **0**
O&M Grade: **0**
Clock Start/From:
Clock To:
1st Value:
2nd Value:
Value Percent:
Continuous Index:
Within 8" of Joint: **NO**
Remarks: **M-405-038**
