Profile/Photo Observation Report

Date:	09/15/2022	Weather:		Coding:	PACP 7.0
Pipe Length (ft):	311.0	Owner:	City of Hobart	Pre Clean:	Heavy Cleaning
P.O.#:	YES502259	Surveyor:	S. Bucklin	PSR:	P-405-043-020
Customer:	City of Hobart	Clean Date:	08/18/2022	Shape:	C

Street:	West 3rd Street	Flow Control:	Not Controlled
City:	Hobart, IN	Year Renewed:	
Location:	Easement/Right of Way	Tape/Media #:	
Purpose:	Routine Assessment	Dia/Height:	15"
Use:	Sanitary Sewage Pipe	Material:	RCP
Drain Area:		Lining:	None
Category:	NA		
Comment:			
Location Details:		Direction of Survey:	Downstream
US MH:	M-405-043	DS MH:	M-405-020
		Total Length Surveyed (ft):	309.1

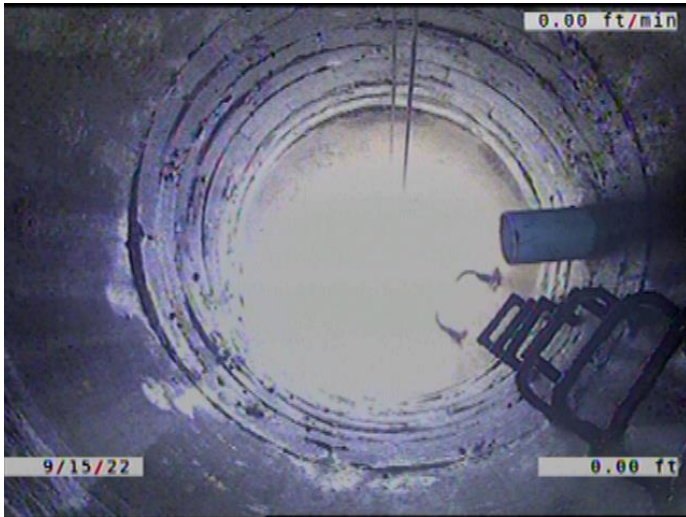
Code: **AMH**
Description: **Manhole**

Distance (ft): **.0**
Structural Grade: **0**
O&M Grade: **0**
Clock Start/From:
Clock To:
1st Value:
2nd Value:
Value Percent:
Continuous Index:
Within 8" of Joint: **NO**
Remarks: **M-405-043**

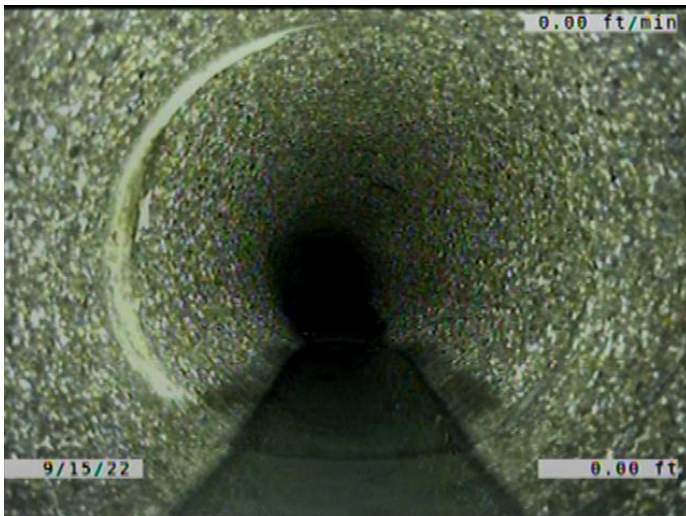
Code: **MWL**
Description: **Miscellaneous Water Level**

Distance (ft): **.0**
Structural Grade: **0**
O&M Grade: **0**
Clock Start/From:
Clock To:
1st Value:
2nd Value:
Value Percent: **5.000**
Continuous Index:
Within 8" of Joint: **NO**
Remarks:

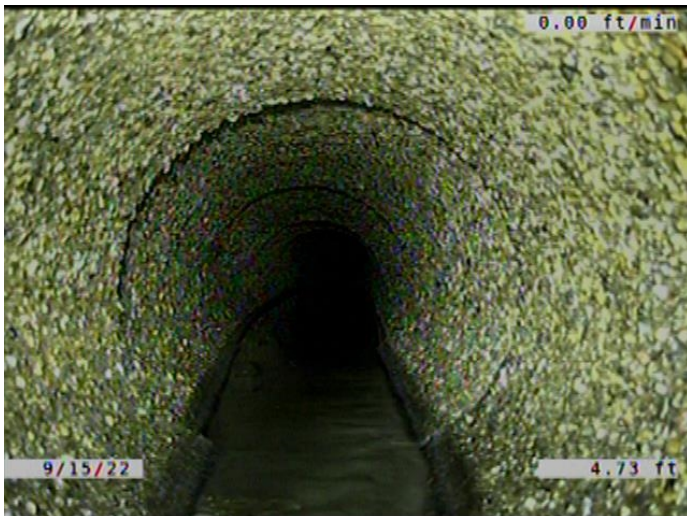
Code: **MWLS**
 Description: **Miscellaneous Water Level Sag**

Distance (ft): **4.7**
 Structural Grade: **2**
 O&M Grade: **0**
 Clock Start/From:
 Clock To:
 1st Value:
 2nd Value:
 Value Percent: **10.000**
 Continuous Index: **S01**
 Within 8" of Joint: **NO**
 Remarks:

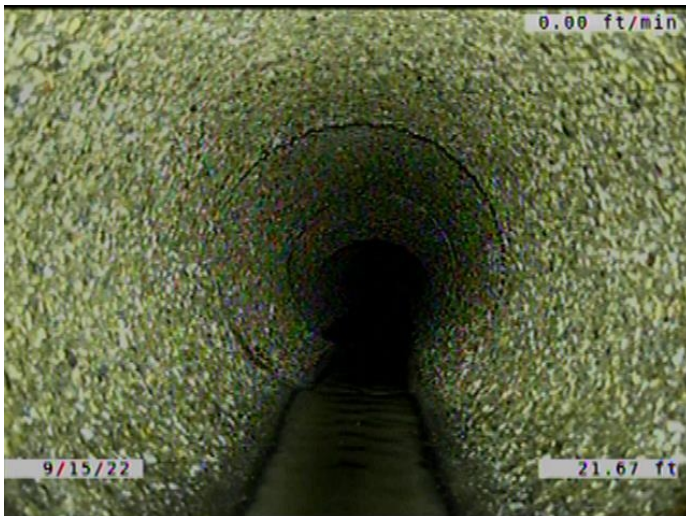
Code: **MWLS**
 Description: **Miscellaneous Water Level Sag**

Distance (ft): **21.7**
 Structural Grade: **2**
 O&M Grade: **0**
 Clock Start/From:
 Clock To:
 1st Value:
 2nd Value:
 Value Percent: **10.000**
 Continuous Index: **F01**
 Within 8" of Joint: **NO**
 Remarks:

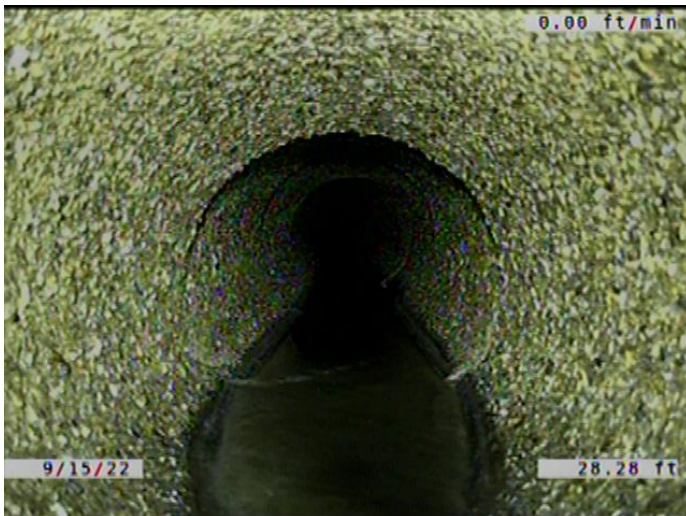
Code: **MWLS**
Description: **Miscellaneous Water Level Sag**

Distance (ft): **28.3**
Structural Grade: **2**
O&M Grade: **0**
Clock Start/From:
Clock To:
1st Value:
2nd Value:
Value Percent: **10.000**
Continuous Index: **S03**
Within 8" of Joint: **NO**
Remarks:

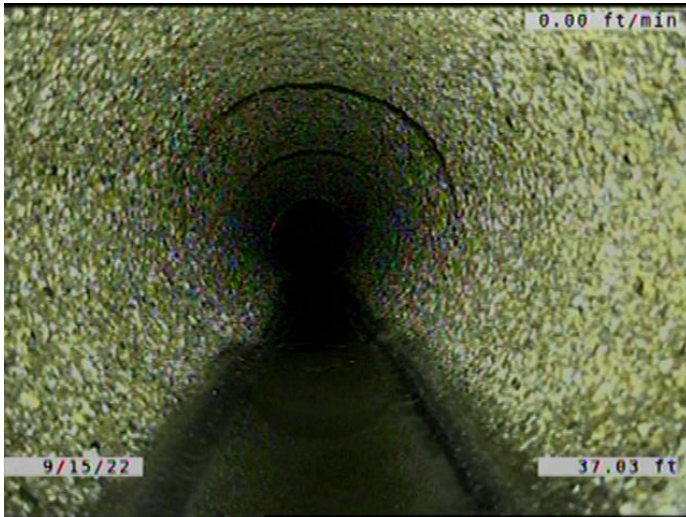
Code: **MWLS**
 Description: **Miscellaneous Water Level Sag**

Distance (ft): **37.0**
 Structural Grade: **2**
 O&M Grade: **0**
 Clock Start/From:
 Clock To:
 1st Value:
 2nd Value:
 Value Percent: **10.000**
 Continuous Index: **F03**
 Within 8" of Joint: **NO**
 Remarks:

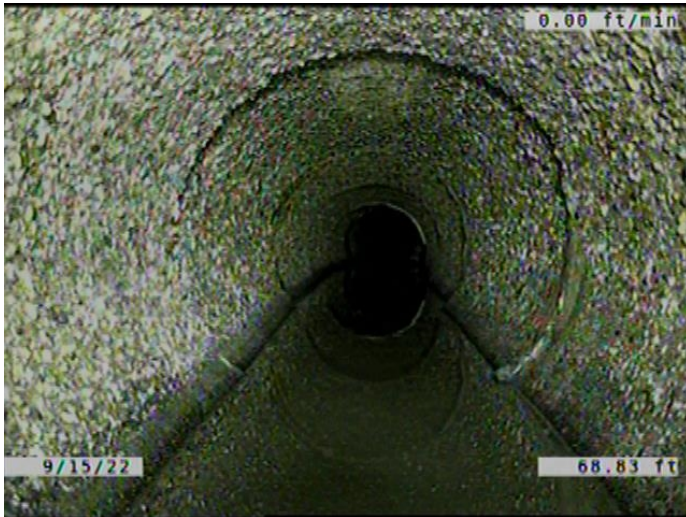
Code: **MWLS**
Description: **Miscellaneous Water Level Sag**

Distance (ft): **68.8**
Structural Grade: **2**
O&M Grade: **0**
Clock Start/From:
Clock To:
1st Value:
2nd Value:
Value Percent: **15.000**
Continuous Index: **S04**
Within 8" of Joint: **NO**
Remarks:

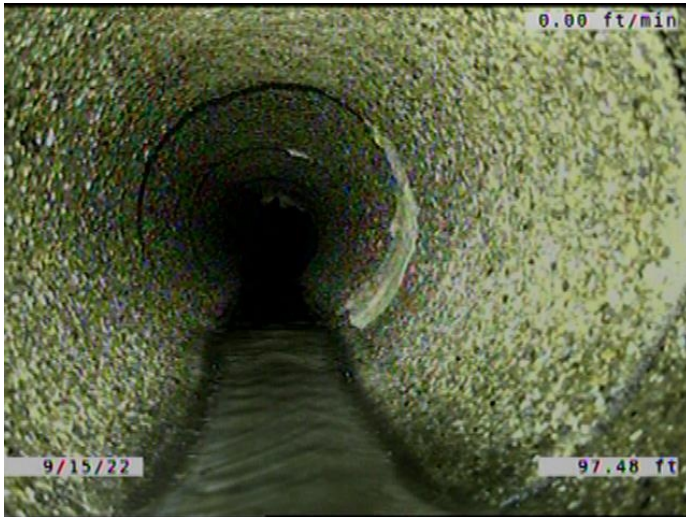
Code: **MWLS**
Description: **Miscellaneous Water Level Sag**

Distance (ft): **97.5**
Structural Grade: **2**
O&M Grade: **0**
Clock Start/From:
Clock To:
1st Value:
2nd Value:
Value Percent: **15.000**
Continuous Index: **F04**
Within 8" of Joint: **NO**
Remarks:

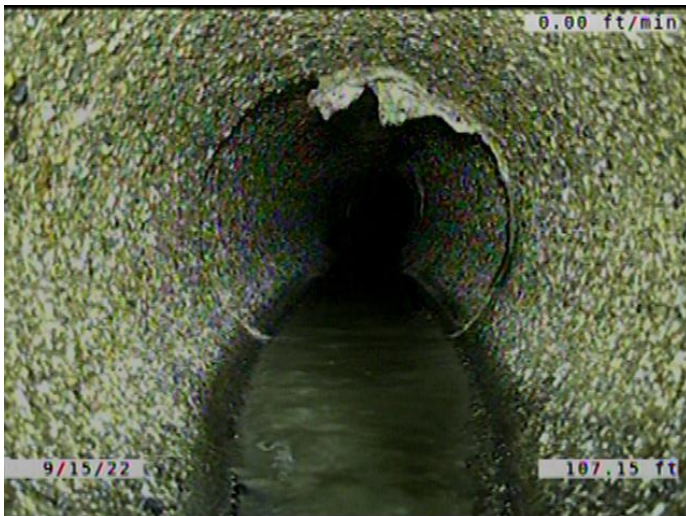
Code: **MWLS**
Description: **Miscellaneous Water Level Sag**

Distance (ft): **107.1**
Structural Grade: **2**
O&M Grade: **0**
Clock Start/From:
Clock To:
1st Value:
2nd Value:
Value Percent: **10.000**
Continuous Index: **S05**
Within 8" of Joint: **NO**
Remarks:

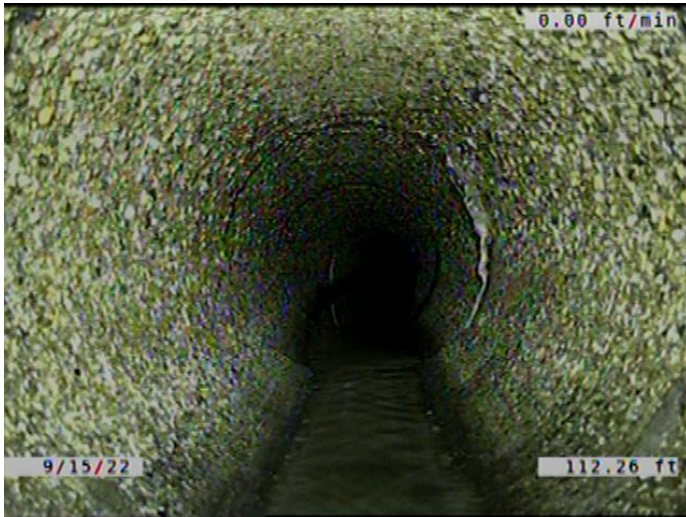
Code:	MWLS
Description:	Miscellaneous Water Level Sag
Distance (ft):	112.3
Structural Grade:	2
O&M Grade:	0
Clock Start/From:	
Clock To:	
1st Value:	
2nd Value:	
Value Percent:	10.000
Continuous Index:	F05
Within 8" of Joint:	NO
Remarks:

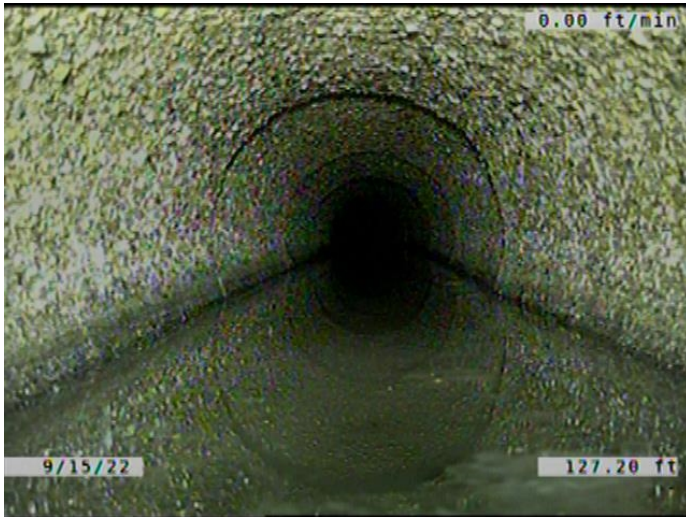
Code: **MWL**
 Description: **Miscellaneous Water Level**

Distance (ft): **127.2**
 Structural Grade: **0**
 O&M Grade: **0**
 Clock Start/From:
 Clock To:
 1st Value:
 2nd Value:
 Value Percent: **25.000**
 Continuous Index:
 Within 8" of Joint: **NO**
 Remarks:

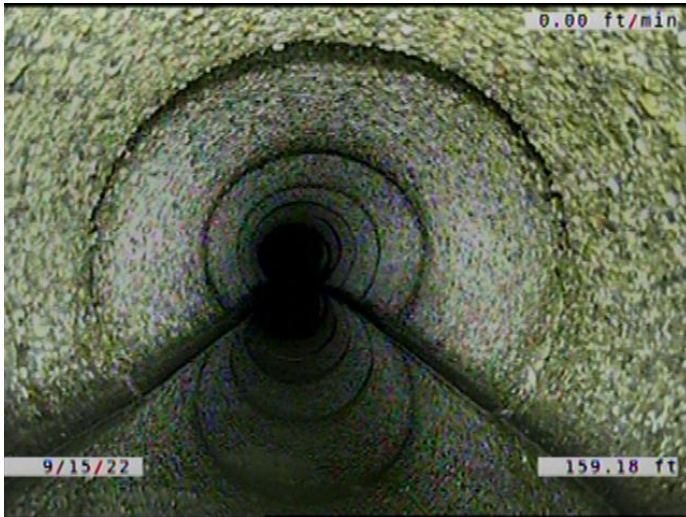
Code: **LL**
Description: **Line Left**

Distance (ft): **159.2**
Structural Grade: **0**
O&M Grade: **2**
Clock Start/From:
Clock To:
1st Value:
2nd Value:
Value Percent: **20.000**
Continuous Index: **F06**
Within 8" of Joint: **NO**
Remarks:

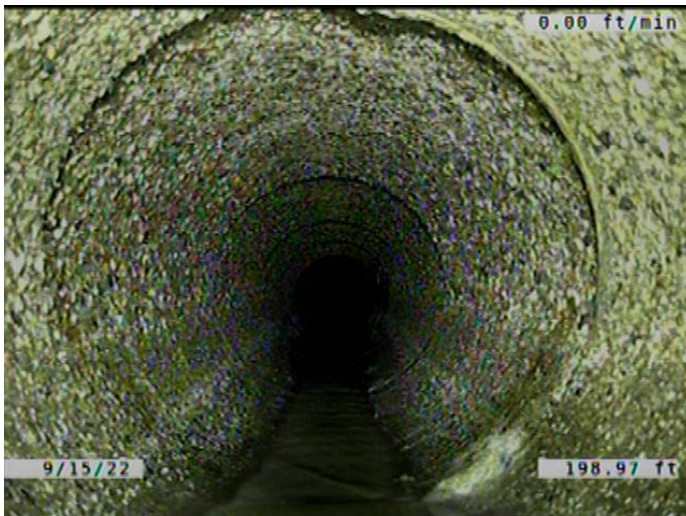
Code:	MWL
Description:	Miscellaneous Water Level
Distance (ft):	199.0
Structural Grade:	0
O&M Grade:	0
Clock Start/From:	
Clock To:	
1st Value:	
2nd Value:	
Value Percent:	5.000
Continuous Index:	
Within 8" of Joint:	NO
Remarks:

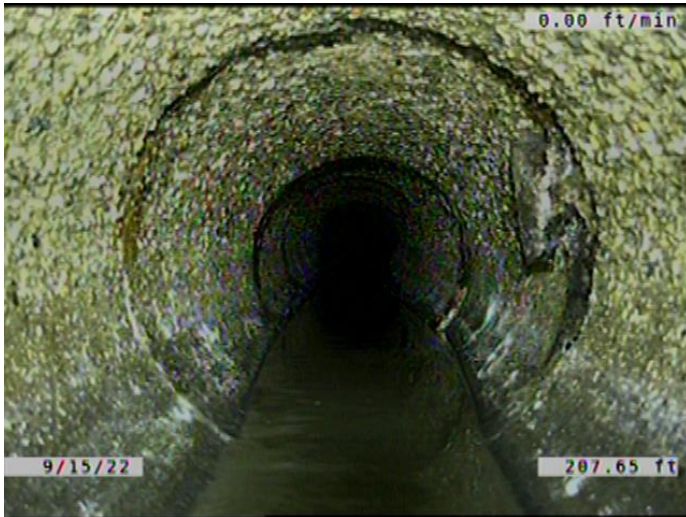
Code: **MWL**
 Description: **Miscellaneous Water Level**

Distance (ft): **207.6**
 Structural Grade: **0**
 O&M Grade: **0**
 Clock Start/From:
 Clock To:
 1st Value:
 2nd Value:
 Value Percent: **15.000**
 Continuous Index:
 Within 8" of Joint: **NO**
 Remarks:

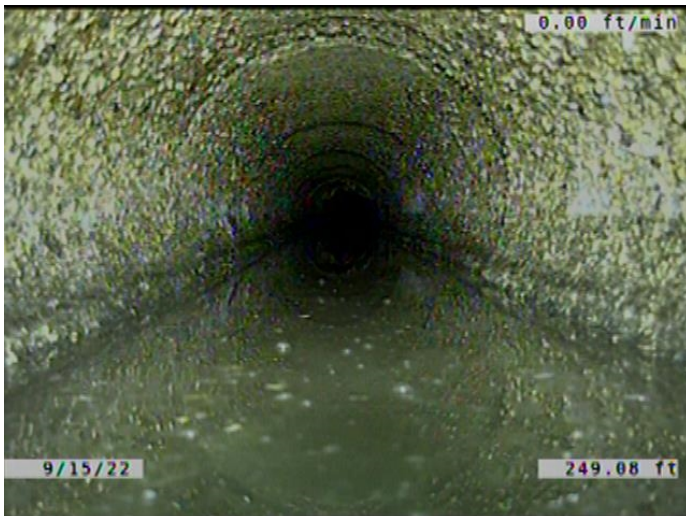
Code:	MWL
Description:	Miscellaneous Water Level
Distance (ft):	249.1
Structural Grade:	0
O&M Grade:	0
Clock Start/From:	
Clock To:	
1st Value:	
2nd Value:	
Value Percent:	25.000
Continuous Index:	
Within 8" of Joint:	NO
Remarks:

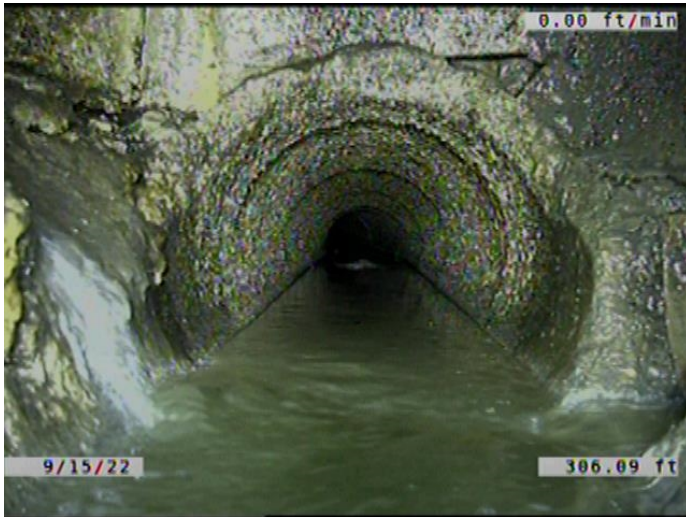
Code: **DAE**
 Description: **Deposits Attached Encrustation**

Distance (ft): **306.1**
 Structural Grade: **0**
 O&M Grade: **2**
 Clock Start/From: **7**
 Clock To: **5**
 1st Value:
 2nd Value:
 Value Percent: **5.000**
 Continuous Index: **F02**
 Within 8" of Joint: **YES**
 Remarks:
