Profile/Photo Observation Report

Date:	04/25/2018	Weather:		Coding:	PACP 6.0
Pipe Length (ft):		Owner:	City of Hobart	Pre Clean:	No Pre-Cleaning
P.O.#:	78	Surveyor:	M. Pielacha	PSR:	P-405-044-043
Customer:	City of Hobart	Clean Date:		Shape:	C

Street:	3rd Street	Flow Control:	Not Controlled
City:	Hobart, IN	Year Renewed:	
Location:	Light Highway	Tape/Media #:	DEP 78
Purpose:	Routine Assessment	Dia/Height:	15"
Use:	Sanitary	Material:	CP
Drain Area:		Lining:	
Category:	NA		
Comment:	YES501824 Submittal 2		
Location Details:		Direction of Survey:	Upstream
US MH:	M-405-044	DS MH:	M-405-043
		Total Length Surveyed (ft):	41.4

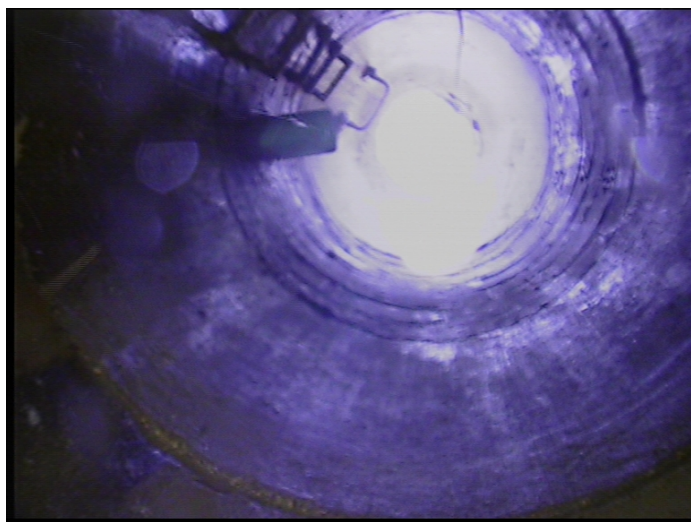
Code: **AMH**
Description: **Manhole**

Distance (ft): **.0**
Structural Grade: **0**
O&M Grade: **0**
Clock Start/From:
Clock To:
1st Value:
2nd Value:
Value Percent:
Continuous Index:
Within 8" of Joint: **NO**
Remarks: **M-405-043**

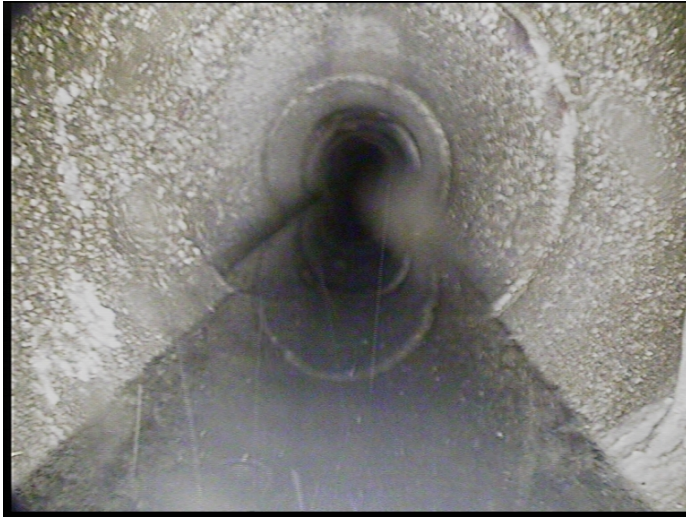
Code: **MWL**
Description: **Water Level**

Distance (ft): **.0**
Structural Grade: **0**
O&M Grade: **0**
Clock Start/From:
Clock To:
1st Value:
2nd Value:
Value Percent: **10.000**
Continuous Index:
Within 8" of Joint: **NO**
Remarks:

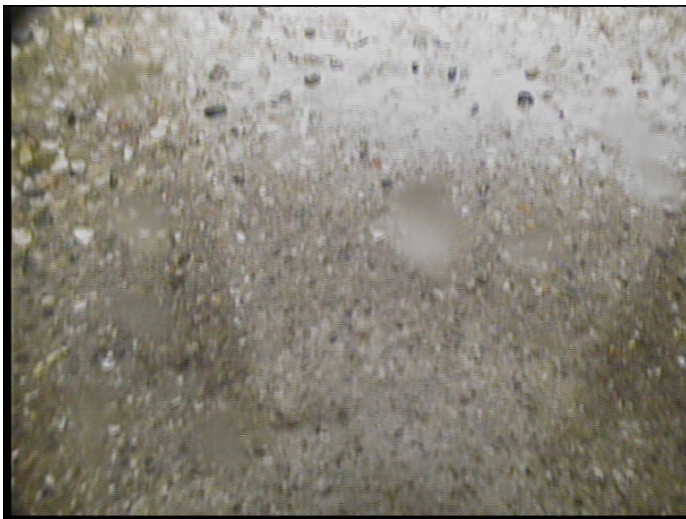
Code: **SAV**
Description: **Surface Aggregate Visible**

Distance (ft): **12.3**
Structural Grade: **3**
O&M Grade: **0**
Clock Start/From: **8**
Clock To: **4**
1st Value:
2nd Value:
Value Percent:
Continuous Index: **S01**
Within 8" of Joint: **YES**
Remarks:

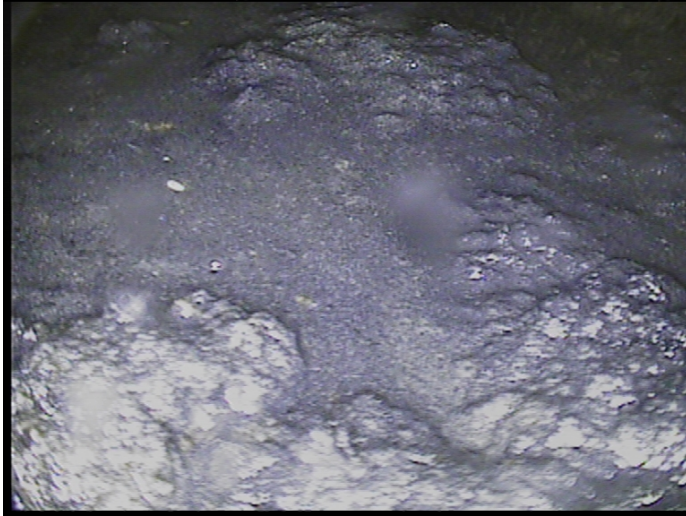
Code: **DSF**
Description: **Deposits Settled Fine**

Distance (ft): **40.5**
Structural Grade: **0**
O&M Grade: **3**
Clock Start/From: **4**
Clock To: **8**
1st Value:
2nd Value:
Value Percent: **20.000**
Continuous Index:
Within 8" of Joint: **YES**
Remarks:

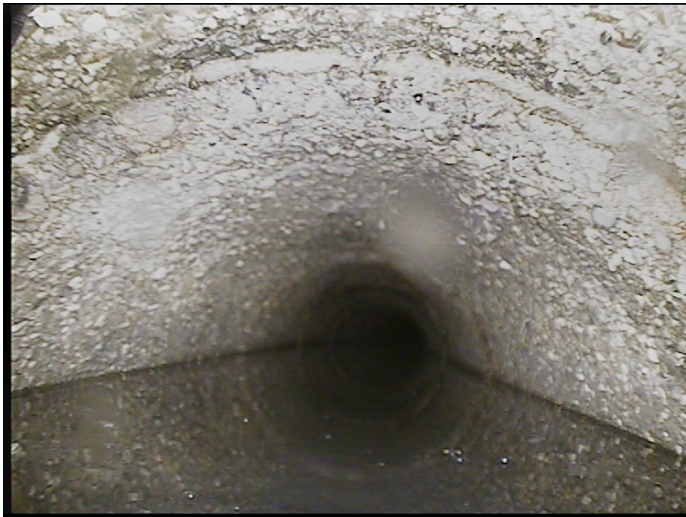
Code: **SAV**
Description: **Surface Aggregate Visible**

Distance (ft): **41.4**
Structural Grade: **3**
O&M Grade: **0**
Clock Start/From: **8**
Clock To: **4**
1st Value:
2nd Value:
Value Percent:
Continuous Index: **F01**
Within 8" of Joint: **NO**
Remarks:

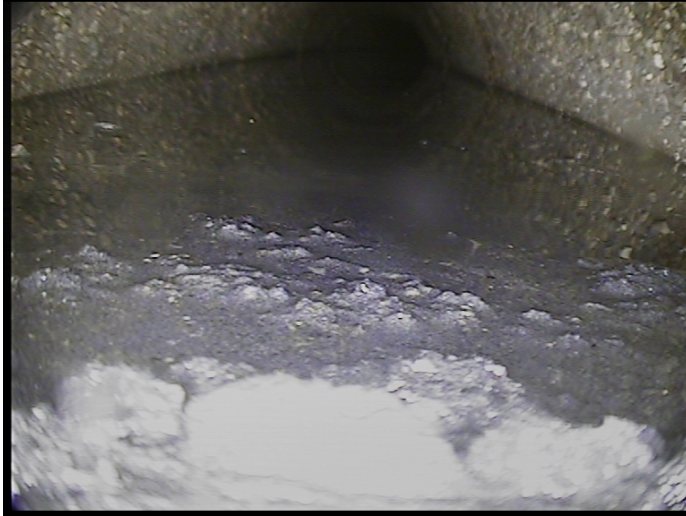
Code:	MSA
Description:	Abandoned Survey
Distance (ft):	41.4
Structural Grade:	0
O&M Grade:	0
Clock Start/From:	
Clock To:	
1st Value:	
2nd Value:	
Value Percent:	
Continuous Index:	
Within 8" of Joint:	NO
Remarks:	deep sediment
