Profile/Photo Observation Report

Date:	04/25/2018	Weather:		Coding:	PACP 6.0
Pipe Length (ft):		Owner:	City of Hobart	Pre Clean:	No Pre-Cleaning
P.O.#:	76	Surveyor:	M. Pielacha	PSR:	P-405-045-044
Customer:	City of Hobart	Clean Date:		Shape:	C

Street:	3rd Street	Flow Control:	Not Controlled
City:	Hobart, IN	Year Renewed:	
Location:	Light Highway	Tape/Media #:	DEP 76
Purpose:	Routine Assessment	Dia/Height:	15"
Use:	Sanitary	Material:	CP
Drain Area:		Lining:	
Category:	NA		
Comment:	YES501824 Submittal 2		
Location Details:		Direction of Survey:	Upstream
US MH:	M-405-045	DS MH:	M-405-044
		Total Length Surveyed (ft):	11.1

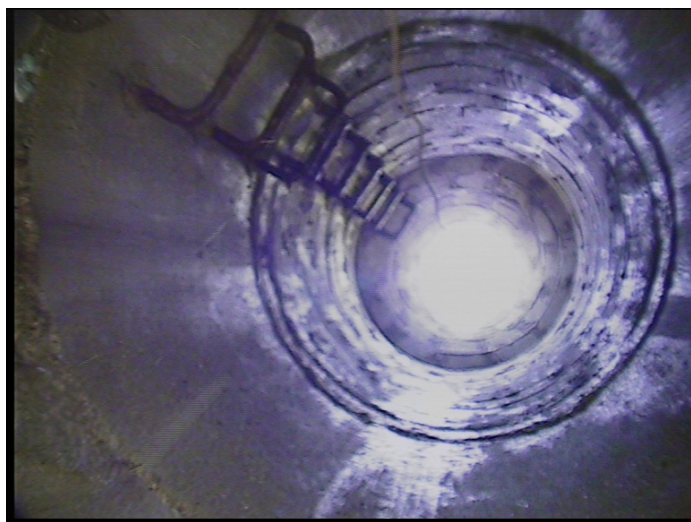
Code: **AMH**
Description: **Manhole**

Distance (ft): **.0**
Structural Grade: **0**
O&M Grade: **0**
Clock Start/From:
Clock To:
1st Value:
2nd Value:
Value Percent:
Continuous Index:
Within 8" of Joint: **NO**
Remarks: **M-405-044**

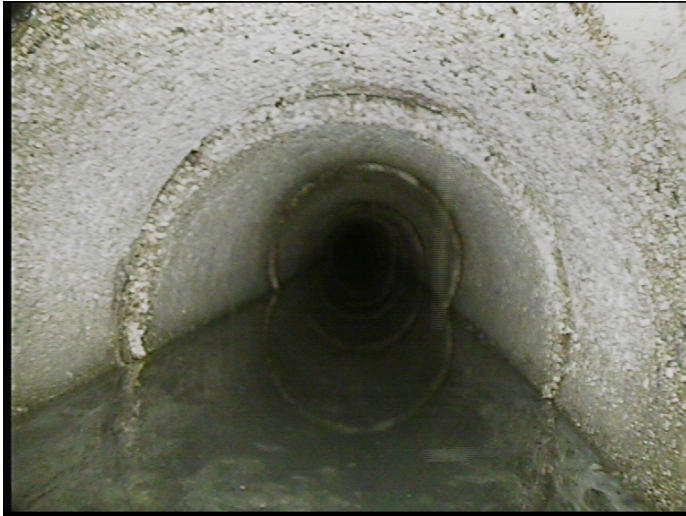
Code: **MWL**
Description: **Water Level**

Distance (ft): **.0**
Structural Grade: **0**
O&M Grade: **0**
Clock Start/From:
Clock To:
1st Value:
2nd Value:
Value Percent: **10.000**
Continuous Index:
Within 8" of Joint: **NO**
Remarks:

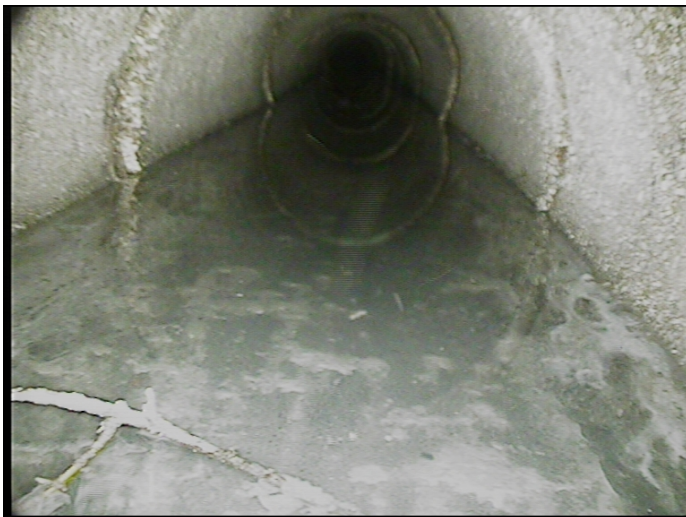
Code: **DSF**
Description: **Deposits Settled Fine**

Distance (ft): **.0**
Structural Grade: **0**
O&M Grade: **3**
Clock Start/From: **5**
Clock To: **7**
1st Value:
2nd Value:
Value Percent: **15.000**
Continuous Index: **S01**
Within 8" of Joint: **YES**
Remarks:

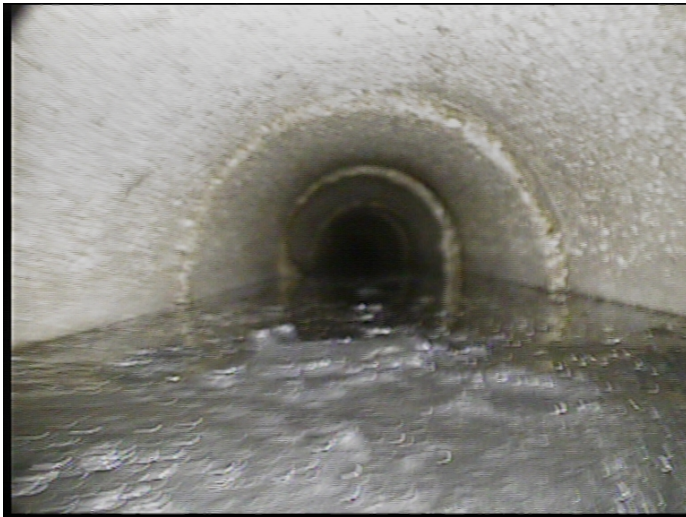
Code: **DSF**
Description: **Deposits Settled Fine**

Distance (ft): **11.1**
Structural Grade: **0**
O&M Grade: **3**
Clock Start/From: **5**
Clock To: **7**
1st Value:
2nd Value:
Value Percent: **15.000**
Continuous Index: **F01**
Within 8" of Joint: **NO**
Remarks:

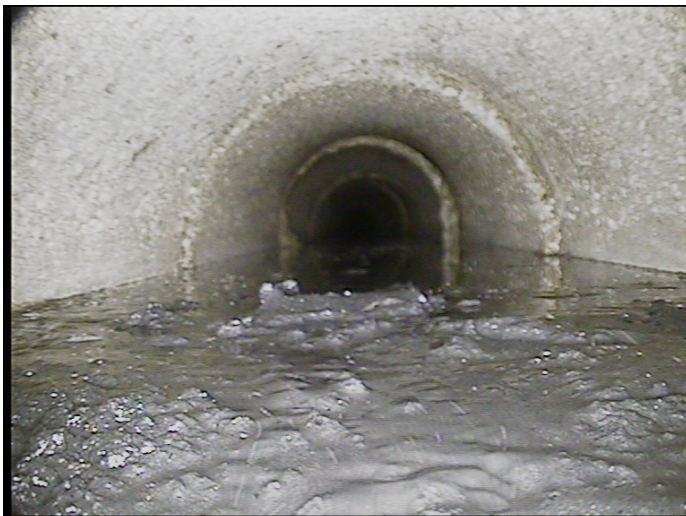
Code: **MSA**
Description: **Abandoned Survey**

Distance (ft): **11.1**
Structural Grade: **0**
O&M Grade: **0**
Clock Start/From:
Clock To:
1st Value:
2nd Value:
Value Percent:
Continuous Index:
Within 8" of Joint: **NO**
Remarks: **Deep sediment**
