Profile/Photo Observation Report

Street:	OFF W 3RD ST	Flow Control:	Not Controlled
City:	Hobart, IN	Year Renewed:	
Location:	Yard	Tape/Media #:	
Purpose:	Routine Assessment	Dia/Height:	12"
Use:	Sanitary	Material:	VCP
Drain Area:	NA	Lining:	
Category:	NA		
Comment:

Location Details:		Direction of Survey:	Downstream
US MH:	M-405-049	DS MH:	M-405-050
		Total Length Surveyed (ft):	173.2

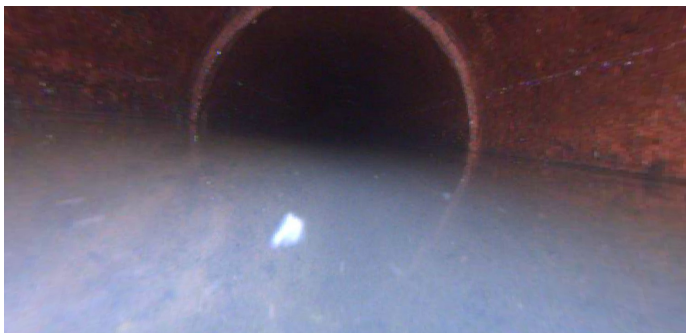
Code: **AMH**
Description: **Manhole**

Distance (ft): **.0**
Structural Grade: **0**
O&M Grade: **0**
Clock Start/From:
Clock To:
1st Value:
2nd Value:
Value Percent:
Continuous Index:
Within 8" of Joint: **NO**
Remarks: **M-405-049**

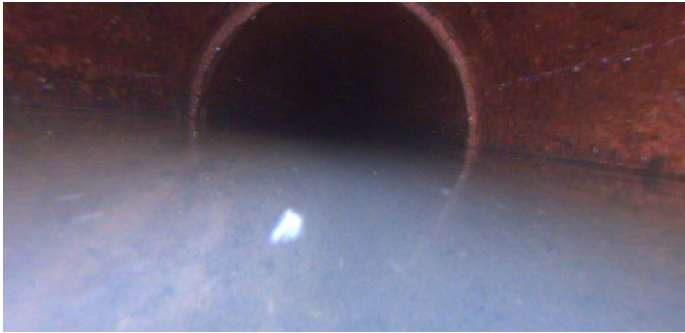
Code:	MWL
Description:	Water Level

Distance (ft):	.0
Structural Grade:	0
O&M Grade:	0
Clock Start/From:	
Clock To:	
1st Value:	
2nd Value:	
Value Percent:	5.000
Continuous Index:	
Within 8" of Joint:	NO
Remarks:

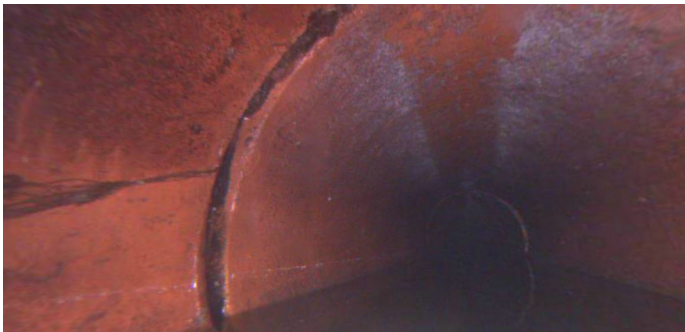
Code:	RFJ
Description:	Roots Fine Joint

Distance (ft):	47.5
Structural Grade:	0
O&M Grade:	1
Clock Start/From:	9
Clock To:	
1st Value:	
2nd Value:	
Value Percent:	
Continuous Index:	
Within 8" of Joint:	YES
Remarks:

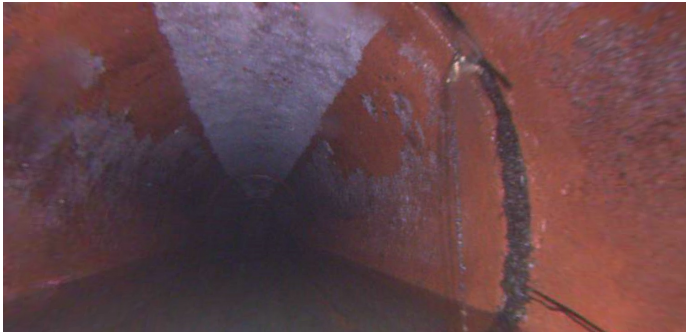
Code: **RFJ**
Description: **Roots Fine Joint**

Distance (ft): **62.8**
Structural Grade: **0**
O&M Grade: **1**
Clock Start/From: **2**
Clock To: **4**
1st Value:
2nd Value:
Value Percent:
Continuous Index:
Within 8" of Joint: **YES**
Remarks:

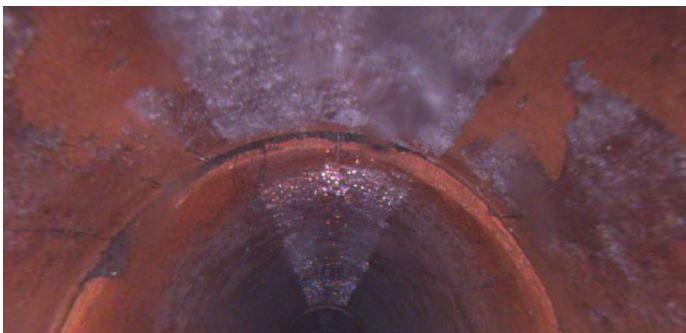
Code: **RFJ**
Description: **Roots Fine Joint**

Distance (ft): **65.6**
Structural Grade: **0**
O&M Grade: **1**
Clock Start/From: **10**
Clock To: **2**
1st Value:
2nd Value:
Value Percent:
Continuous Index:
Within 8" of Joint: **YES**
Remarks:

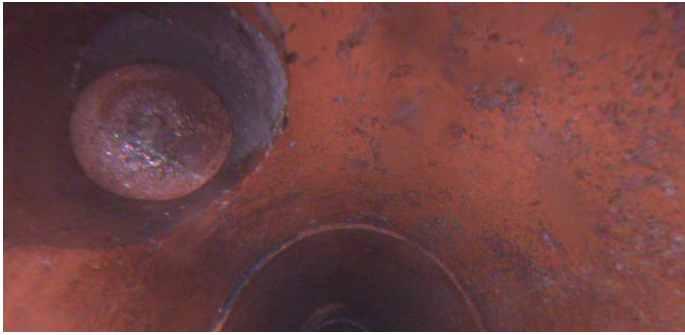
Code: **TFC**
Description: **Tap Factory Capped**

Distance (ft): **79.3**
Structural Grade: **0**
O&M Grade: **0**
Clock Start/From: **10**
Clock To:
1st Value: **4.000**
2nd Value:
Value Percent:
Continuous Index:
Within 8" of Joint:
Remarks:

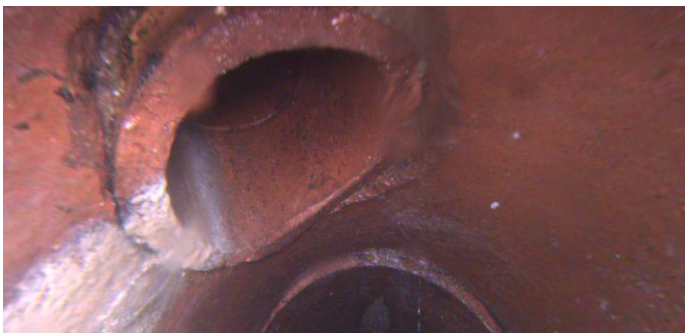
Code: **TBI**
Description: **Tap Break-in Intruding**

Distance (ft): **82.2**
Structural Grade: **0**
O&M Grade: **2**
Clock Start/From: **11**
Clock To:
1st Value: **4.000**
2nd Value: **1.000**
Value Percent:
Continuous Index:
Within 8" of Joint:
Remarks:

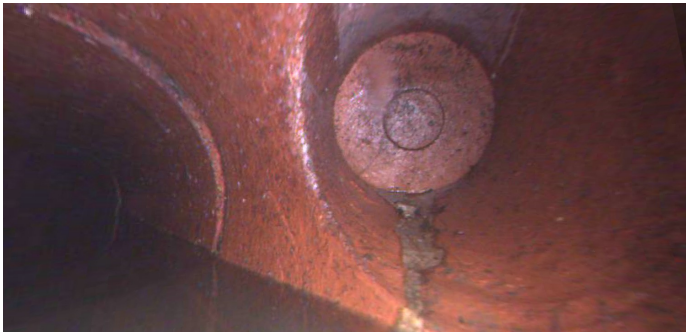
Code: **TFC**
Description: **Tap Factory Capped**

Distance (ft): **84.6**
Structural Grade: **0**
O&M Grade: **0**
Clock Start/From: **3**
Clock To:
1st Value: **4.000**
2nd Value:
Value Percent:
Continuous Index:
Within 8" of Joint:
Remarks:

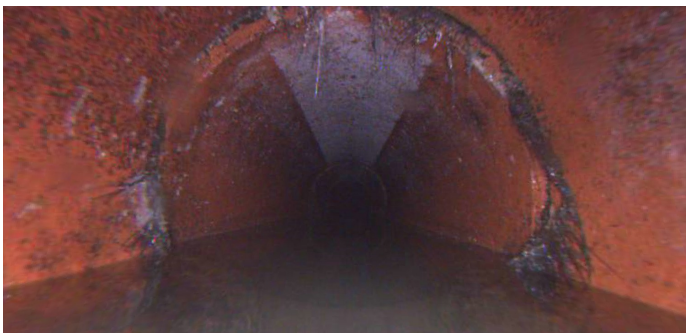
Code: **RFJ**
Description: **Roots Fine Joint**

Distance (ft): **115.2**
Structural Grade: **0**
O&M Grade: **1**
Clock Start/From: **8**
Clock To: **4**
1st Value:
2nd Value:
Value Percent:
Continuous Index:
Within 8" of Joint: **YES**
Remarks:

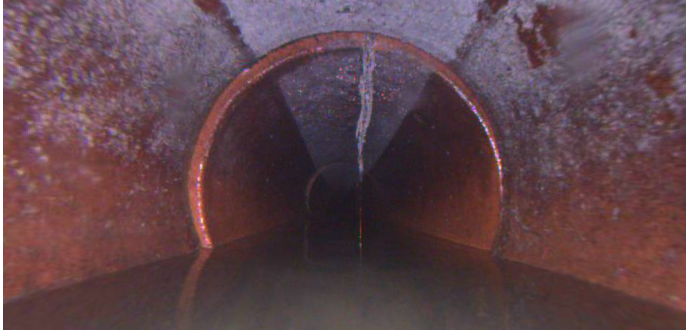
Code: **RFJ**
Description: **Roots Fine Joint**

Distance (ft): **133.5**
Structural Grade: **0**
O&M Grade: **1**
Clock Start/From: **12**
Clock To:
1st Value:
2nd Value:
Value Percent:
Continuous Index:
Within 8" of Joint: **YES**
Remarks:

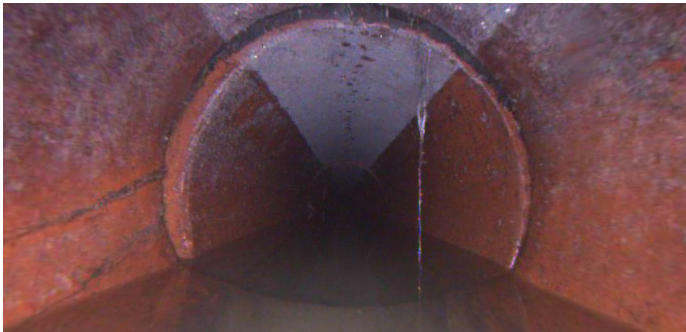
Code: **RFJ**
Description: **Roots Fine Joint**

Distance (ft): **136.7**
Structural Grade: **0**
O&M Grade: **1**
Clock Start/From: **8**
Clock To: **4**
1st Value:
2nd Value:
Value Percent:
Continuous Index:
Within 8" of Joint: **YES**
Remarks:

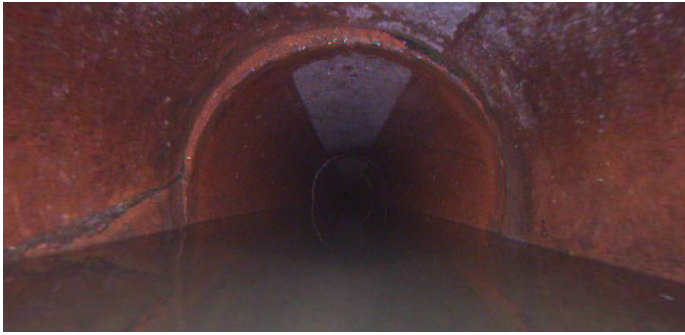
Code: **RFJ**
Description: **Roots Fine Joint**

Distance (ft): **154.9**
Structural Grade: **0**
O&M Grade: **1**
Clock Start/From: **9**
Clock To:
1st Value:
2nd Value:
Value Percent:
Continuous Index:
Within 8" of Joint: **YES**
Remarks:

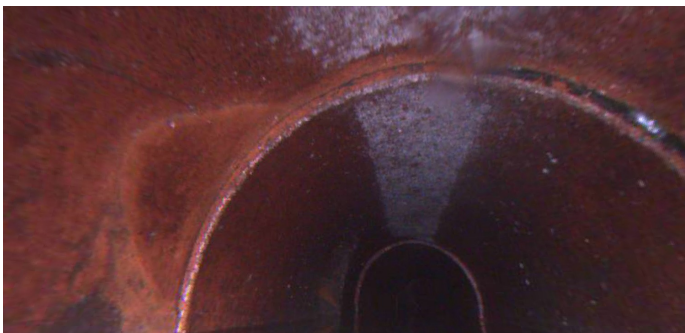
Code: **FC**
Description: **Fracture Circumferential**

Distance (ft): **170.5**
Structural Grade: **2**
O&M Grade: **0**
Clock Start/From: **8**
Clock To: **11**
1st Value:
2nd Value:
Value Percent:
Continuous Index:
Within 8" of Joint: **YES**
Remarks:

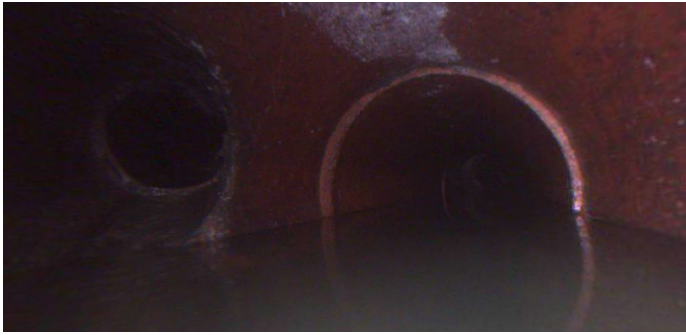
Code: **TF**
Description: **Tap Factory**

Distance (ft): **171.9**
Structural Grade: **0**
O&M Grade: **0**
Clock Start/From: **9**
Clock To:
1st Value: **4.000**
2nd Value:
Value Percent:
Continuous Index:
Within 8" of Joint:
Remarks:

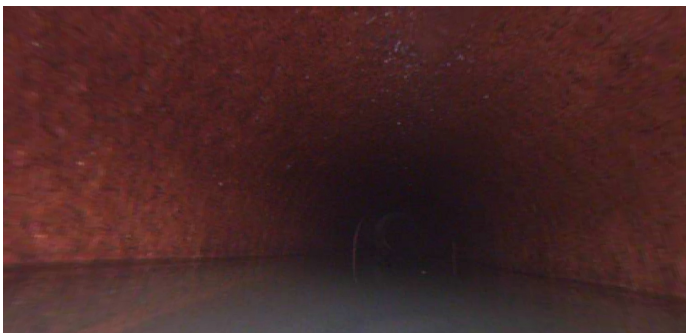
Code: **AMH**
Description: **Manhole**

Distance (ft): **173.2**
Structural Grade: **0**
O&M Grade: **0**
Clock Start/From:
Clock To:
1st Value:
2nd Value:
Value Percent:
Continuous Index:
Within 8" of Joint: **NO**
Remarks: **M-405-050**
