Profile/Photo Observation Report

| Street: | FOXCROFT STREET | Flow Control: | Not Controlled |
| City: | Hobart, IN | Year Renewed: | |

| US MH: | M-405-049 | DS MH: | M-405-050 |

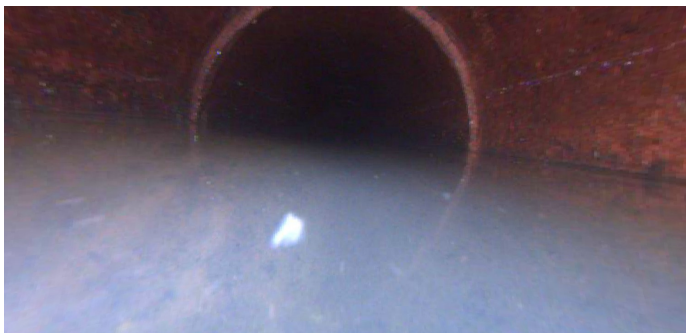
Code: **AMH**
Description: **Manhole**

Distance (ft): **.0**
Structural Grade: **0**
O&M Grade: **0**
Clock Start/From:
Clock To:
1st Value:
2nd Value:
Value Percent:
Continuous Index:
Within 8" of Joint: **NO**
Remarks: **M-405-049**

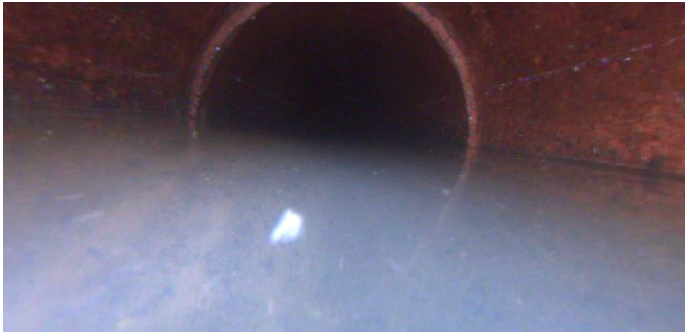
| Code: | MWL |
| Description: | Water Level |

| Distance (ft): | .0 |
| Value Percent: | 5.000 |

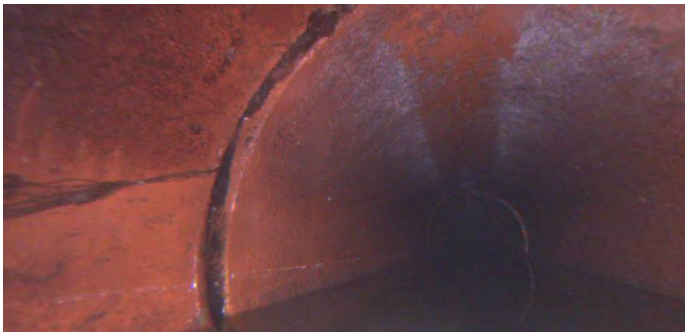
| Code: | RFJ |
| Description: | Roots Fine Joint |

| Distance (ft): | 47.5 |
| O&M Grade: | 1 |
| Clock Start/From: | 9 |
| Within 8" of Joint: | YES |

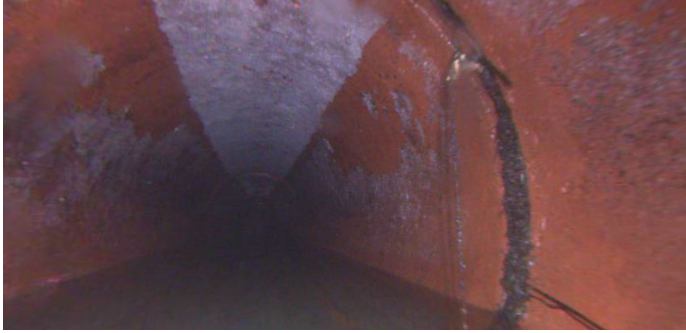
Code: **RFJ**
Description: **Roots Fine Joint**

Distance (ft): **62.8**
Structural Grade: **0**
O&M Grade: **1**
Clock Start/From: **2**
Clock To: **4**
1st Value:
2nd Value:
Value Percent:
Continuous Index:
Within 8" of Joint: **YES**
Remarks:

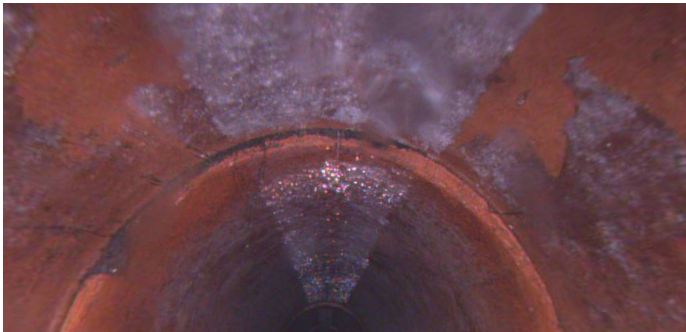
Code: **RFJ**
Description: **Roots Fine Joint**

Distance (ft): **65.6**
Structural Grade: **0**
O&M Grade: **1**
Clock Start/From: **10**
Clock To: **2**
1st Value:
2nd Value:
Value Percent:
Continuous Index:
Within 8" of Joint: **YES**
Remarks:

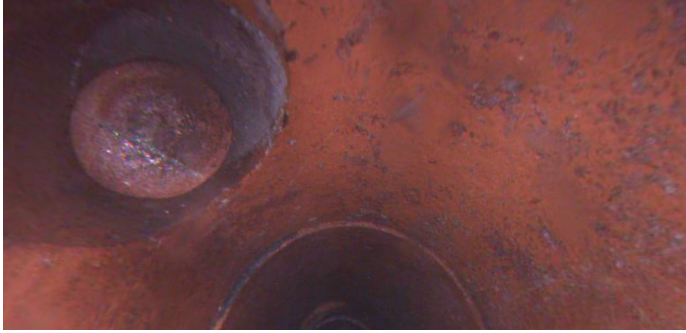
Code: **TFC**
Description: **Tap Factory Capped**

Distance (ft): **79.3**
Structural Grade: **0**
O&M Grade: **0**
Clock Start/From: **10**
Clock To:
1st Value: **4.000**
2nd Value:
Value Percent:
Continuous Index:
Within 8" of Joint:
Remarks:

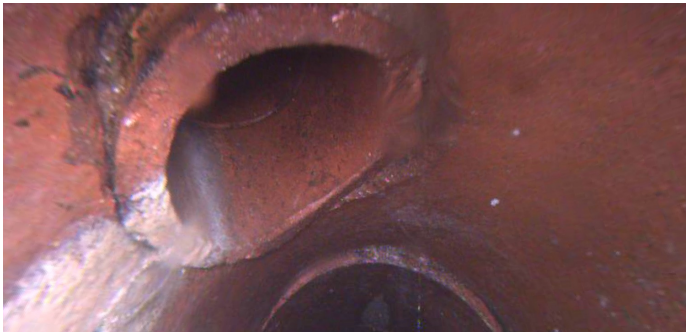
Code: **TBI**
Description: **Tap Break-in Intruding**

Distance (ft): **82.2**
Structural Grade: **0**
O&M Grade: **2**
Clock Start/From: **11**
Clock To:
1st Value: **4.000**
2nd Value: **1.000**
Value Percent:
Continuous Index:
Within 8" of Joint:
Remarks:

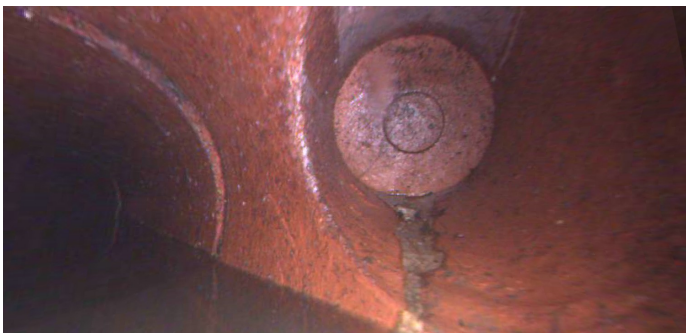
Code: **TFC**
Description: **Tap Factory Capped**

Distance (ft): **84.6**
Structural Grade: **0**
O&M Grade: **0**
Clock Start/From: **3**
Clock To:
1st Value: **4.000**
2nd Value:
Value Percent:
Continuous Index:
Within 8" of Joint:
Remarks:

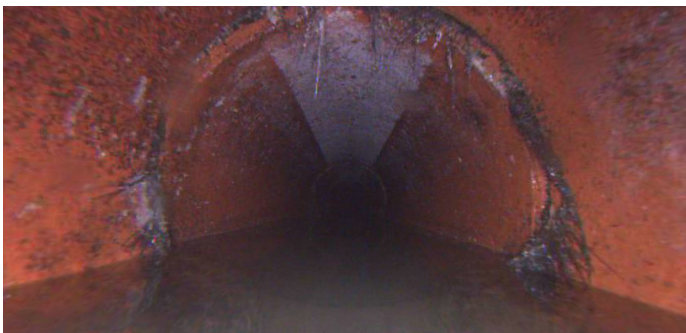
Code: **RFJ**
Description: **Roots Fine Joint**

Distance (ft): **115.2**
Structural Grade: **0**
O&M Grade: **1**
Clock Start/From: **8**
Clock To: **4**
1st Value:
2nd Value:
Value Percent:
Continuous Index:
Within 8" of Joint: **YES**
Remarks:

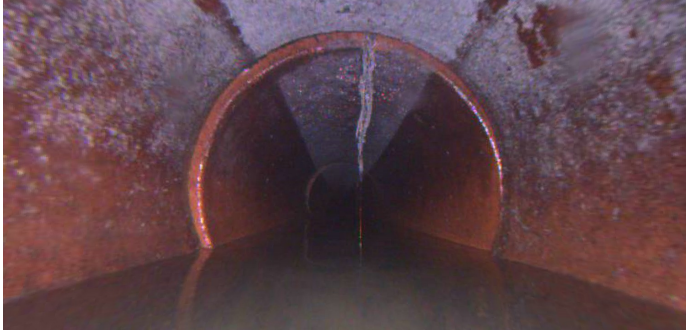
Code: **RFJ**
Description: **Roots Fine Joint**

Distance (ft): **133.5**
Structural Grade: **0**
O&M Grade: **1**
Clock Start/From: **12**
Clock To:
1st Value:
2nd Value:
Value Percent:
Continuous Index:
Within 8" of Joint: **YES**
Remarks:

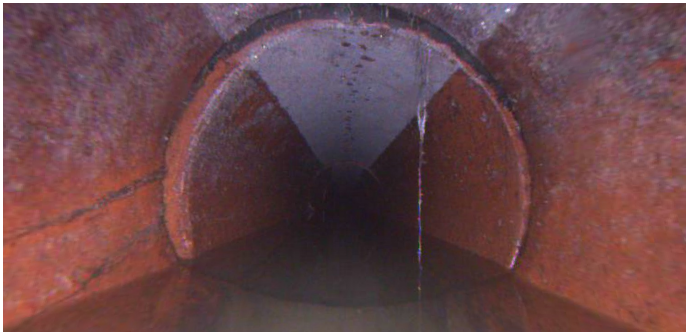
Code: **RFJ**
Description: **Roots Fine Joint**

Distance (ft): **136.7**
Structural Grade: **0**
O&M Grade: **1**
Clock Start/From: **8**
Clock To: **4**
1st Value:
2nd Value:
Value Percent:
Continuous Index:
Within 8" of Joint: **YES**
Remarks:

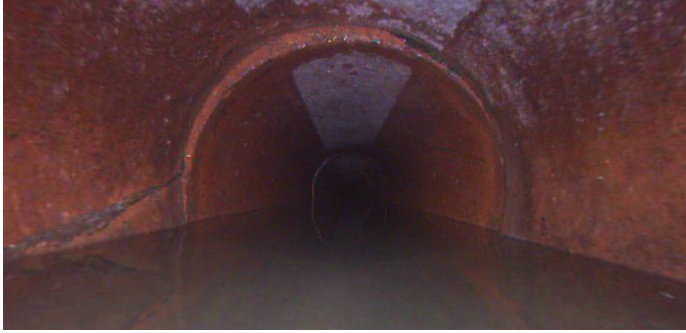
Code: **RFJ**
Description: **Roots Fine Joint**

Distance (ft): **154.9**
Structural Grade: **0**
O&M Grade: **1**
Clock Start/From: **9**
Clock To:
1st Value:
2nd Value:
Value Percent:
Continuous Index:
Within 8" of Joint: **YES**
Remarks:

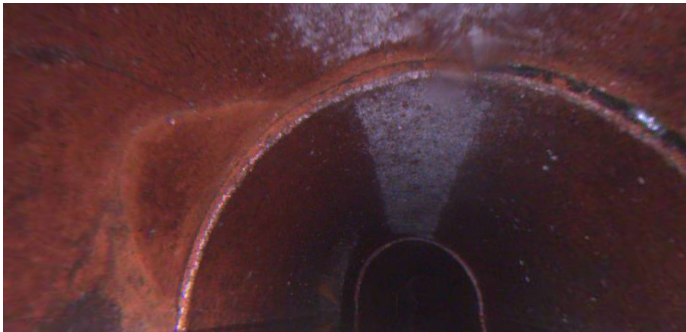
Code: **FC**
Description: **Fracture Circumferential**

Distance (ft): **170.5**
Structural Grade: **2**
O&M Grade: **0**
Clock Start/From: **8**
Clock To: **11**
1st Value:
2nd Value:
Value Percent:
Continuous Index:
Within 8" of Joint: **YES**
Remarks:

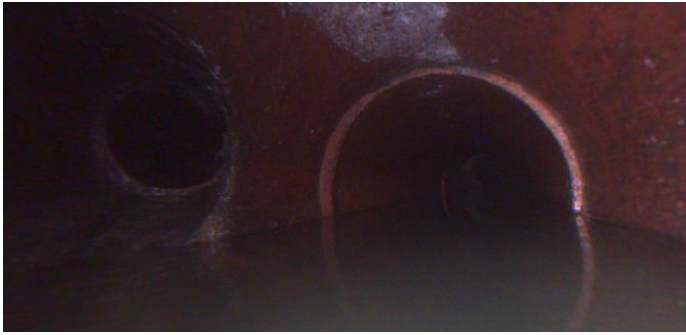
Code: **TF**
Description: **Tap Factory**

Distance (ft): **171.9**
Structural Grade: **0**
O&M Grade: **0**
Clock Start/From: **9**
Clock To:
1st Value: **4.000**
2nd Value:
Value Percent:
Continuous Index:
Within 8" of Joint:
Remarks:

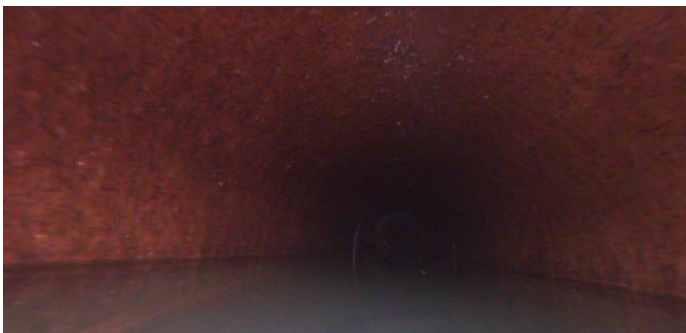
Code: **AMH**
Description: **Manhole**

Distance (ft): **173.2**
Structural Grade: **0**
O&M Grade: **0**
Clock Start/From:
Clock To:
1st Value:
2nd Value:
Value Percent:
Continuous Index:
Within 8" of Joint: **NO**
Remarks: **M-405-050**
