Profile/Photo Observation Report

Date:	04/16/2018	Weather:		Coding:	PACP 6.0
Pipe Length (ft):	172.9	Owner:	NA	Pre Clean:	No Pre-Cleaning
P.O.#:		Surveyor:	Mark Ruby	PSR:	P-405-050-049
Customer:		Clean Date:	01/01/1900	Shape:	C

Street:	OFF W 3RD ST	Flow Control:	Not Controlled
City:	Hobart, IN	Year Renewed:	
Location:	Yard	Tape/Media #:	
Purpose:	Routine Assessment	Dia/Height:	12"
Use:	Sanitary	Material:	VCP
Drain Area:	NA	Lining:	
Category:	NA		
Comment:	Flow direction is marked wrong.		
Location Details:		Direction of Survey:	Downstream
US MH:	M-405-049	DS MH:	M-405-050
		Total Length Surveyed (ft):	180.2

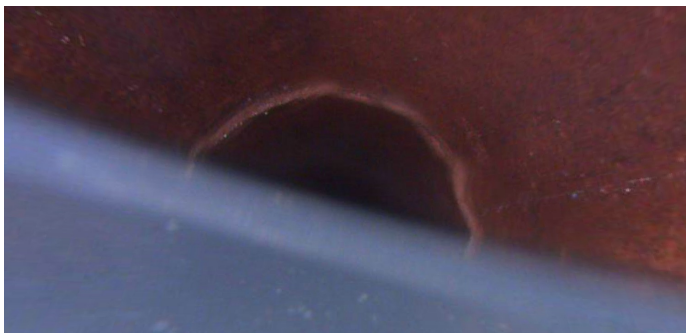
Code: **AMH**
Description: **Manhole**

Distance (ft): **.0**
Structural Grade: **0**
O&M Grade: **0**
Clock Start/From:
Clock To:
1st Value:
2nd Value:
Value Percent:
Continuous Index:
Within 8" of Joint: **NO**
Remarks: **M-405-049**

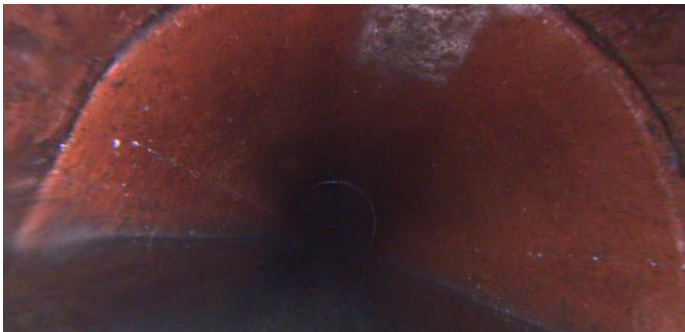
Code:	MWL
Description:	Water Level

Distance (ft):	4.6
Structural Grade:	0
O&M Grade:	0
Clock Start/From:	
Clock To:	
1st Value:	
2nd Value:	
Value Percent:	20.000
Continuous Index:	
Within 8" of Joint:	NO
Remarks:

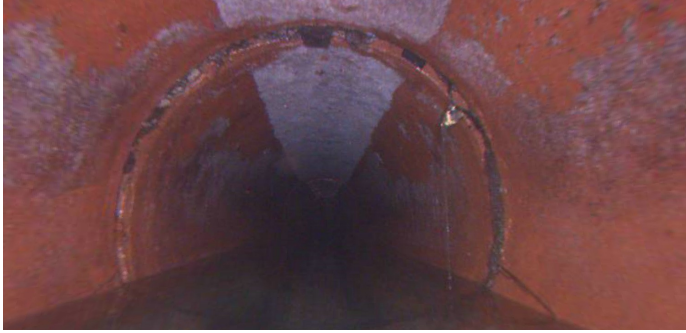
Code: **RFJ**
Description: **Roots Fine Joint**

Distance (ft): **62.3**
Structural Grade: **0**
O&M Grade: **1**
Clock Start/From: **2**
Clock To:
1st Value:
2nd Value:
Value Percent:
Continuous Index:
Within 8" of Joint: **YES**
Remarks:

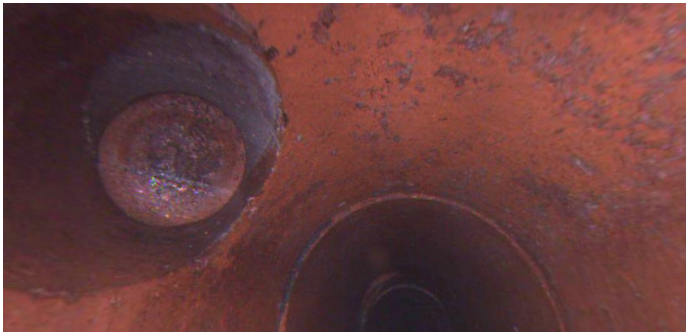
Code: **TFC**
Description: **Tap Factory Capped**

Distance (ft): **79.1**
Structural Grade: **0**
O&M Grade: **0**
Clock Start/From: **10**
Clock To:
1st Value: **4.000**
2nd Value:
Value Percent:
Continuous Index:
Within 8" of Joint:
Remarks:

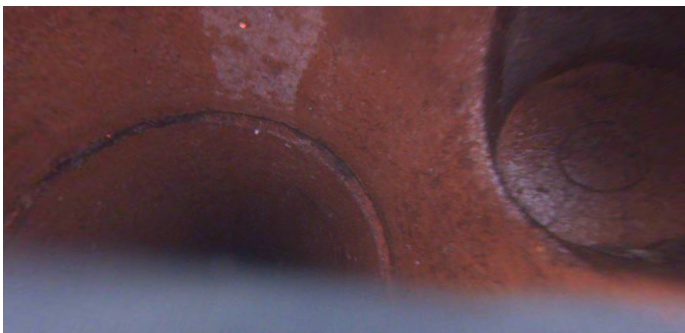
Code: **TFC**
Description: **Tap Factory Capped**

Distance (ft): **84.6**
Structural Grade: **0**
O&M Grade: **0**
Clock Start/From: **3**
Clock To:
1st Value: **4.000**
2nd Value:
Value Percent:
Continuous Index:
Within 8" of Joint:
Remarks:

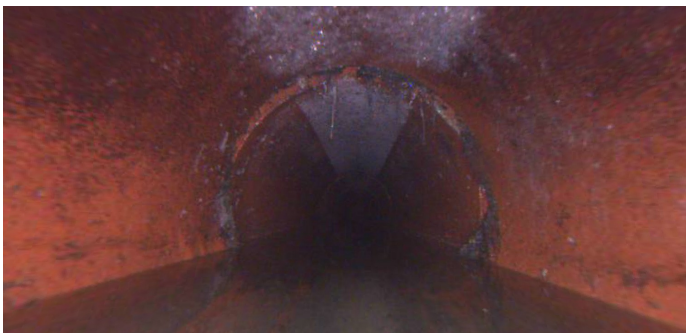
Code: **RFJ**
Description: **Roots Fine Joint**

Distance (ft): **115.0**
Structural Grade: **0**
O&M Grade: **1**
Clock Start/From: **7**
Clock To: **5**
1st Value:
2nd Value:
Value Percent:
Continuous Index:
Within 8" of Joint: **YES**
Remarks:

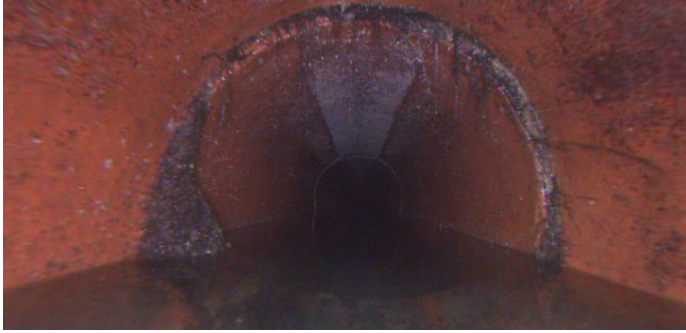
Code: **RFJ**
Description: **Roots Fine Joint**

Distance (ft): **118.4**
Structural Grade: **0**
O&M Grade: **1**
Clock Start/From: **7**
Clock To: **5**
1st Value:
2nd Value:
Value Percent:
Continuous Index:
Within 8" of Joint: **YES**
Remarks:

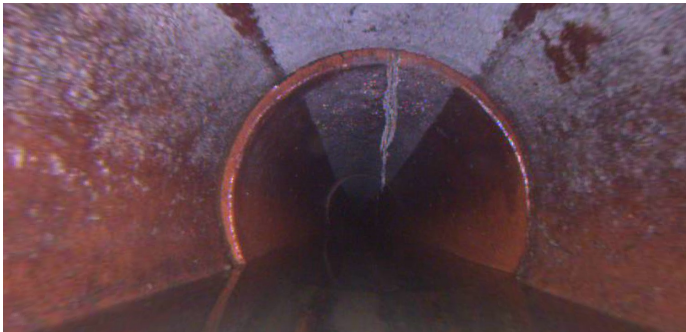
Code: **RFJ**
Description: **Roots Fine Joint**

Distance (ft): **133.5**
Structural Grade: **0**
O&M Grade: **1**
Clock Start/From: **12**
Clock To:
1st Value:
2nd Value:
Value Percent:
Continuous Index:
Within 8" of Joint: **YES**
Remarks:

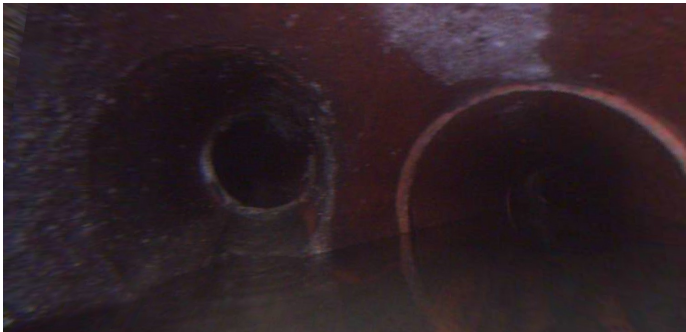
Code: **TF**
Description: **Tap Factory**

Distance (ft): **172.0**
Structural Grade: **0**
O&M Grade: **0**
Clock Start/From: **8**
Clock To:
1st Value: **4.000**
2nd Value:
Value Percent:
Continuous Index:
Within 8" of Joint:
Remarks:

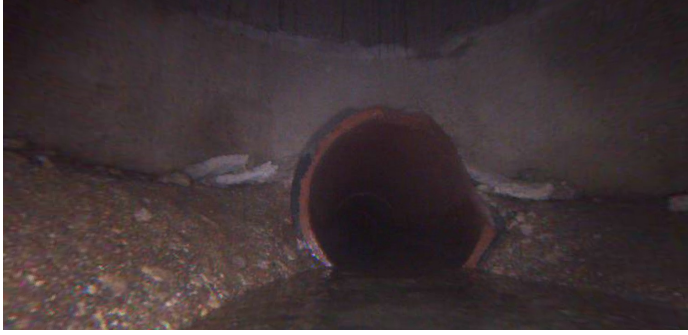
Code:	AMH
Description:	Manhole
Distance (ft):	180.2
Structural Grade:	0
O&M Grade:	0
Clock Start/From:	
Clock To:	
1st Value:	
2nd Value:	
Value Percent:	
Continuous Index:	
Within 8" of Joint:	NO
Remarks:	M-405-050
