Profile/Photo Observation Report

Street:	OAKWOOD DR	Flow Control:	Not Controlled
City:	Hobart, IN	Year Renewed:	
Location:	Yard	Tape/Media #:	
Purpose:	Routine Assessment	Dia/Height:	12"
Use:	Sanitary	Material:	VCP
Drain Area:	NA	Lining:	
Category:	NA		
Comment:	.P_C at 24 ft debris . Flow direction wrong		
Location Details:		Direction of Survey:	Upstream
US MH:	M-405-050	DS MH:	M-405-051
		Total Length Surveyed (ft):	25.9

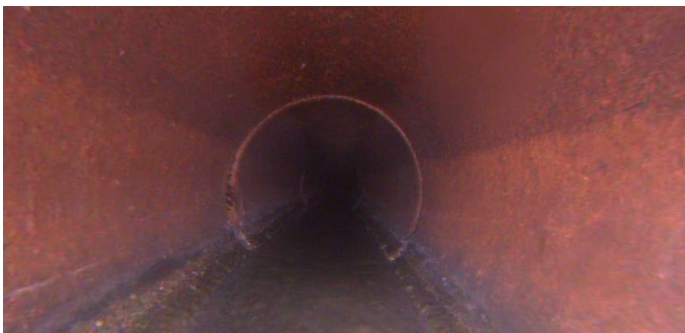
Code: **AMH**
Description: **Manhole**

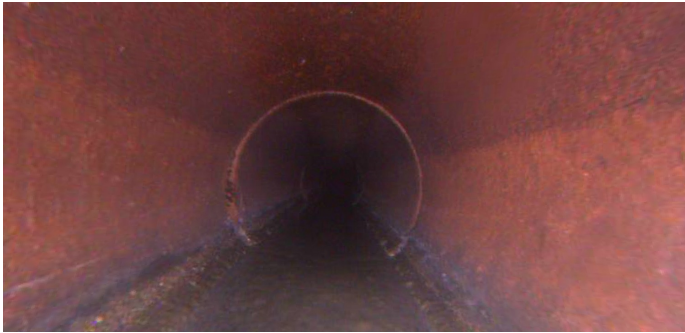
Code:	MWL
Description:	Water Level

Distance (ft):	.0
Structural Grade:	0
O&M Grade:	0
Clock Start/From:	
Clock To:	
1st Value:	
2nd Value:	
Value Percent:	5.000
Continuous Index:	
Within 8" of Joint:	NO
Remarks:

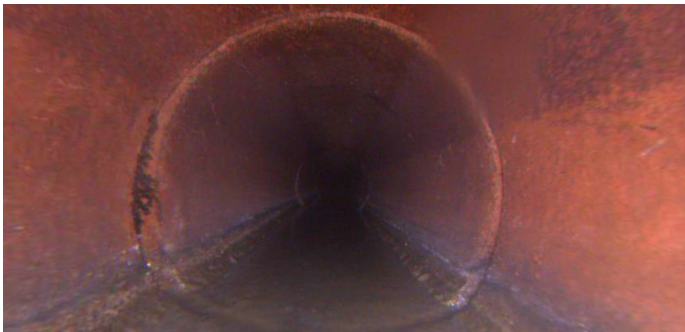
Code:	RFJ
Description:	Roots Fine Joint

Distance (ft):	1.8
Structural Grade:	0
O&M Grade:	1
Clock Start/From:	8
Clock To:	9
1st Value:	
2nd Value:	
Value Percent:	
Continuous Index:	
Within 8" of Joint:	YES
Remarks:

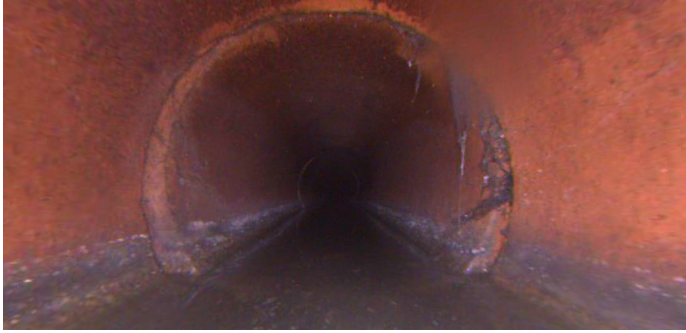
Code: **RFJ**
Description: **Roots Fine Joint**

Distance (ft): **4.9**
Structural Grade: **0**
O&M Grade: **1**
Clock Start/From: **8**
Clock To: **4**
1st Value:
2nd Value:
Value Percent:
Continuous Index: **S01**
Within 8" of Joint: **YES**
Remarks:

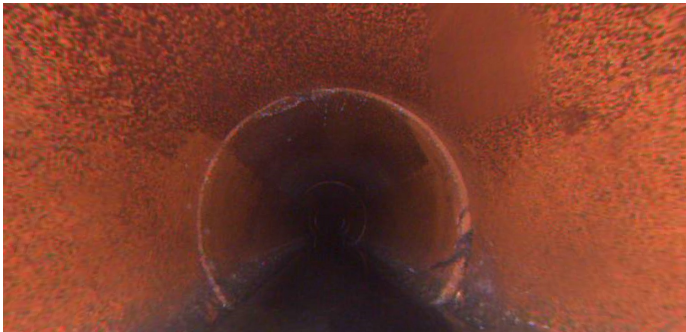
Code: **MSA**
Description: **Abandoned Survey**

Distance (ft): **25.9**
Structural Grade: **0**
O&M Grade: **0**
Clock Start/From:
Clock To:
1st Value:
2nd Value:
Value Percent:
Continuous Index:
Within 8" of Joint: **NO**
Remarks: **UNKNOWN**

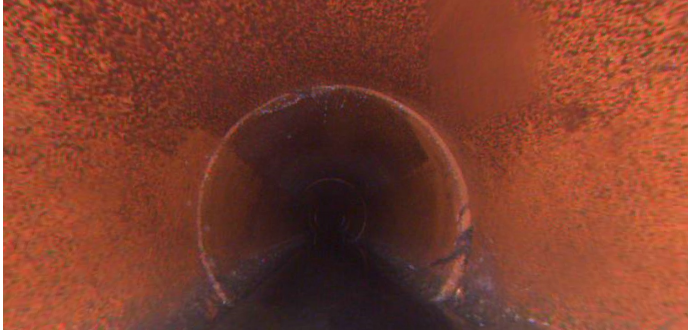
Code:	RFJ
Description:	Roots Fine Joint
Distance (ft):	25.9
Structural Grade:	0
O&M Grade:	1
Clock Start/From:	8
Clock To:	4
1st Value:	
2nd Value:	
Value Percent:	
Continuous Index:	F01
Within 8" of Joint:	YES
Remarks:
