## Profile/Photo Observation Report

Date:	<b>04/23/2018</b>	Weather:		Coding:	<b>PACP 6.0</b>
Pipe Length (ft):	<b>333.1</b>	Owner:	<b>NA</b>	Pre Clean:	<b>No Pre-Cleaning</b>
P.O.#:		Surveyor:	<b>Jen Costello</b>	PSR:	<b>P-405-051-050</b>
Customer:		Clean Date:	<b>01/01/1900</b>	Shape:	<b>C</b>

Street:	<b>FOXCROFT STREET</b>	Flow Control:	<b>Not Controlled</b>
City:	<b>Hobart, IN</b>	Year Renewed:	
Location:	<b>Yard</b>	Tape/Media #:	
Purpose:	<b>Routine Assessment</b>	Dia/Height:	<b>12"</b>
Use:	<b>Sanitary</b>	Material:	<b>VCP</b>
Drain Area:	<b>NA</b>	Lining:	
Category:	<b>NA</b>		
Comment:	<b>.P_C at 24 ft debris . Flow direction wrong</b>		
Location Details:		Direction of Survey:	<b>Upstream</b>
US MH:	<b>M-405-050</b>	DS MH:	<b>M-405-051</b>
		Total Length Surveyed (ft):	<b>25.9</b>

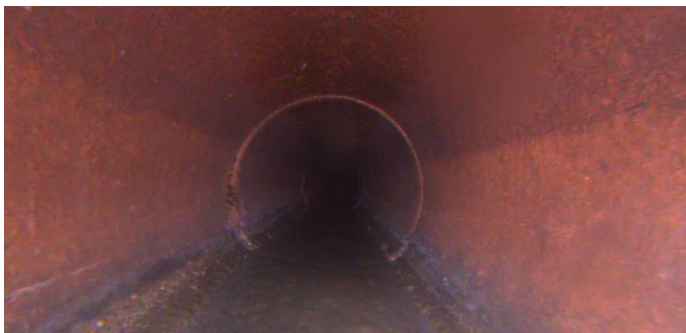
Code: **AMH**  
Description: **Manhole**

Distance (ft): **.0**  
Structural Grade: **0**  
O&M Grade: **0**  
Clock Start/From:  
Clock To:  
1st Value:  
2nd Value:  
Value Percent:  
Continuous Index:  
Within 8" of Joint: **NO**  
Remarks: **M-405-051**

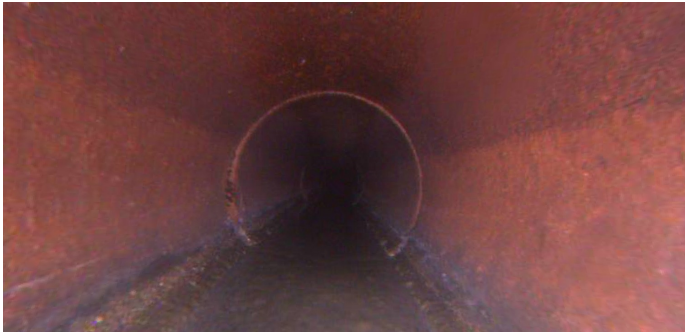
Code:	<b>MWL</b>
Description:	<b>Water Level</b>

Distance (ft):	<b>.0</b>
Structural Grade:	<b>0</b>
O&M Grade:	<b>0</b>
Clock Start/From:	
Clock To:	
1st Value:	
2nd Value:	
Value Percent:	<b>5.000</b>
Continuous Index:	
Within 8" of Joint:	<b>NO</b>
Remarks:

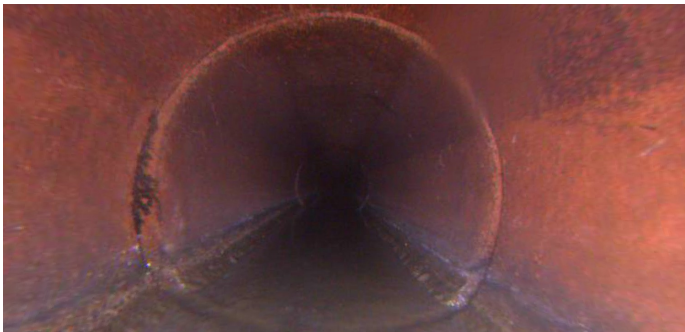
Code:	<b>RFJ</b>
Description:	<b>Roots Fine Joint</b>

Distance (ft):	<b>1.8</b>
Structural Grade:	<b>0</b>
O&M Grade:	<b>1</b>
Clock Start/From:	<b>8</b>
Clock To:	<b>9</b>
1st Value:	
2nd Value:	
Value Percent:	
Continuous Index:	
Within 8" of Joint:	<b>YES</b>
Remarks:

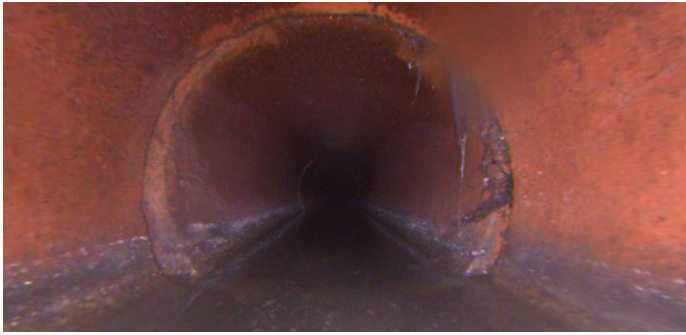
Code: **RFJ**  
Description: **Roots Fine Joint**

Distance (ft): **4.9**  
Structural Grade: **0**  
O&M Grade: **1**  
Clock Start/From: **8**  
Clock To: **4**  
1st Value:  
2nd Value:  
Value Percent:  
Continuous Index: **S01**  
Within 8" of Joint: **YES**  
Remarks:
