RedZone
ROBOTICS

Street:	W 3RD ST		Flow Control:	Not Controlled	
City:	Hobart, IN		Year Renewed:		
Location:	Easement/Right of Way		Tape/Media #:		
Purpose:	Sewer System Evaluation Survey (SS		Dia/Height:	12"	
Use:	Sanitary Sewage Pipe		Material:	VCP	
Drain Area:			Lining:	None	
Category:	NA				
Comment:					
Location Details:			Direction of Survey:	Downstream	
US MH:	M-405-050	DS MH:	M-405-051	Total Length Surveyed (ft):	330.7

Friday, April 26, 2024

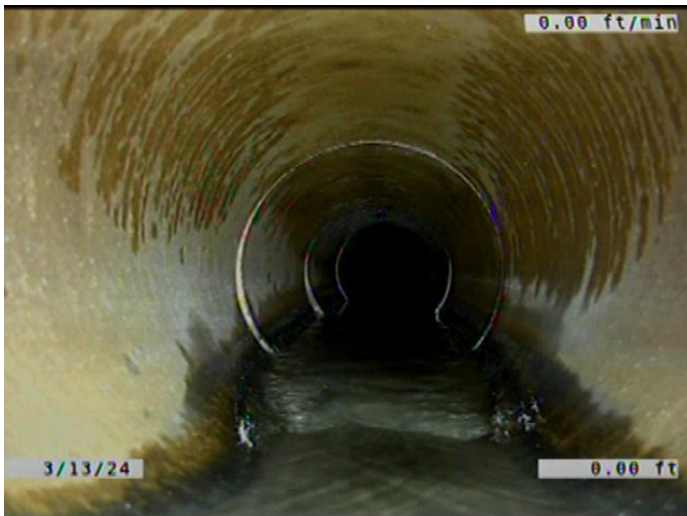
Code: **MWL**
Description: **Miscellaneous Water Level**

Distance (ft): **.0**
Structural Grade: **0**
O&M Grade: **0**
Clock Start/From:
Clock To:
1st Value:
2nd Value:
Value Percent: **5.000**
Continuous Index:
Within 8" of Joint: **NO**
Remarks:

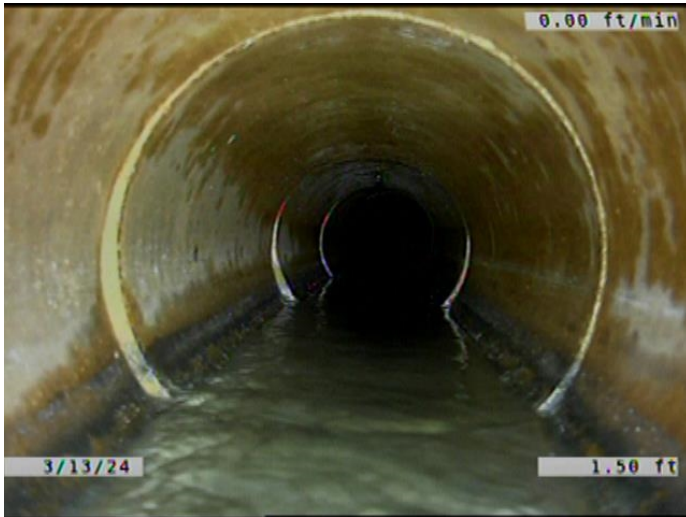
Code: **MWLS**
Description: **Miscellaneous Water Level Sag**

Distance (ft): **1.5**
Structural Grade: **2**
O&M Grade: **0**
Clock Start/From:
Clock To:
1st Value:
2nd Value:
Value Percent: **20.000**
Continuous Index: **S01**
Within 8" of Joint: **NO**
Remarks:

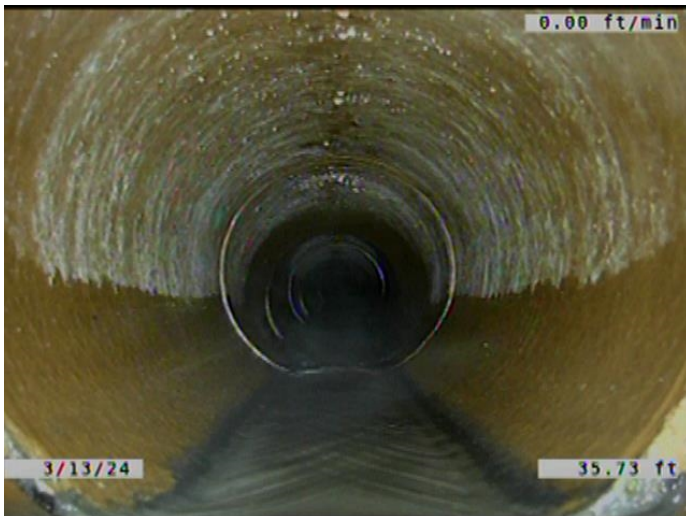
Code: **MWLS**
Description: **Miscellaneous Water Level Sag**

Distance (ft): **35.7**
Structural Grade: **2**
O&M Grade: **0**
Clock Start/From:
Clock To:
1st Value:
2nd Value:
Value Percent: **20.000**
Continuous Index: **F01**
Within 8" of Joint: **NO**
Remarks:

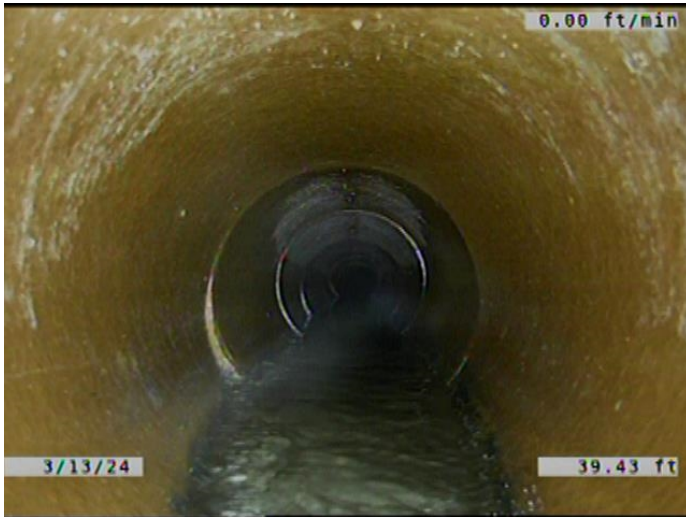
Code: **MWLS**
Description: **Miscellaneous Water Level Sag**

Distance (ft): **39.4**
Structural Grade: **2**
O&M Grade: **0**
Clock Start/From:
Clock To:
1st Value:
2nd Value:
Value Percent: **10.000**
Continuous Index: **S02**
Within 8" of Joint: **NO**
Remarks:

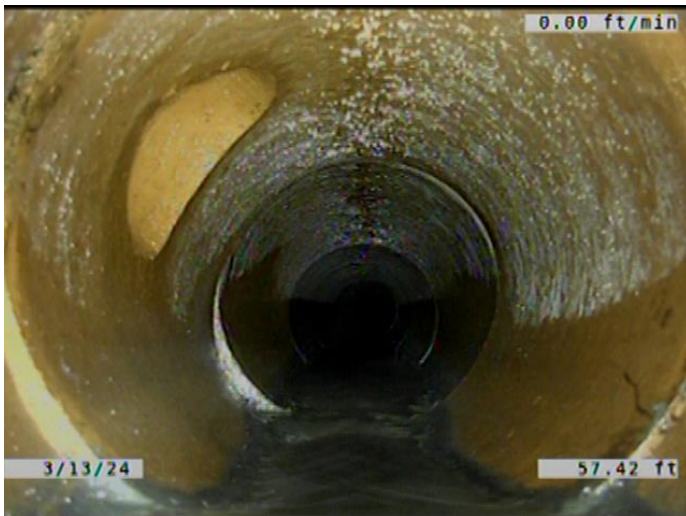
Code: **MWLS**
Description: **Miscellaneous Water Level Sag**

Distance (ft): **57.4**
Structural Grade: **2**
O&M Grade: **0**
Clock Start/From:
Clock To:
1st Value:
2nd Value:
Value Percent: **10.000**
Continuous Index: **F02**
Within 8" of Joint: **NO**
Remarks:

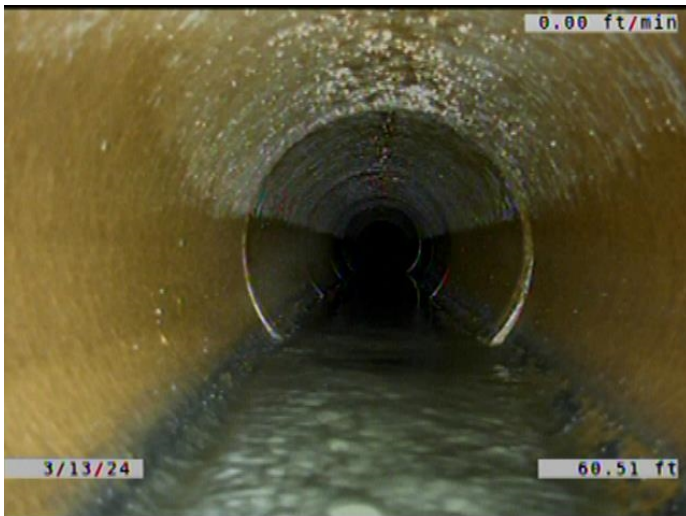
Code: **MWLS**
Description: **Miscellaneous Water Level Sag**

Distance (ft): **60.5**
Structural Grade: **2**
O&M Grade: **0**
Clock Start/From:
Clock To:
1st Value:
2nd Value:
Value Percent: **10.000**
Continuous Index: **S03**
Within 8" of Joint: **NO**
Remarks:

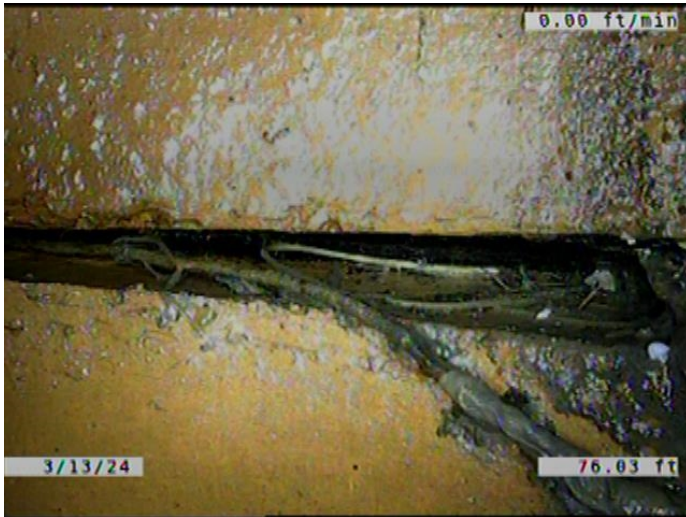
Code: **RFJ**
Description: **Roots Fine Joint**

Distance (ft): **76.0**
Structural Grade: **0**
O&M Grade: **1**
Clock Start/From: **2**
Clock To: **4**
1st Value:
2nd Value:
Value Percent:
Continuous Index:
Within 8" of Joint: **YES**
Remarks:

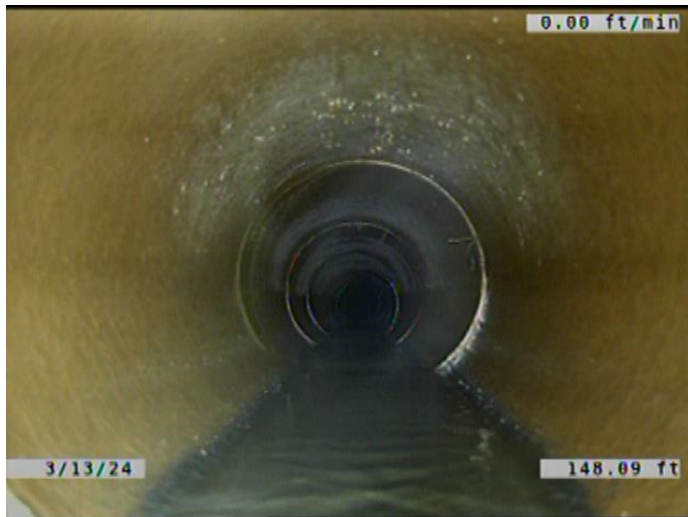
Code: **MWLS**
Description: **Miscellaneous Water Level Sag**

Distance (ft): **148.1**
Structural Grade: **2**
O&M Grade: **0**
Clock Start/From:
Clock To:
1st Value:
2nd Value:
Value Percent: **15.000**
Continuous Index: **F04**
Within 8" of Joint: **NO**
Remarks:

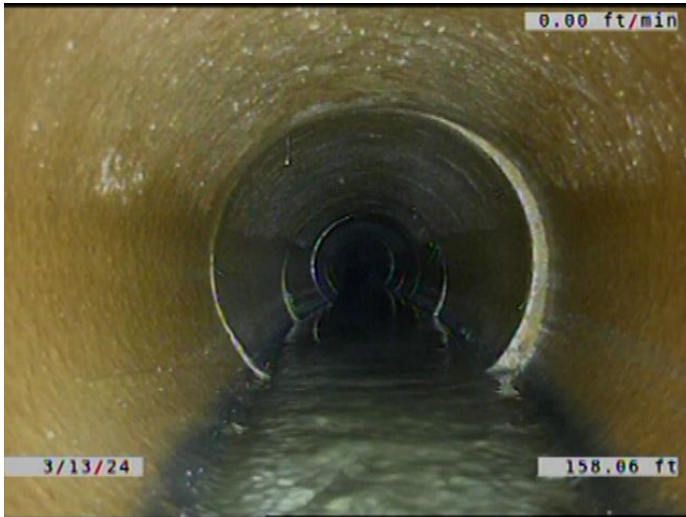
Code: **MWLS**
Description: **Miscellaneous Water Level Sag**

Distance (ft): **158.1**
Structural Grade: **2**
O&M Grade: **0**
Clock Start/From:
Clock To:
1st Value:
2nd Value:
Value Percent: **15.000**
Continuous Index: **S06**
Within 8" of Joint: **NO**
Remarks:

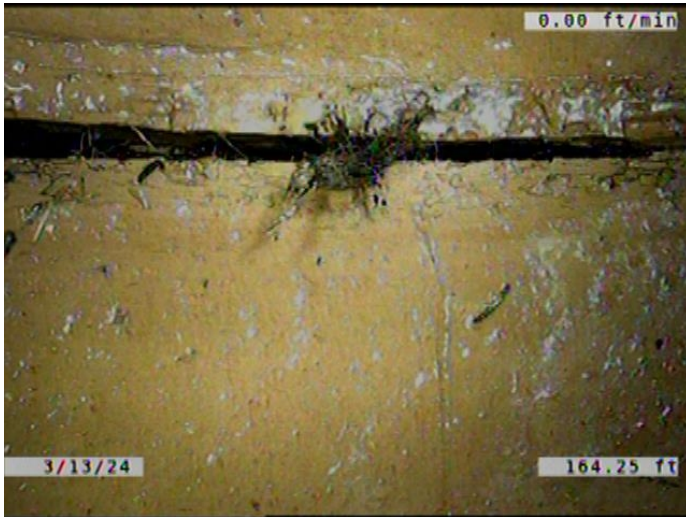
Code: **IDJ**
 Description: **Infiltration Dripper Joint**

Distance (ft): **164.2**
 Structural Grade: **0**
 O&M Grade: **3**
 Clock Start/From: **10**
 Clock To: **11**
 1st Value:
 2nd Value:
 Value Percent:
 Continuous Index:
 Within 8" of Joint: **YES**
 Remarks:

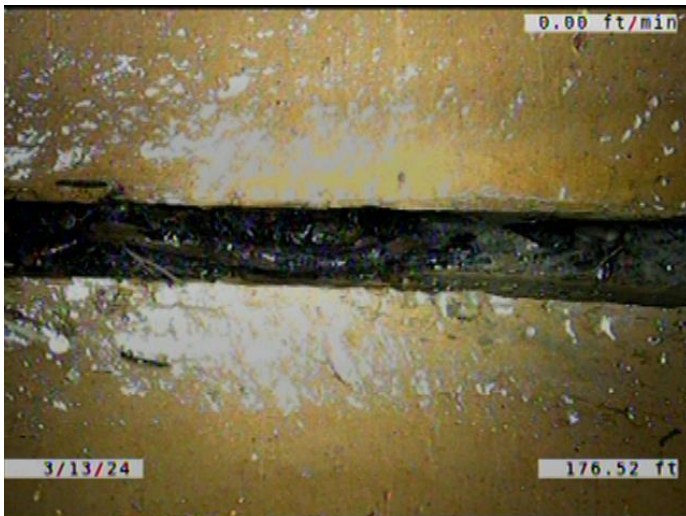
Code: **IRJ**
 Description: **Infiltration Runner Joint**

Distance (ft): **176.5**
 Structural Grade: **0**
 O&M Grade: **4**
 Clock Start/From: **1**
 Clock To:
 1st Value:
 2nd Value:
 Value Percent:
 Continuous Index:
 Within 8" of Joint: **YES**
 Remarks:

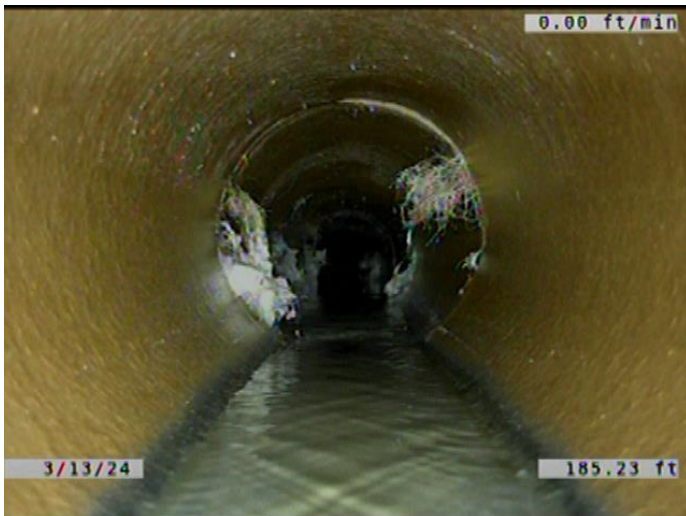
Code: **MWLS**
Description: **Miscellaneous Water Level Sag**

Distance (ft): **185.2**
Structural Grade: **2**
O&M Grade: **0**
Clock Start/From:
Clock To:
1st Value:
2nd Value:
Value Percent: **15.000**
Continuous Index: **F06**
Within 8" of Joint: **NO**
Remarks:

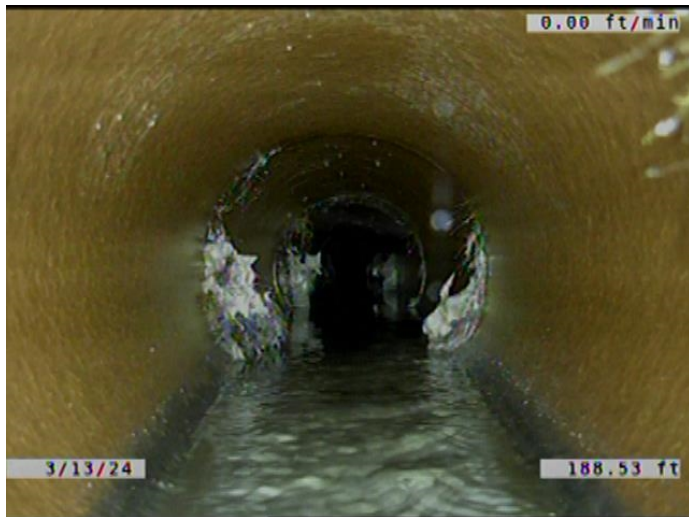
Code: **RFJ**
 Description: **Roots Fine Joint**

Distance (ft): **188.5**
 Structural Grade: **0**
 O&M Grade: **1**
 Clock Start/From: **8**
 Clock To: **4**
 1st Value:
 2nd Value:
 Value Percent:
 Continuous Index: **F05**
 Within 8" of Joint: **YES**
 Remarks:

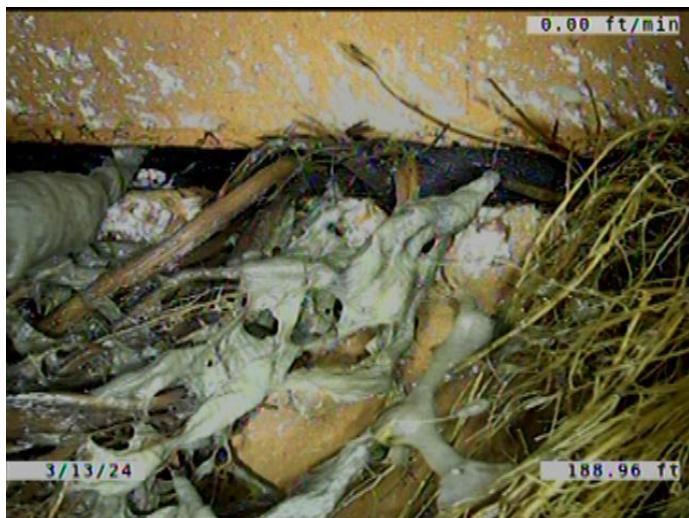
Code: **RMJ**
 Description: **Roots Medium Joint**

Distance (ft): **189.0**
 Structural Grade: **0**
 O&M Grade: **3**
 Clock Start/From: **7**
 Clock To: **5**
 1st Value:
 2nd Value:
 Value Percent: **5.000**
 Continuous Index: **S07**
 Within 8" of Joint: **YES**
 Remarks:

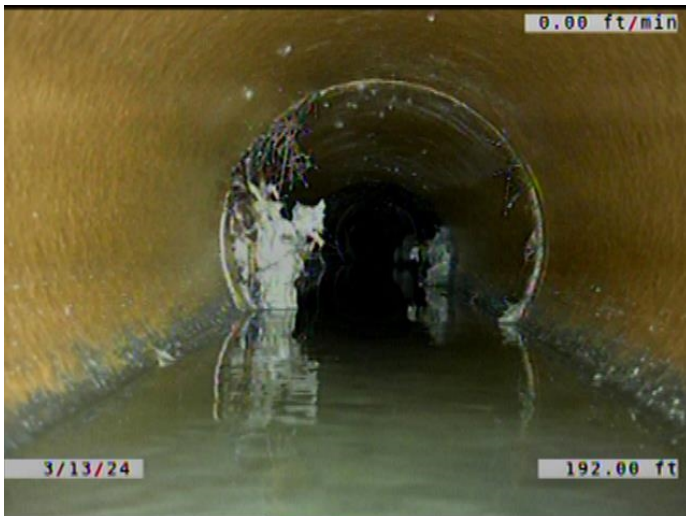
Code: **MWLS**
Description: **Miscellaneous Water Level Sag**

Distance (ft): **192.0**
Structural Grade: **2**
O&M Grade: **0**
Clock Start/From:
Clock To:
1st Value:
2nd Value:
Value Percent: **15.000**
Continuous Index: **S08**
Within 8" of Joint: **NO**
Remarks:

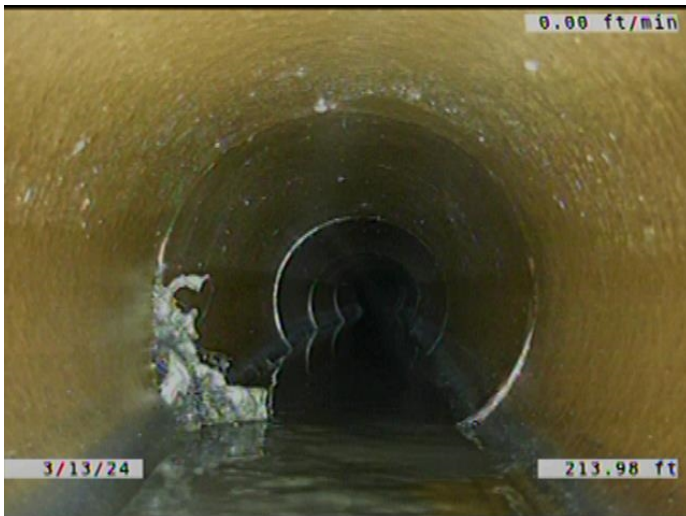
Code: **MWLS**
Description: **Miscellaneous Water Level Sag**

Distance (ft): **214.0**
Structural Grade: **2**
O&M Grade: **0**
Clock Start/From:
Clock To:
1st Value:
2nd Value:
Value Percent: **10.000**
Continuous Index: **S09**
Within 8" of Joint: **NO**
Remarks:

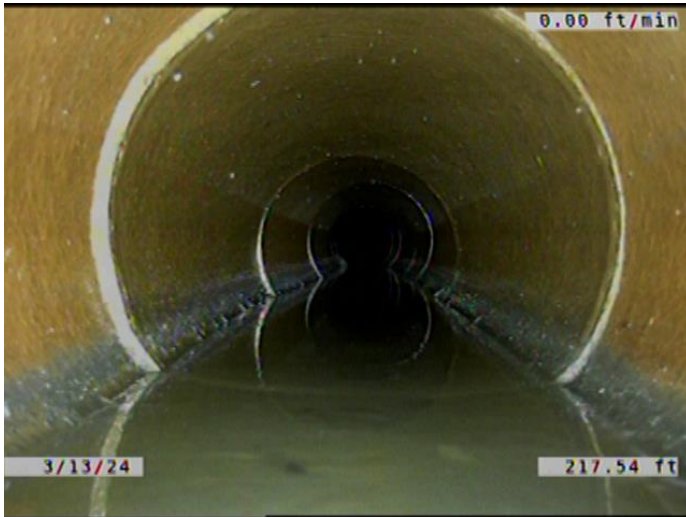
Code: **RMJ**
Description: **Roots Medium Joint**

Distance (ft): **217.5**
Structural Grade: **0**
O&M Grade: **3**
Clock Start/From: **7**
Clock To: **5**
1st Value:
2nd Value:
Value Percent: **5.000**
Continuous Index: **F07**
Within 8" of Joint: **YES**
Remarks:

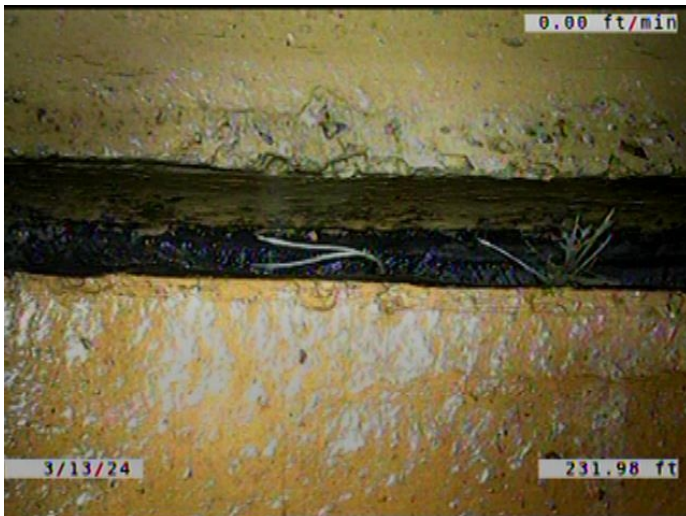
Code: **RFJ**
Description: **Roots Fine Joint**

Distance (ft): **232.0**
Structural Grade: **0**
O&M Grade: **1**
Clock Start/From: **3**
Clock To:
1st Value:
2nd Value:
Value Percent:
Continuous Index:
Within 8" of Joint: **YES**
Remarks:

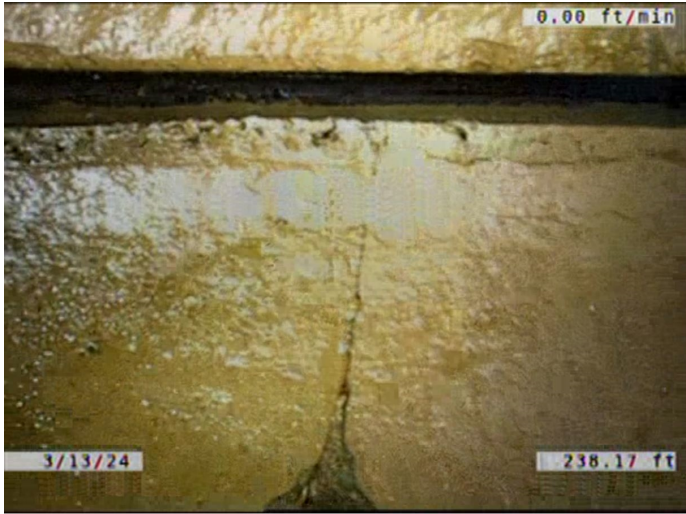
Code: **CL**
Description: **Crack Longitudinal**

Distance (ft): **238.2**
Structural Grade: **2**
O&M Grade: **0**
Clock Start/From: **12**
Clock To:
1st Value:
2nd Value:
Value Percent:
Continuous Index:
Within 8" of Joint: **NO**
Remarks:

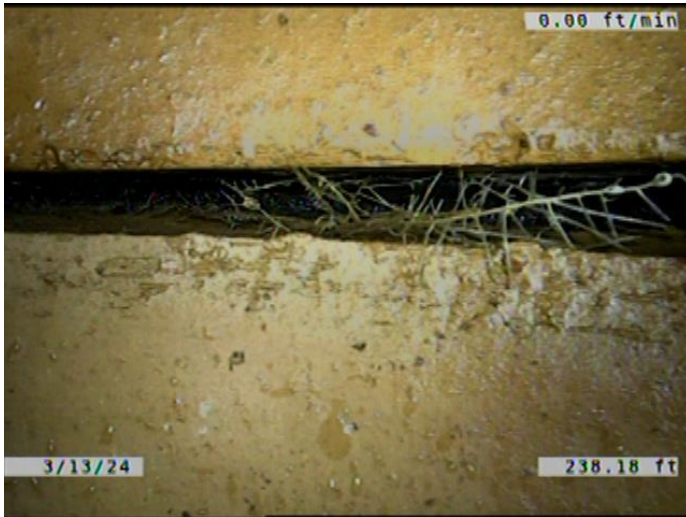
Code: **RFJ**
Description: **Roots Fine Joint**

Distance (ft): **238.2**
Structural Grade: **0**
O&M Grade: **1**
Clock Start/From: **2**
Clock To: **3**
1st Value:
2nd Value:
Value Percent:
Continuous Index:
Within 8" of Joint: **YES**
Remarks:

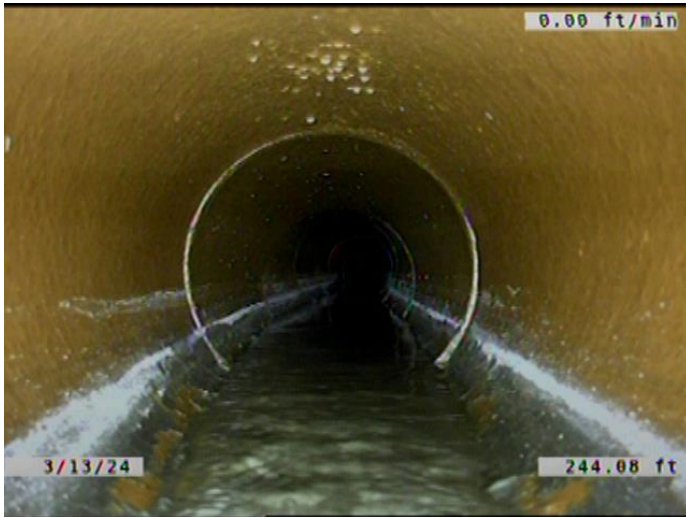
Code: **MWLS**
 Description: **Miscellaneous Water Level Sag**

Distance (ft): **244.1**
 Structural Grade: **2**
 O&M Grade: **0**
 Clock Start/From:
 Clock To:
 1st Value:
 2nd Value:
 Value Percent: **25.000**
 Continuous Index: **S11**
 Within 8" of Joint: **NO**
 Remarks:

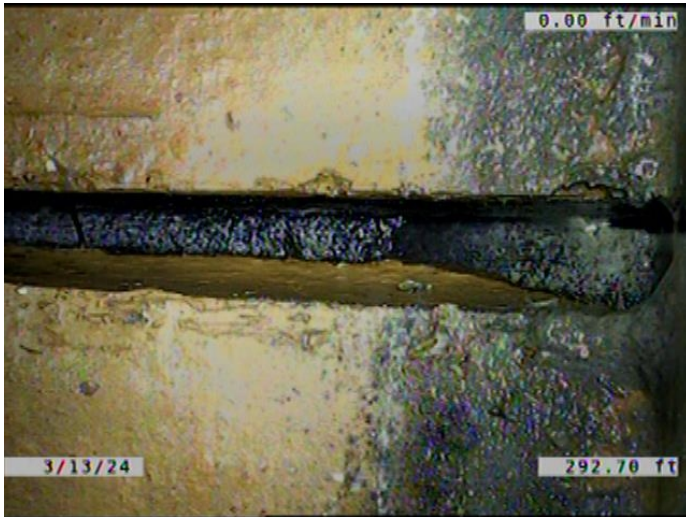
Code: **IRJ**
Description: **Infiltration Runner Joint**

Distance (ft): **292.7**
Structural Grade: **0**
O&M Grade: **4**
Clock Start/From: **2**
Clock To: **3**
1st Value:
2nd Value:
Value Percent:
Continuous Index:
Within 8" of Joint: **YES**
Remarks:

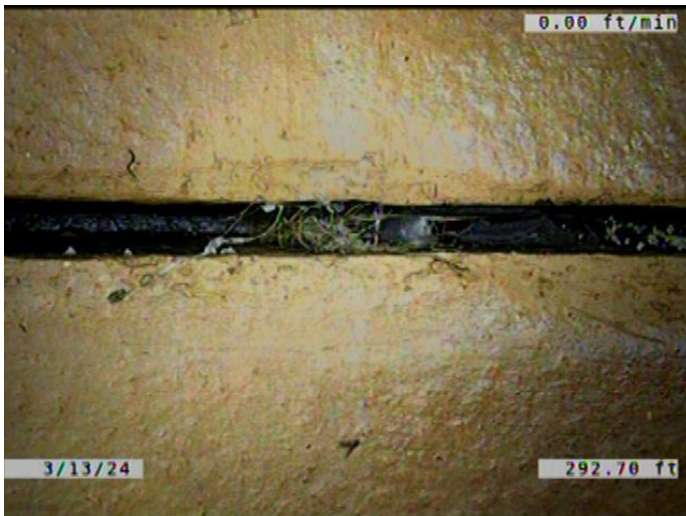
Code: **RFJ**
Description: **Roots Fine Joint**

Distance (ft): **292.7**
Structural Grade: **0**
O&M Grade: **1**
Clock Start/From: **10**
Clock To: **11**
1st Value:
2nd Value:
Value Percent:
Continuous Index:
Within 8" of Joint: **YES**
Remarks:

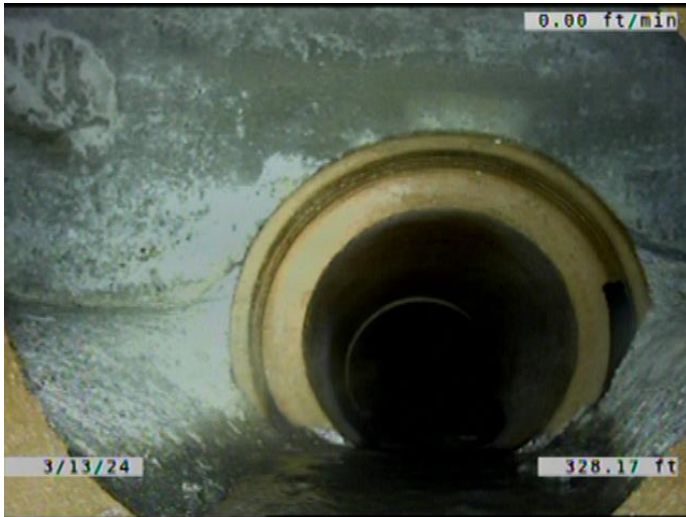
Code: **MWLS**
Description: **Miscellaneous Water Level Sag**

Distance (ft): **328.2**
Structural Grade: **2**
O&M Grade: **0**
Clock Start/From:
Clock To:
1st Value:
2nd Value:
Value Percent: **25.000**
Continuous Index: **F11**
Within 8" of Joint: **NO**
Remarks:

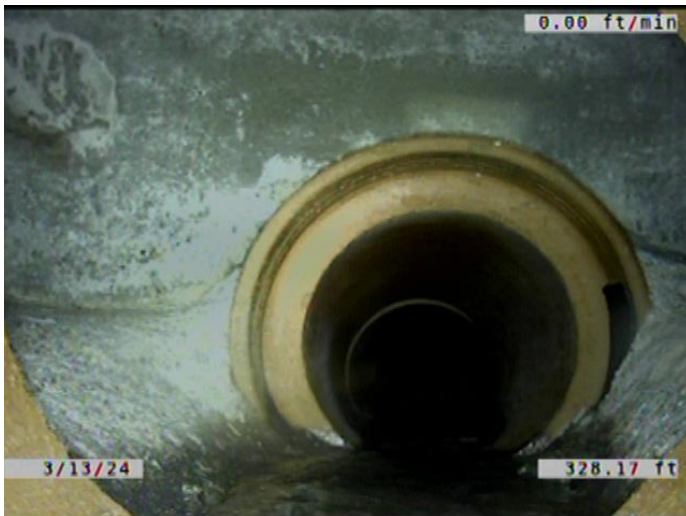
Code: **DSF**
Description: **Deposits Settled Fine**

Distance (ft): **328.2**
Structural Grade: **0**
O&M Grade: **2**
Clock Start/From: **5**
Clock To: **7**
1st Value:
2nd Value:
Value Percent: **5.000**
Continuous Index: **F10**
Within 8" of Joint: **YES**
Remarks:
