## Profile/Photo Observation Report

Street:	<b>ALLEY BETWEEN OAKWOOD DR &amp; S</b>	Flow Control:	<b>Not Controlled</b>
City:	<b>Hobart, IN</b>	Year Renewed:	
Location:	<b>Yard</b>	Tape/Media #:	
Purpose:	<b>Routine Assessment</b>	Dia/Height:	<b>10"</b>
Use:	<b>Sanitary</b>	Material:	<b>VCP</b>
Drain Area:	<b>NA</b>	Lining:	
Category:	<b>NA</b>		
Comment:	<b>Flow direction wrong</b>

Location Details:		Direction of Survey:	<b>Downstream</b>
US MH:	<b>M-405-051</b>	DS MH:	<b>M-405-052</b>
		Total Length Surveyed (ft):	<b>193.5</b>

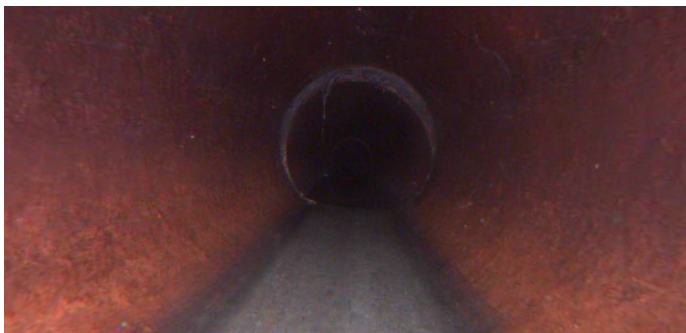
Code: **AMH**  
Description: **Manhole**

Distance (ft): **.0**  
Structural Grade: **0**  
O&M Grade: **0**  
Clock Start/From:  
Clock To:  
1st Value:  
2nd Value:  
Value Percent:  
Continuous Index:  
Within 8" of Joint: **NO**  
Remarks: **M-405-051**

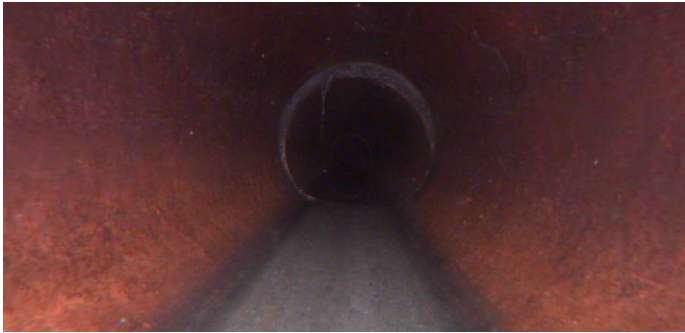
Code:	<b>MWL</b>
Description:	<b>Water Level</b>

Distance (ft):	<b>.0</b>
Structural Grade:	<b>0</b>
O&M Grade:	<b>0</b>
Clock Start/From:	
Clock To:	
1st Value:	
2nd Value:	
Value Percent:	<b>5.000</b>
Continuous Index:	
Within 8" of Joint:	<b>NO</b>
Remarks:

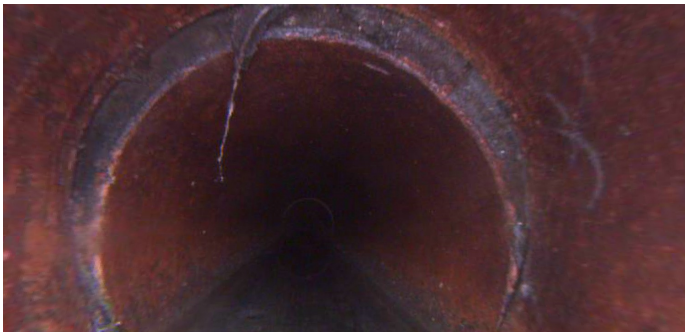
Code:	<b>RFJ</b>
Description:	<b>Roots Fine Joint</b>

Distance (ft):	<b>2.2</b>
Structural Grade:	<b>0</b>
O&M Grade:	<b>1</b>
Clock Start/From:	<b>12</b>
Clock To:	
1st Value:	
2nd Value:	
Value Percent:	
Continuous Index:	
Within 8" of Joint:	<b>YES</b>
Remarks:

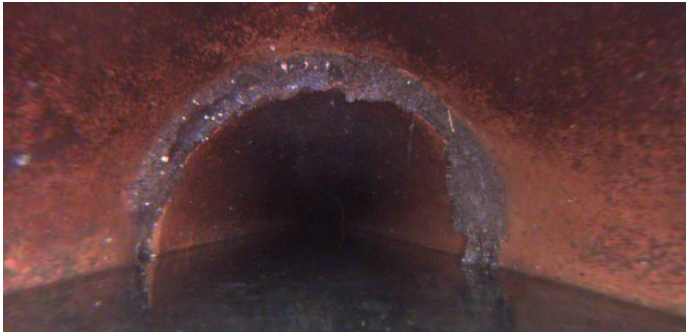
Code: **RFJ**  
Description: **Roots Fine Joint**

Distance (ft): **10.1**  
Structural Grade: **0**  
O&M Grade: **1**  
Clock Start/From: **8**  
Clock To: **4**  
1st Value:  
2nd Value:  
Value Percent:  
Continuous Index: **S01**  
Within 8" of Joint: **YES**  
Remarks:

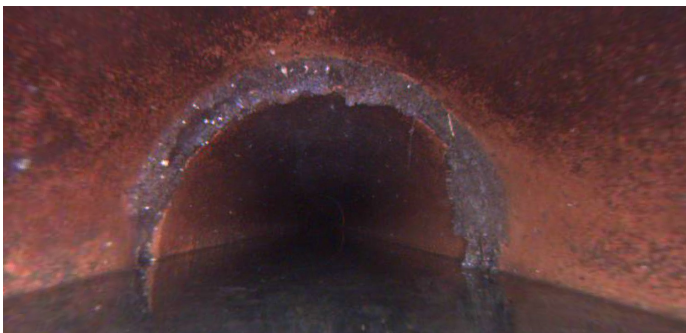
Code: **MWL**  
Description: **Water Level**

Distance (ft): **10.1**  
Structural Grade: **0**  
O&M Grade: **0**  
Clock Start/From:  
Clock To:  
1st Value:  
2nd Value:  
Value Percent: **40.000**  
Continuous Index:  
Within 8" of Joint: **NO**  
Remarks:

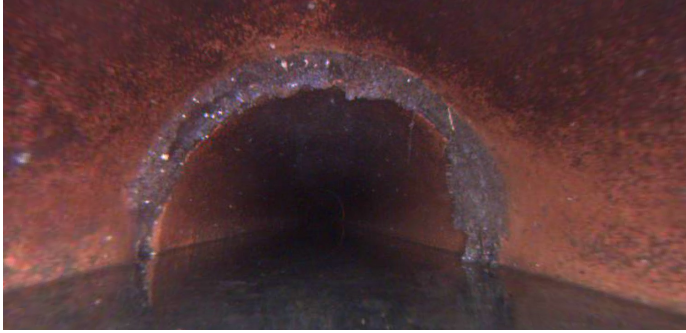
Code:	<b>DAZ</b>
Description:	<b>Deposits Attached Other</b>

Distance (ft):	<b>10.1</b>
Structural Grade:	<b>0</b>
O&M Grade:	<b>2</b>
Clock Start/From:	<b>8</b>
Clock To:	<b>4</b>
1st Value:	
2nd Value:	
Value Percent:	<b>5.000</b>
Continuous Index:	<b>S02</b>
Within 8" of Joint:	<b>YES</b>
Remarks:

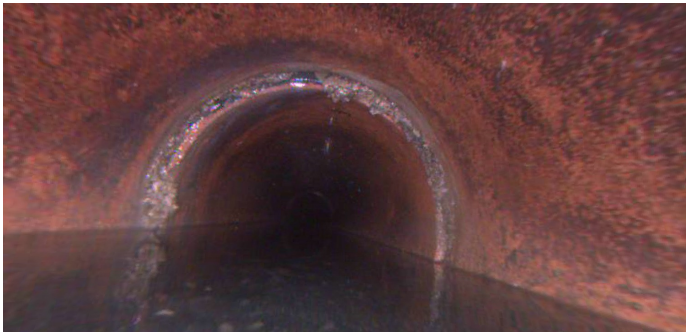
Code:	<b>ID</b>
Description:	<b>Infil Dripper</b>

Distance (ft):	<b>18.3</b>
Structural Grade:	<b>0</b>
O&M Grade:	<b>3</b>
Clock Start/From:	<b>12</b>
Clock To:	
1st Value:	
2nd Value:	
Value Percent:	
Continuous Index:	
Within 8" of Joint:	<b>YES</b>
Remarks:

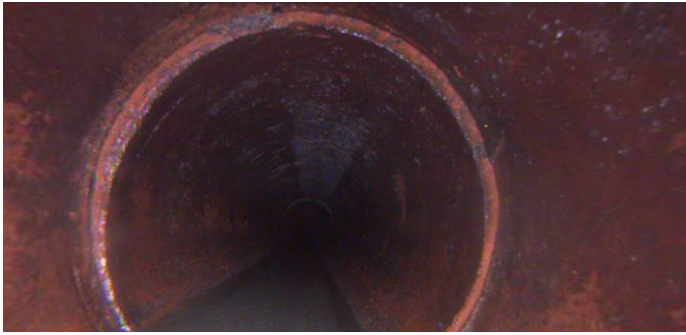
Code: **RFJ**  
Description: **Roots Fine Joint**

Distance (ft): **68.1**  
Structural Grade: **0**  
O&M Grade: **1**  
Clock Start/From: **8**  
Clock To: **4**  
1st Value:  
2nd Value:  
Value Percent:  
Continuous Index: **F01**  
Within 8" of Joint: **YES**  
Remarks:

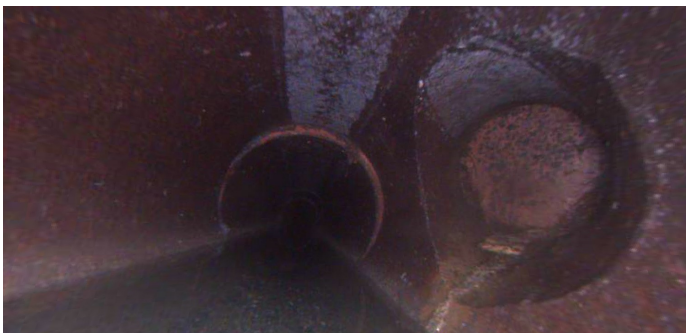
Code: **TF**  
Description: **Tap Factory**

Distance (ft): **81.6**  
Structural Grade: **0**  
O&M Grade: **0**  
Clock Start/From: **3**  
Clock To:  
1st Value: **4.000**  
2nd Value:  
Value Percent:  
Continuous Index:  
Within 8" of Joint:  
Remarks:

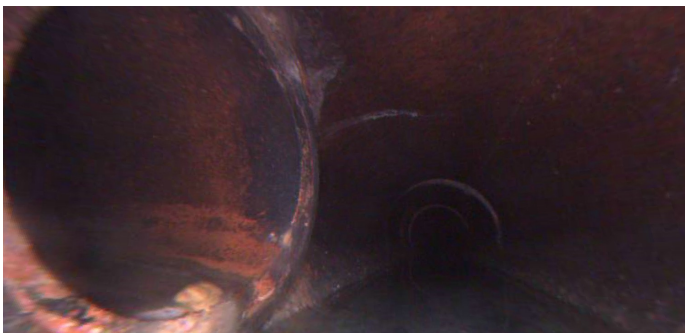
Code: **TBI**  
Description: **Tap Break-in Intruding**

Distance (ft): **146.6**  
Structural Grade: **0**  
O&M Grade: **2**  
Clock Start/From: **9**  
Clock To:  
1st Value: **4.000**  
2nd Value: **1.000**  
Value Percent:  
Continuous Index:  
Within 8" of Joint:  
Remarks:

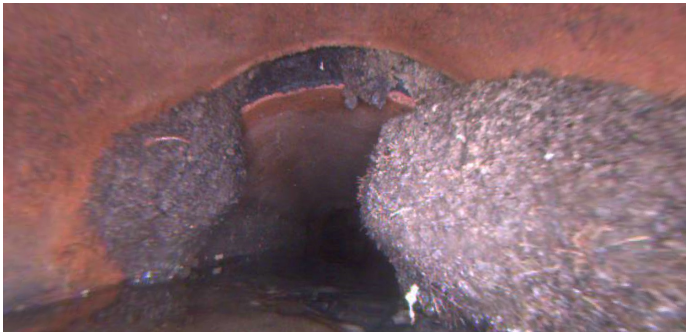
Code: **RMJ**  
Description: **Roots Medium Joint**

Distance (ft): **187.6**  
Structural Grade: **0**  
O&M Grade: **3**  
Clock Start/From: **8**  
Clock To: **4**  
1st Value:  
2nd Value:  
Value Percent: **40.000**  
Continuous Index:  
Within 8" of Joint: **YES**  
Remarks:

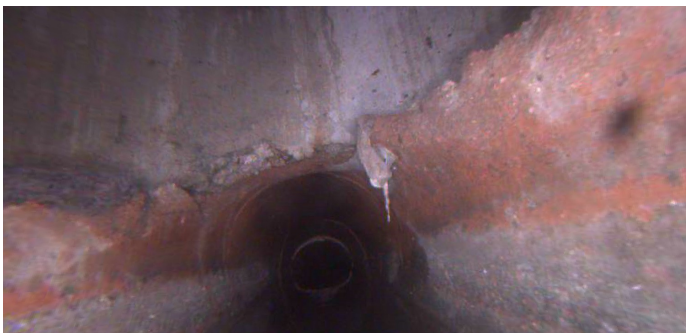
Code: **AMH**  
Description: **Manhole**

Distance (ft): **193.5**  
Structural Grade: **0**  
O&M Grade: **0**  
Clock Start/From:  
Clock To:  
1st Value:  
2nd Value:  
Value Percent:  
Continuous Index:  
Within 8" of Joint: **NO**  
Remarks: **M-405-052**
