Profile/Photo Observation Report

Street:	FOXCROFT STREET	Flow Control:	Not Controlled
City:	Hobart, IN	Year Renewed:	
Location:	Yard	Tape/Media #:	
Purpose:	Routine Assessment	Dia/Height:	12"
Use:	Sanitary	Material:	VCP
Drain Area:	NA	Lining:	
Category:	NA		
Comment:	F_S_P_C at 2 ft grit/ debris.Flow Direction wrong		
Location Details:		Direction of Survey:	Downstream
US MH:	M-405-051	DS MH:	M-405-056
		Total Length Surveyed (ft):	3.7

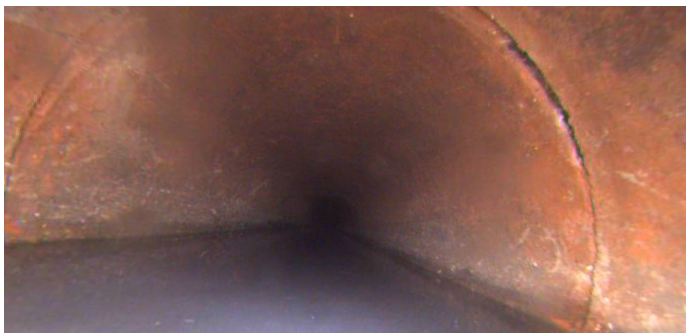
Code: **AMH**
Description: **Manhole**

Distance (ft): **.0**
Structural Grade: **0**
O&M Grade: **0**
Clock Start/From:
Clock To:
1st Value:
2nd Value:
Value Percent:
Continuous Index:
Within 8" of Joint: **NO**
Remarks: **M-405-051**

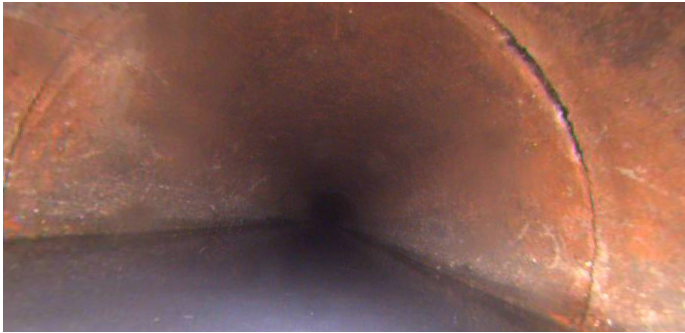
Code:	MWL
Description:	Water Level

Distance (ft):	.0
Structural Grade:	0
O&M Grade:	0
Clock Start/From:	
Clock To:	
1st Value:	
2nd Value:	
Value Percent:	40.000
Continuous Index:	
Within 8" of Joint:	NO
Remarks:

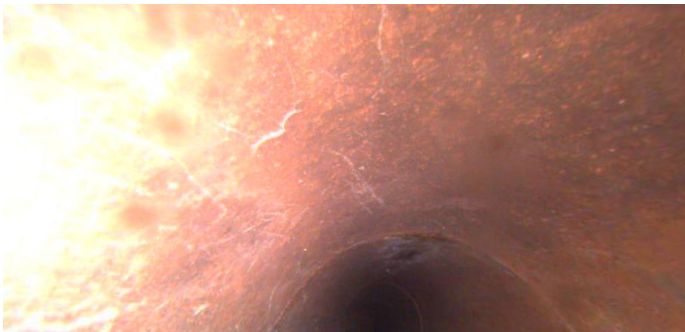
Code:	MSA
Description:	Abandoned Survey

Distance (ft):	3.7
Structural Grade:	0
O&M Grade:	0
Clock Start/From:	
Clock To:	
1st Value:	
2nd Value:	
Value Percent:	
Continuous Index:	
Within 8" of Joint:	NO
Remarks:	DEBRIS UNDER WATER
