Profile/Photo Observation Report

Date:	04/23/2018	Weather:		Coding:	PACP 6.0
Pipe Length (ft):	191.7	Owner:	NA	Pre Clean:	No Pre-Cleaning
P.O.#:		Surveyor:	Jen Costello	PSR:	P-405-054-052
Customer:		Clean Date:	01/01/1900	Shape:	C

Street:	ALLEY BETWEEN OAKWOOD DR & S	Flow Control:	Not Controlled
City:	Hobart, IN	Year Renewed:	
Location:	Yard	Tape/Media #:	
Purpose:	Routine Assessment	Dia/Height:	10"
Use:	Sanitary	Material:	VCP
Drain Area:	NA	Lining:	
Category:	NA		
Comment:	R_M at 7 ft debris .Flow direction wrong		
Location Details:		Direction of Survey:	Upstream
US MH:	M-405-052	DS MH:	M-405-054
		Total Length Surveyed (ft):	7.5

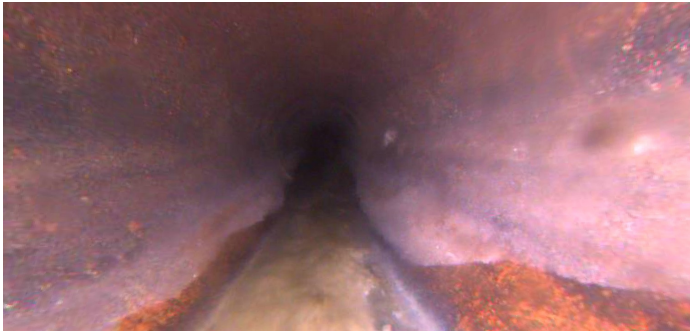
Code: AMH

Description: Manhole

Distance (ft): .0

Remarks: M-405-054

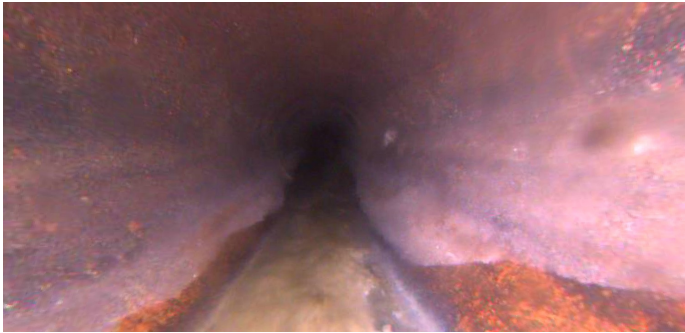
Code:	MWL
Description:	Water Level

Distance (ft):	.0
Structural Grade:	0
O&M Grade:	0
Clock Start/From:	
Clock To:	
1st Value:	
2nd Value:	
Value Percent:	5.000
Continuous Index:	
Within 8" of Joint:	NO
Remarks:

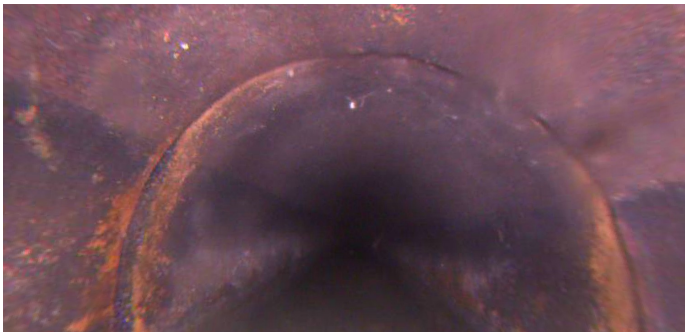
Code:	MSA
Description:	Abandoned Survey

Distance (ft):	7.5
Structural Grade:	0
O&M Grade:	0
Clock Start/From:	
Clock To:	
1st Value:	
2nd Value:	
Value Percent:	
Continuous Index:	
Within 8" of Joint:	NO
Remarks:	UNKNOWN
