Profile/Photo Observation Report

O&M Index:	1.53	O&M Quick:	352F	O&M Rating:	133.00
Structural Index:	2.48	Structural Quick:	5144	Structural Rating:	104.00
Overall Index:	1.84	Overall Quick:	5144	Overall Rating:	237.00

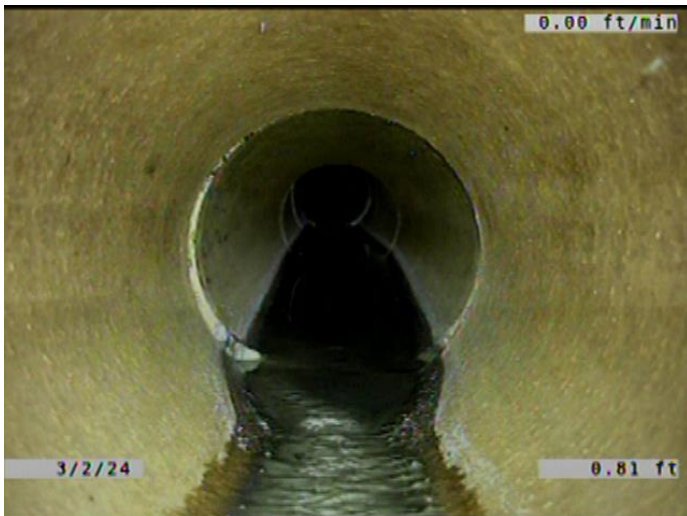
Code: **LD**
Description: **Line Down**

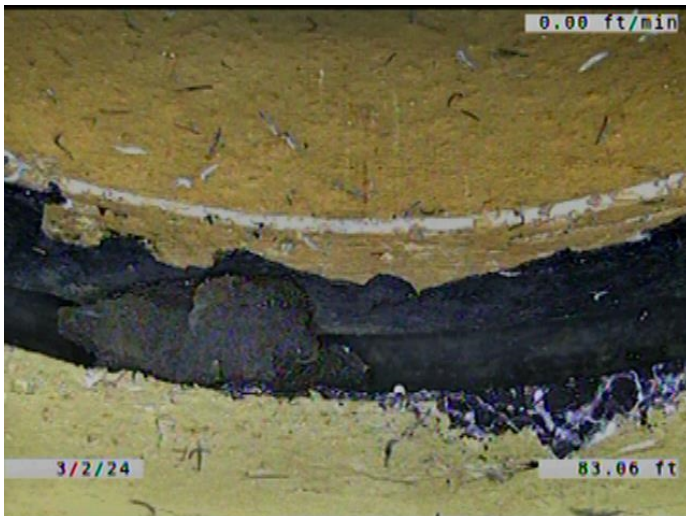
Code: **JOMD**
Description: **Joint Offset Medium Defective**

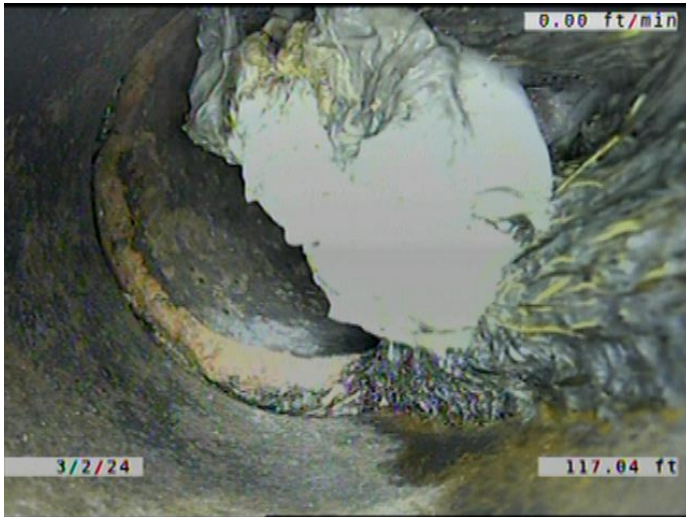
Code:	TFD
Description:	Tap Factory Defective
Distance (ft):	117.0
Structural Grade:	0
O&M Grade:	3
Clock Start/From:	2
Clock To:	
1st Value:	6.000
2nd Value:	
Value Percent:	
Continuous Index:	
Within 8" of Joint:	YES
Remarks:	ROOTS GROWING FROM THE SERVICE TO MAIN CONNECTION INT

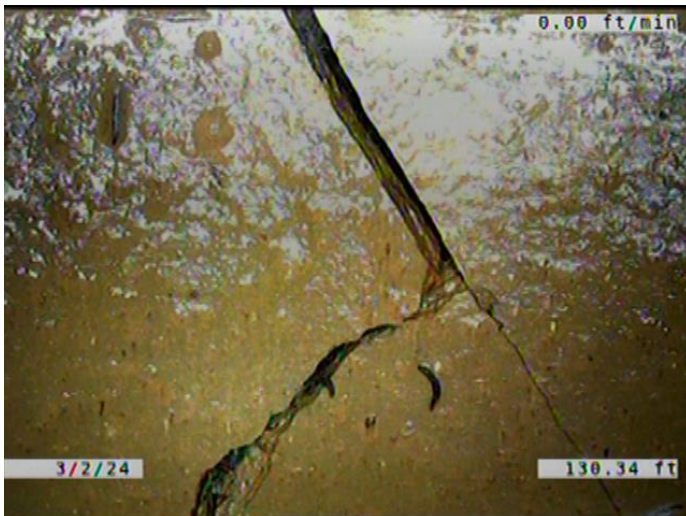
Code: **B**
Description: **Broken**

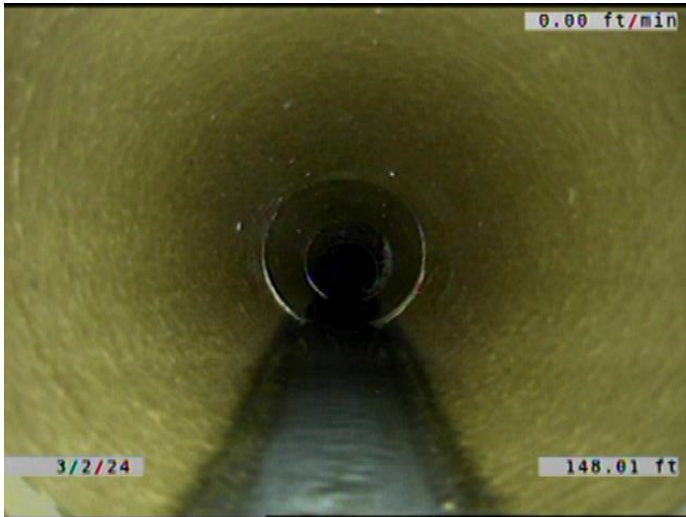
Code: **MWLS**
Description: **Miscellaneous Water Level Sag**

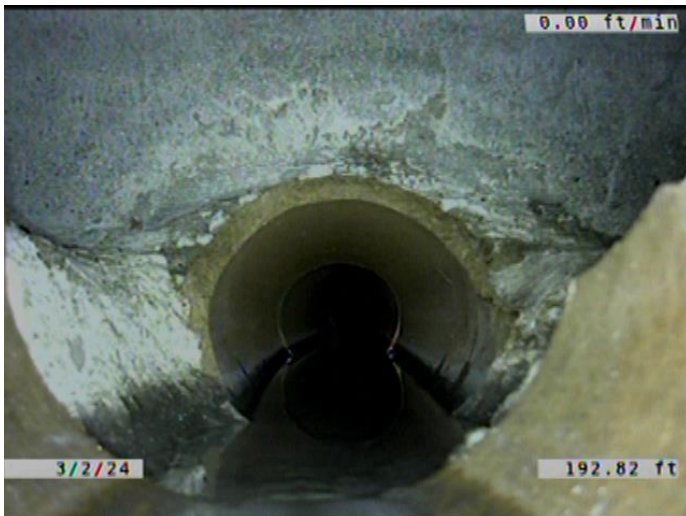
Code: **MWLS**
Description: **Miscellaneous Water Level Sag**
