Profile/Photo Observation Report

Street:	FOXCROFT STREET	Flow Control:	Not Controlled
City:	Hobart, IN	Year Renewed:	
Location:	Woods	Tape/Media #:	
Purpose:	Routine Assessment	Dia/Height:	10"
Use:	Sanitary	Material:	VCP
Drain Area:	NA	Lining:	
Category:	NA		
Comment:	P_C at 12 ft grit . Flow direction wrong		
Location Details:		Direction of Survey:	Upstream
US MH:	M-405-057	DS MH:	M-405-059
		Total Length Surveyed (ft):	12.7

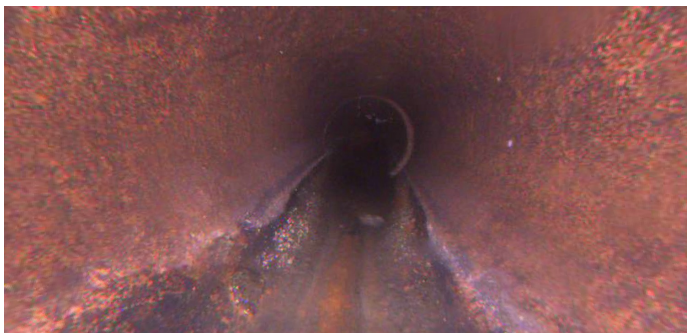
Code: **AMH**
Description: **Manhole**

Distance (ft): **.0**
Structural Grade: **0**
O&M Grade: **0**
Clock Start/From:
Clock To:
1st Value:
2nd Value:
Value Percent:
Continuous Index:
Within 8" of Joint: **NO**
Remarks: **M-405-059**

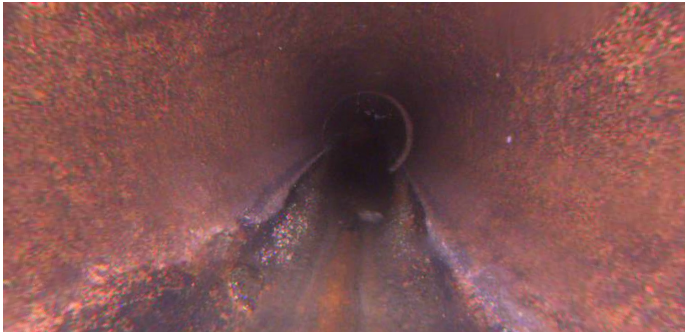
Code:	MWL
Description:	Water Level

Distance (ft):	.0
Structural Grade:	0
O&M Grade:	0
Clock Start/From:	
Clock To:	
1st Value:	
2nd Value:	
Value Percent:	5.000
Continuous Index:	
Within 8" of Joint:	NO
Remarks:

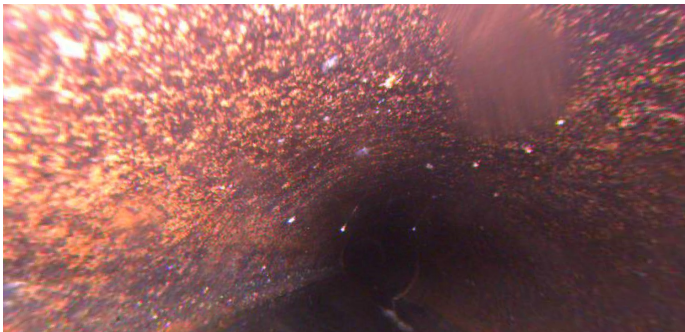
Code:	MSA
Description:	Abandoned Survey

Distance (ft):	12.7
Structural Grade:	0
O&M Grade:	0
Clock Start/From:	
Clock To:	
1st Value:	
2nd Value:	
Value Percent:	
Continuous Index:	
Within 8" of Joint:	NO
Remarks:	UNKNOWN
