Profile/Photo Observation Report

Street:	ALLEY BETWEEN OAKWOOD DR & S	Flow Control:	Not Controlled
City:	Hobart, IN	Year Renewed:	
Location:	Woods	Tape/Media #:	
Purpose:	Routine Assessment	Dia/Height:	8"
Use:	Sanitary	Material:	VCP
Drain Area:	NA	Lining:	
Category:	NA		
Comment:	F_S_P_C at 5 ft grit . Flow direction wrong		
Location Details:		Direction of Survey:	Downstream
US MH:	M-405-059	DS MH:	M-405-060
		Total Length Surveyed (ft):	6.4

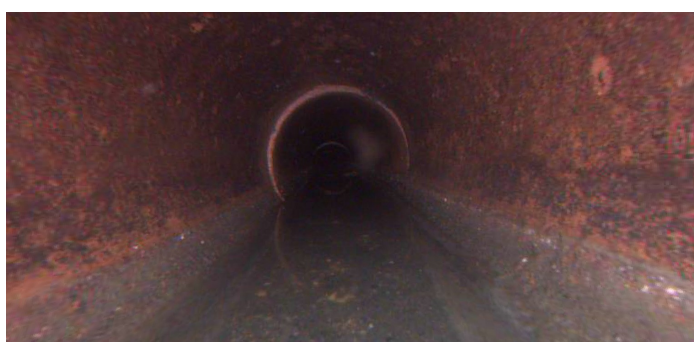
Code: **AMH**
Description: **Manhole**

Distance (ft): **.0**
Structural Grade: **0**
O&M Grade: **0**
Clock Start/From:
Clock To:
1st Value:
2nd Value:
Value Percent:
Continuous Index:
Within 8" of Joint: **NO**
Remarks: **M-405-059**

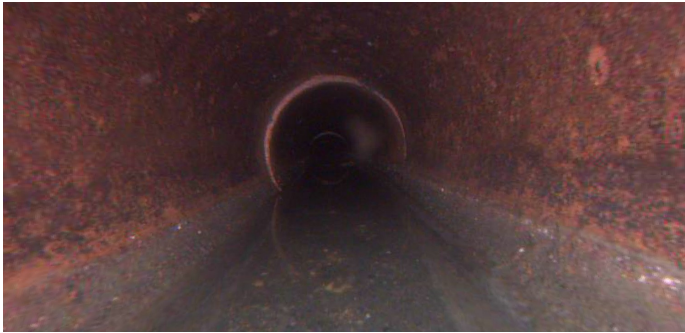
Code:	MWL
Description:	Water Level

Distance (ft):	.0
Structural Grade:	0
O&M Grade:	0
Clock Start/From:	
Clock To:	
1st Value:	
2nd Value:	
Value Percent:	5.000
Continuous Index:	
Within 8" of Joint:	NO
Remarks:

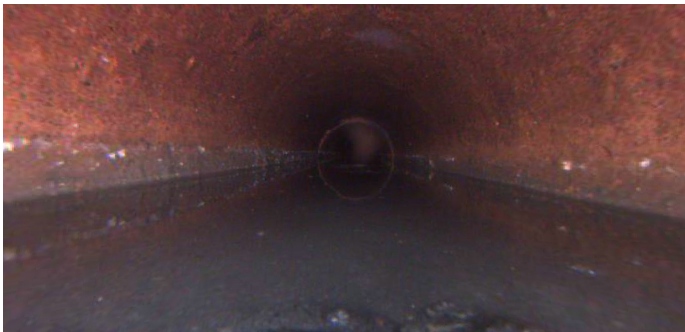
Code:	MSA
Description:	Abandoned Survey

Distance (ft):	6.4
Structural Grade:	0
O&M Grade:	0
Clock Start/From:	
Clock To:	
1st Value:	
2nd Value:	
Value Percent:	
Continuous Index:	
Within 8" of Joint:	NO
Remarks:	DEBRIS UNDER WATER
