Profile/Photo Observation Report

Date:	04/25/2018	Weather:		Coding:	PACP 6.0
Pipe Length (ft):		Owner:	City of Hobart	Pre Clean:	No Pre-Cleaning
P.O.#:	86	Surveyor:	M. Pielacha	PSR:	P-405-069-096
Customer:	City of Hobart	Clean Date:		Shape:	C

Street:	3rd Street	Flow Control:	Not Controlled
City:	Hobart, IN	Year Renewed:	
Location:	Light Highway	Tape/Media #:	DEP 86
Purpose:	Routine Assessment	Dia/Height:	18"
Use:	Sanitary	Material:	CP
Drain Area:		Lining:	
Category:	NA		
Comment:	YES501824 Submittal 2		
Location Details:		Direction of Survey:	Downstream
US MH:	M-405-069	DS MH:	M-505-095
		Total Length Surveyed (ft):	305.9

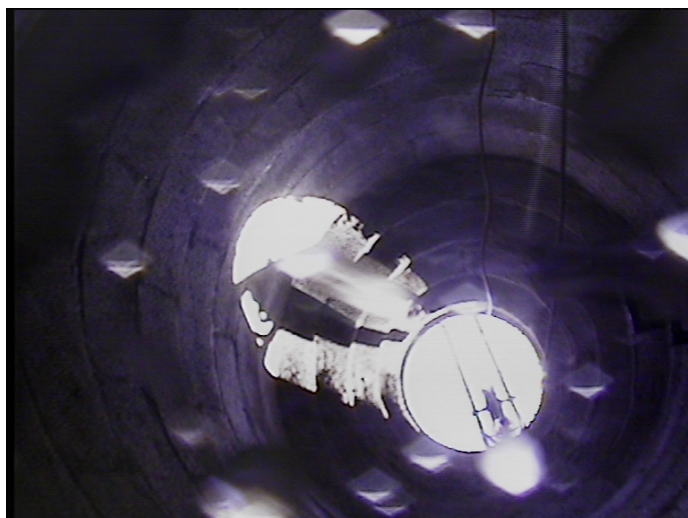
Code: **AMH**
 Description: **Manhole**

Distance (ft): **.0**
 Structural Grade: **0**
 O&M Grade: **0**
 Clock Start/From:
 Clock To:
 1st Value:
 2nd Value:
 Value Percent:
 Continuous Index:
 Within 8" of Joint: **NO**
 Remarks: **M-405-069**

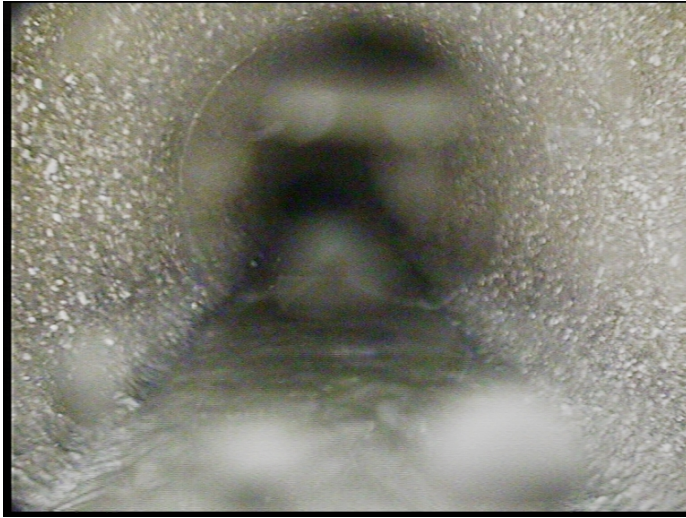
Code: **MWL**
Description: **Water Level**

Distance (ft): **.0**
Structural Grade: **0**
O&M Grade: **0**
Clock Start/From:
Clock To:
1st Value:
2nd Value:
Value Percent: **10.000**
Continuous Index:
Within 8" of Joint: **NO**
Remarks:

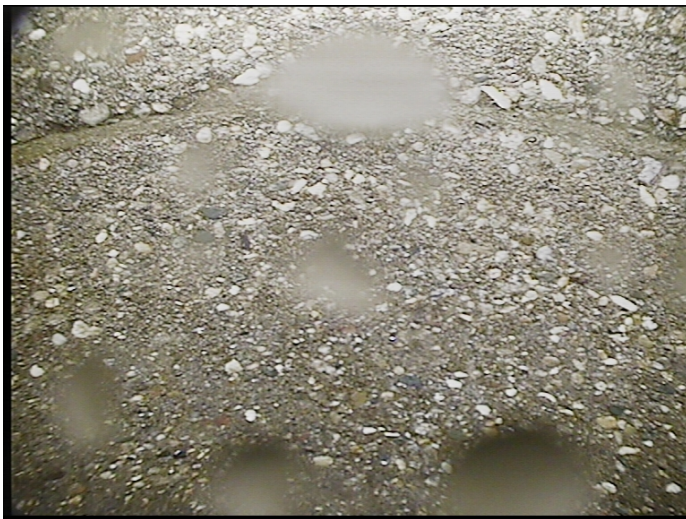
Code: **SAV**
Description: **Surface Aggregate Visible**

Distance (ft): **4.6**
Structural Grade: **3**
O&M Grade: **0**
Clock Start/From: **8**
Clock To: **4**
1st Value:
2nd Value:
Value Percent:
Continuous Index: **S01**
Within 8" of Joint: **YES**
Remarks:

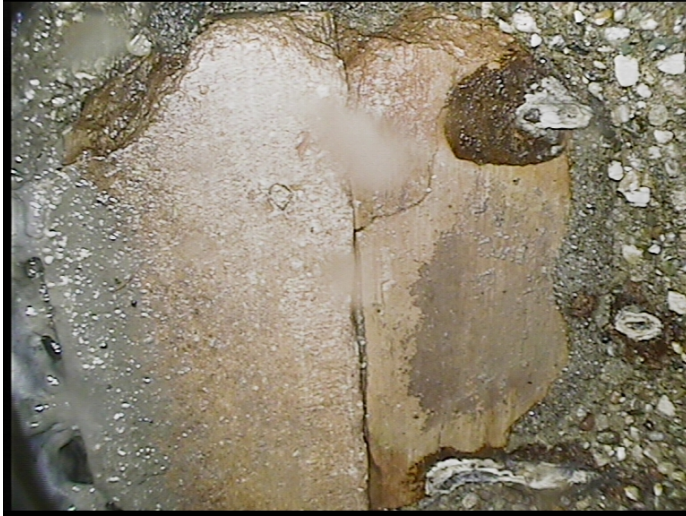
Code: **TBC**
Description: **Tap Break-in Capped**

Distance (ft): **30.1**
Structural Grade: **0**
O&M Grade: **2**
Clock Start/From: **9**
Clock To:
1st Value: **4.000**
2nd Value:
Value Percent:
Continuous Index:
Within 8" of Joint: **NO**
Remarks:

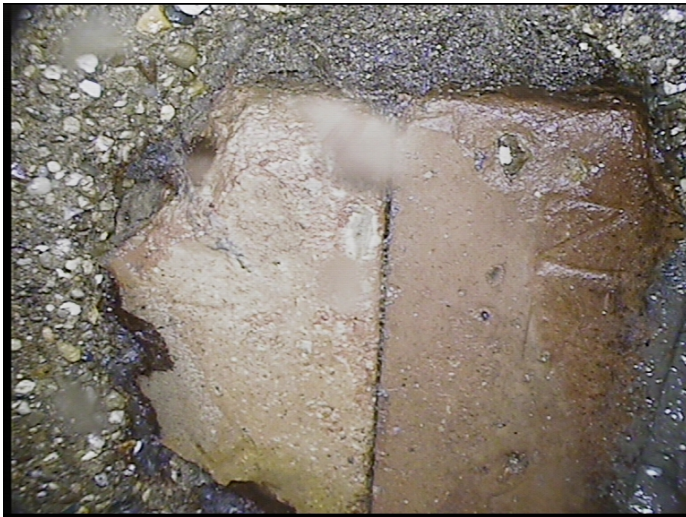
Code: **TBC**
Description: **Tap Break-in Capped**

Distance (ft): **42.4**
Structural Grade: **0**
O&M Grade: **2**
Clock Start/From: **3**
Clock To:
1st Value: **4.000**
2nd Value:
Value Percent:
Continuous Index:
Within 8" of Joint: **NO**
Remarks:

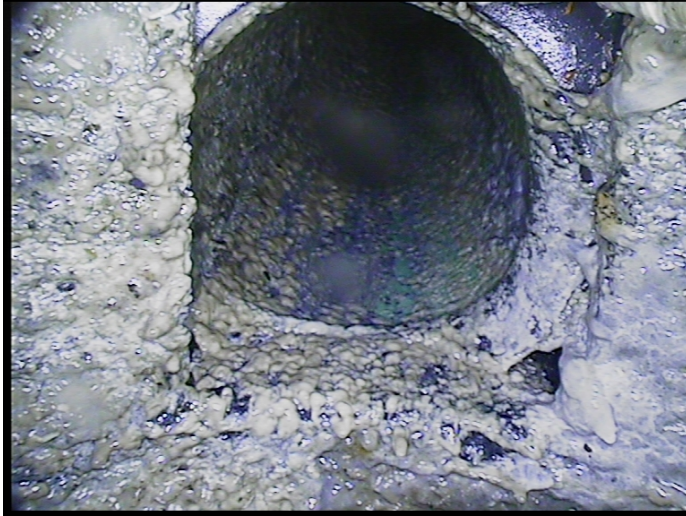
Code: **TB**
Description: **Tap Break-in**

Distance (ft): **134.6**
Structural Grade: **0**
O&M Grade: **0**
Clock Start/From: **12**
Clock To:
1st Value: **4.000**
2nd Value:
Value Percent:
Continuous Index:
Within 8" of Joint: **NO**
Remarks:

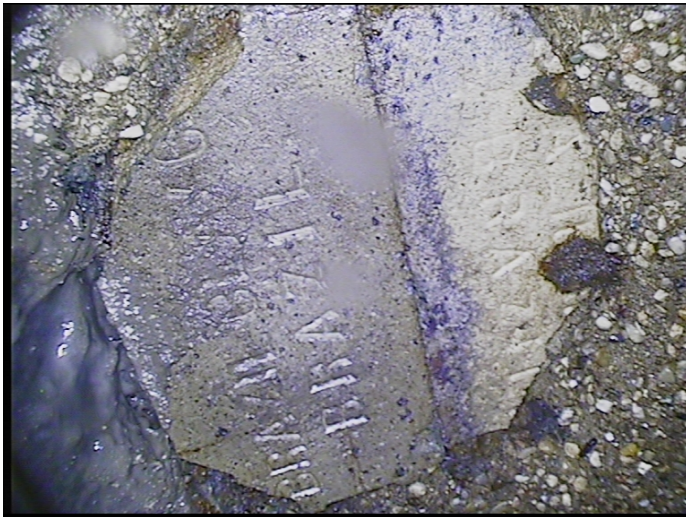
Code: **TB**
Description: **Tap Break-in**

Distance (ft): **167.2**
Structural Grade: **0**
O&M Grade: **0**
Clock Start/From: **9**
Clock To:
1st Value: **4.000**
2nd Value:
Value Percent:
Continuous Index:
Within 8" of Joint: **NO**
Remarks:

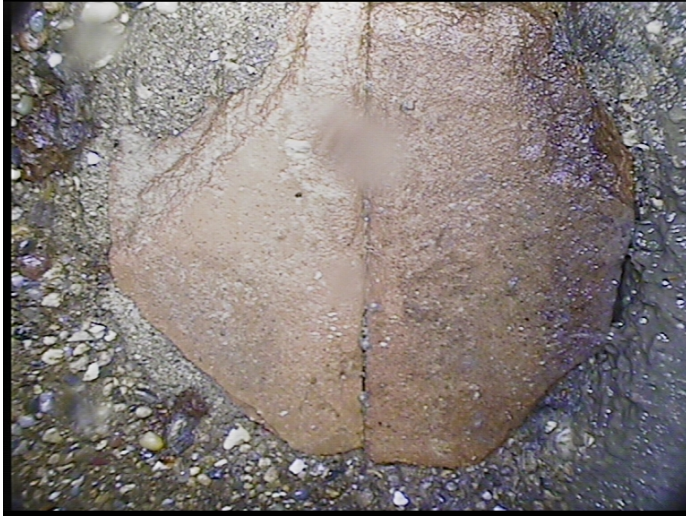
Code: **TB**
Description: **Tap Break-in**

Distance (ft): **170.4**
Structural Grade: **0**
O&M Grade: **0**
Clock Start/From: **3**
Clock To:
1st Value: **4.000**
2nd Value:
Value Percent:
Continuous Index:
Within 8" of Joint: **NO**
Remarks:

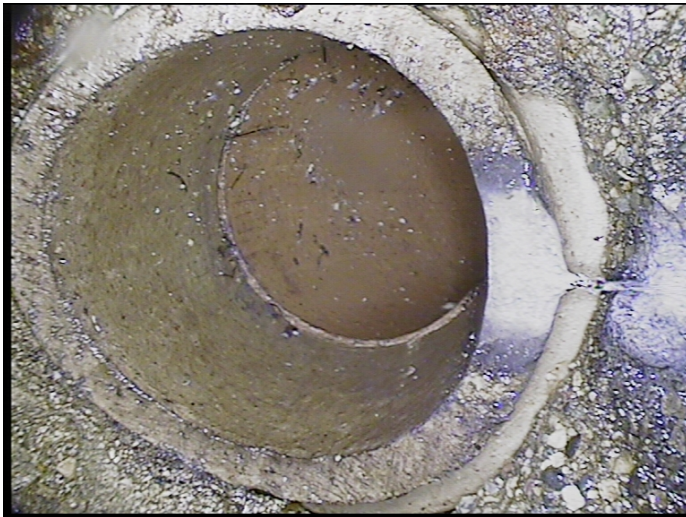
Code: **TBA**
Description: **Tap Break-in Active**

Distance (ft): **195.8**
Structural Grade: **0**
O&M Grade: **0**
Clock Start/From: **2**
Clock To:
1st Value: **4.000**
2nd Value:
Value Percent:
Continuous Index:
Within 8" of Joint: **NO**
Remarks:

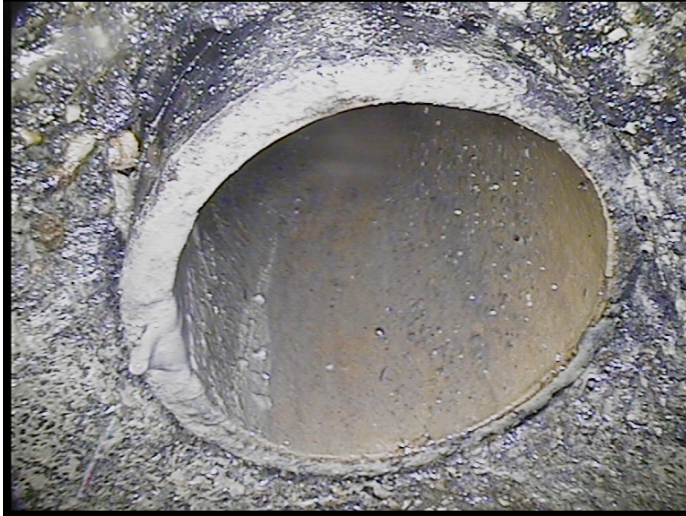
Code: **TB**
Description: **Tap Break-in**

Distance (ft): **221.3**
Structural Grade: **0**
O&M Grade: **0**
Clock Start/From: **11**
Clock To:
1st Value: **4.000**
2nd Value:
Value Percent:
Continuous Index:
Within 8" of Joint: **NO**
Remarks:

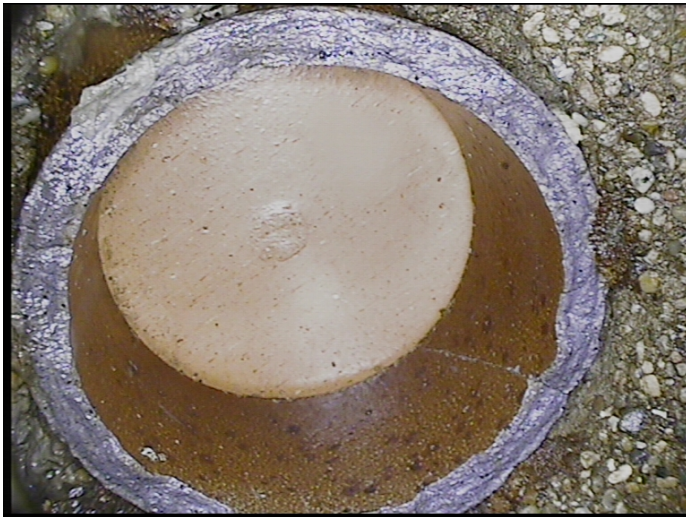
Code: **TBC**
Description: **Tap Break-in Capped**

Distance (ft): **234.3**
Structural Grade: **0**
O&M Grade: **2**
Clock Start/From: **9**
Clock To:
1st Value: **4.000**
2nd Value:
Value Percent:
Continuous Index:
Within 8" of Joint: **NO**
Remarks:

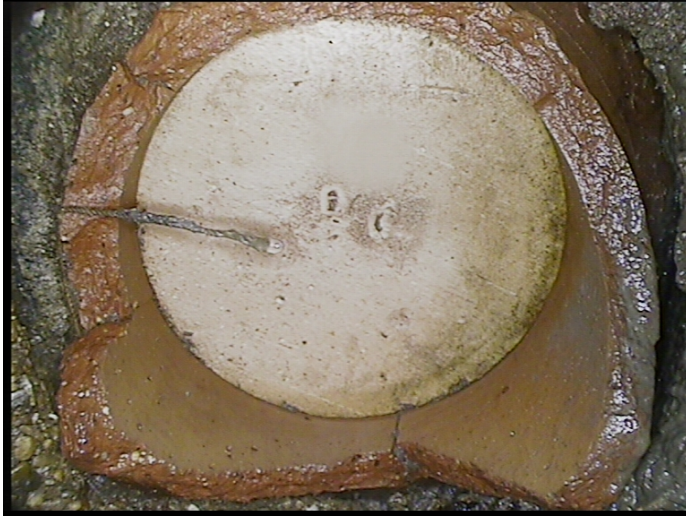
Code: **TBC**
Description: **Tap Break-in Capped**

Distance (ft): **268.2**
Structural Grade: **0**
O&M Grade: **2**
Clock Start/From: **3**
Clock To:
1st Value: **4.000**
2nd Value:
Value Percent:
Continuous Index:
Within 8" of Joint: **NO**
Remarks:

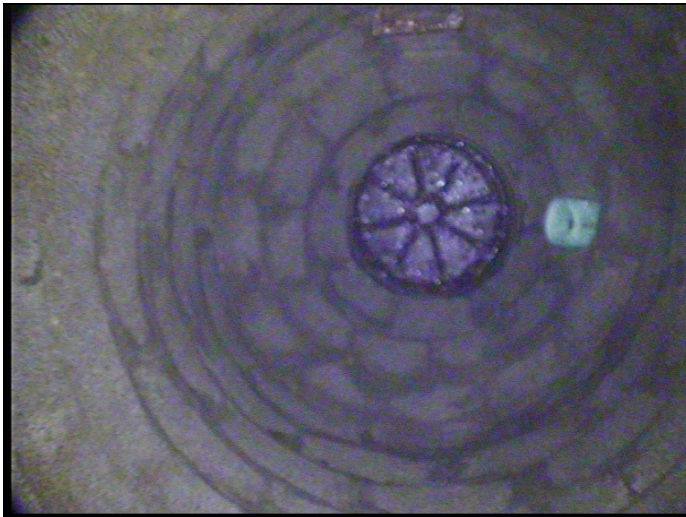
Code: **SAV**
Description: **Surface Aggregate Visible**

Distance (ft): **305.9**
Structural Grade: **3**
O&M Grade: **0**
Clock Start/From: **8**
Clock To: **4**
1st Value:
2nd Value:
Value Percent:
Continuous Index: **F01**
Within 8" of Joint: **NO**
Remarks:

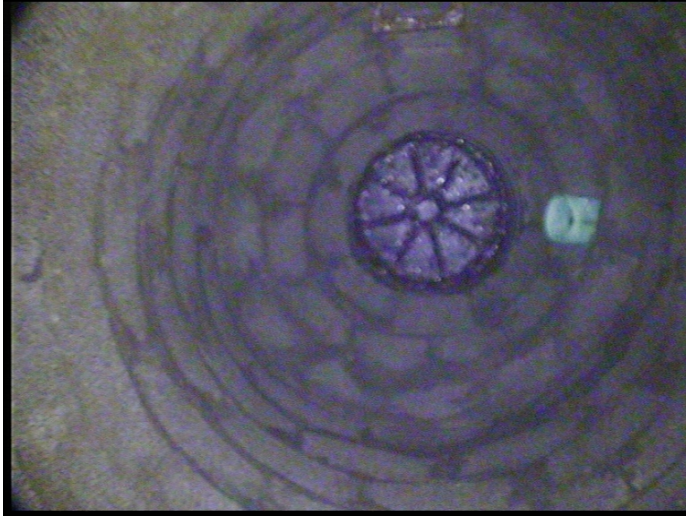
Code:	AMH
Description:	Manhole
Distance (ft):	305.9
Structural Grade:	0
O&M Grade:	0
Clock Start/From:	
Clock To:	
1st Value:	
2nd Value:	
Value Percent:	
Continuous Index:	
Within 8" of Joint:	NO
Remarks:	M-505-095
